**RHIC POWER
SUPPLY
HARWARE PLANS
FOR
FEBRUARY 2002
TO
OCTOBER 2002**

RHIC Power Supply Hardware Plans

Major Problems and Solutions from June 2001 to January 2002

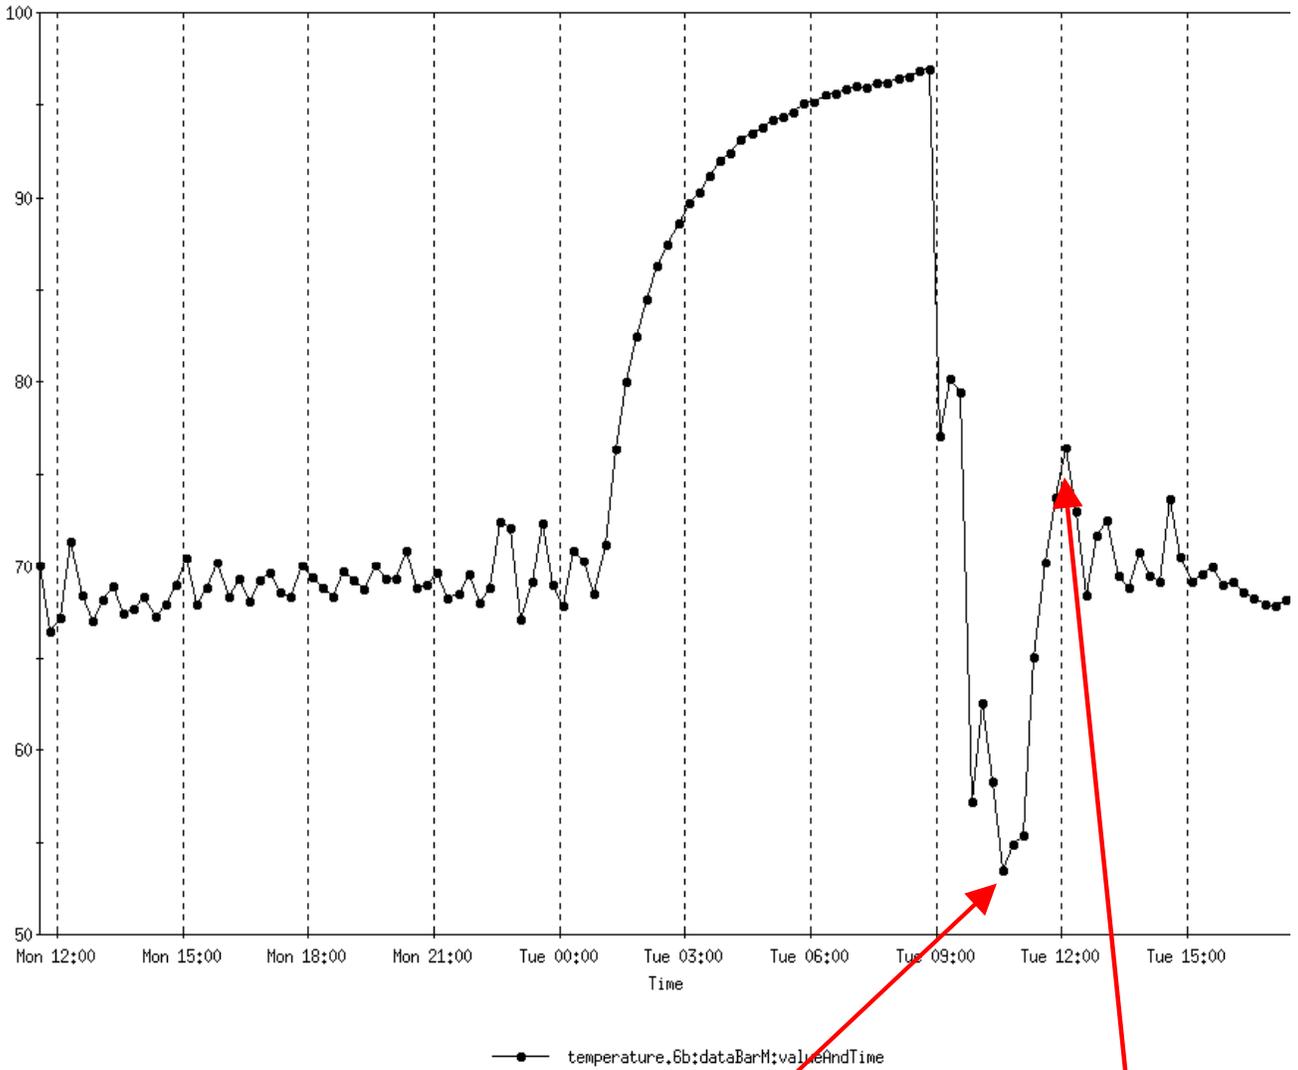
These next two slides show one temperature log of the control room in 6b. We had two unexplained yellow QLI's that originated in 6b, this day, and they occurred when there was a large, fast, temperature variation in the 6b control room. We have not been able to explain this yet.

First Unexplained Yellow QLI (10:32)

Second Unexplained Yellow QLI (12:01)

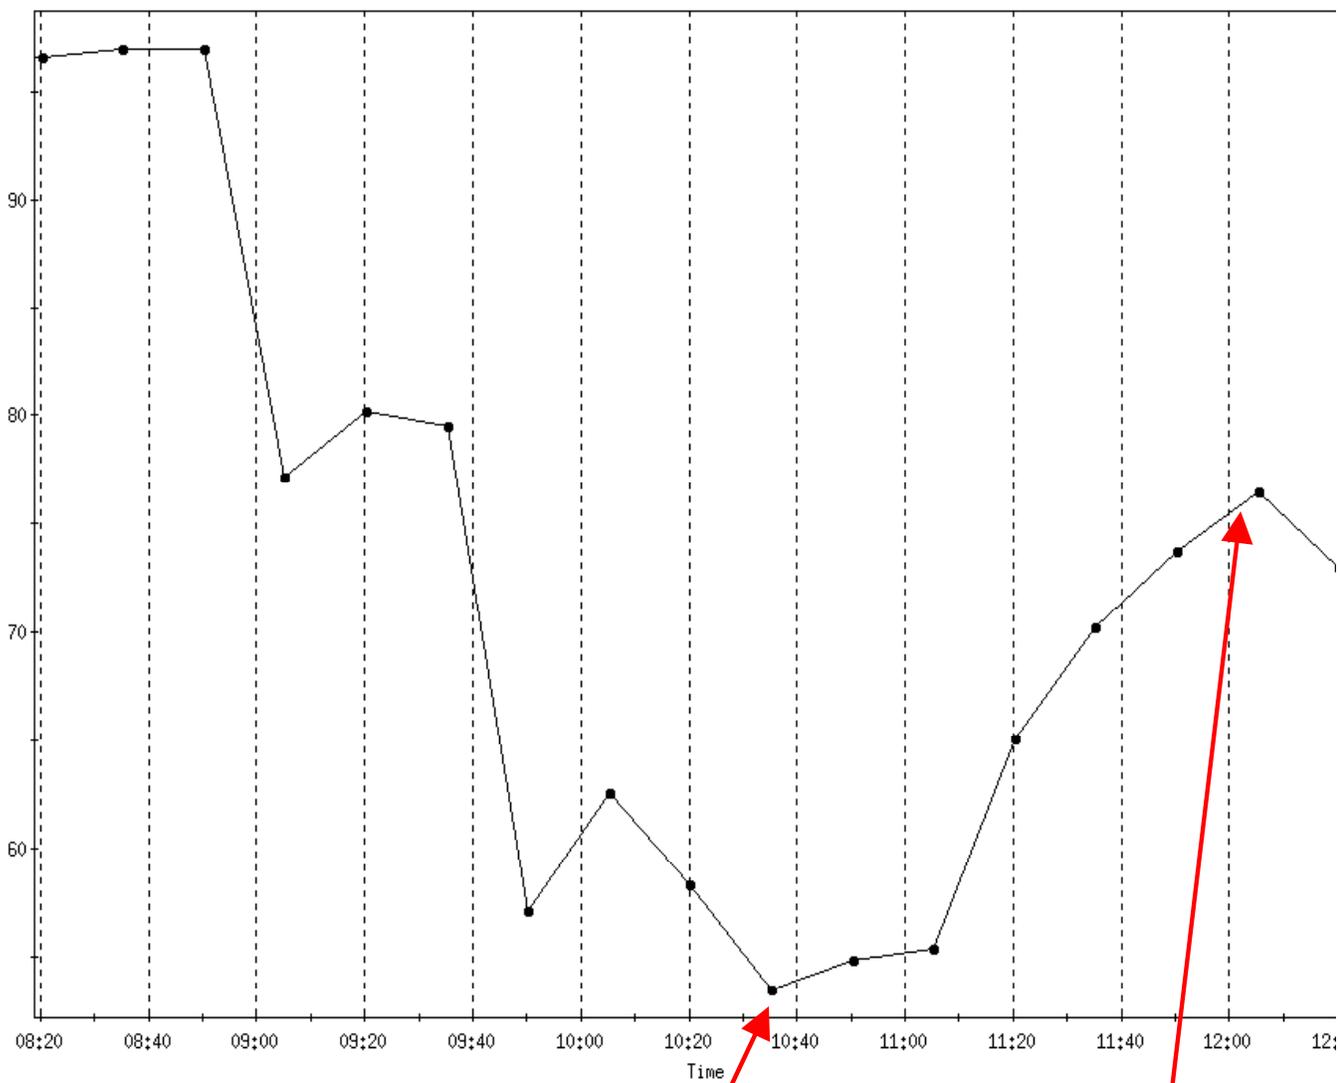
First Unexplained Yellow QLI (10:32)

Second Unexplained Yellow QLI (12:01)
