RHIC - Blue & Yellow Main Power Supply Faults

for the Months of October 2001 - January 2002

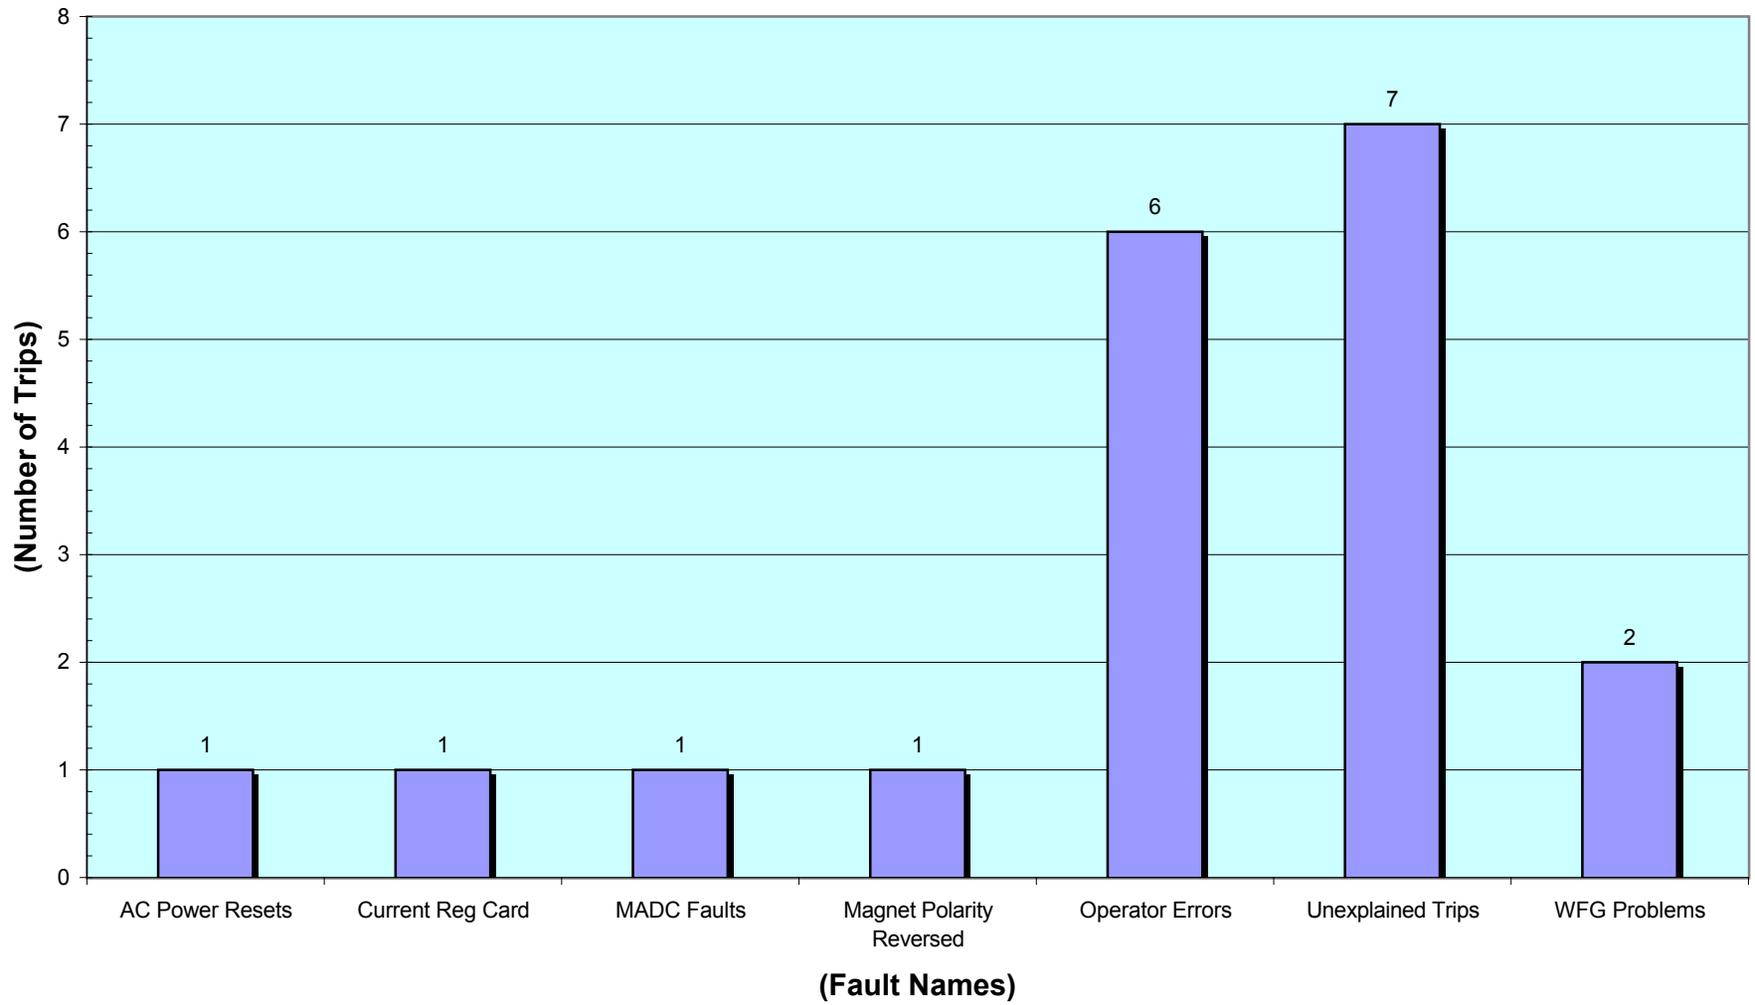
RHIC - Gamma-T Power Supply Faults for the Months of August 2001 - November 2001

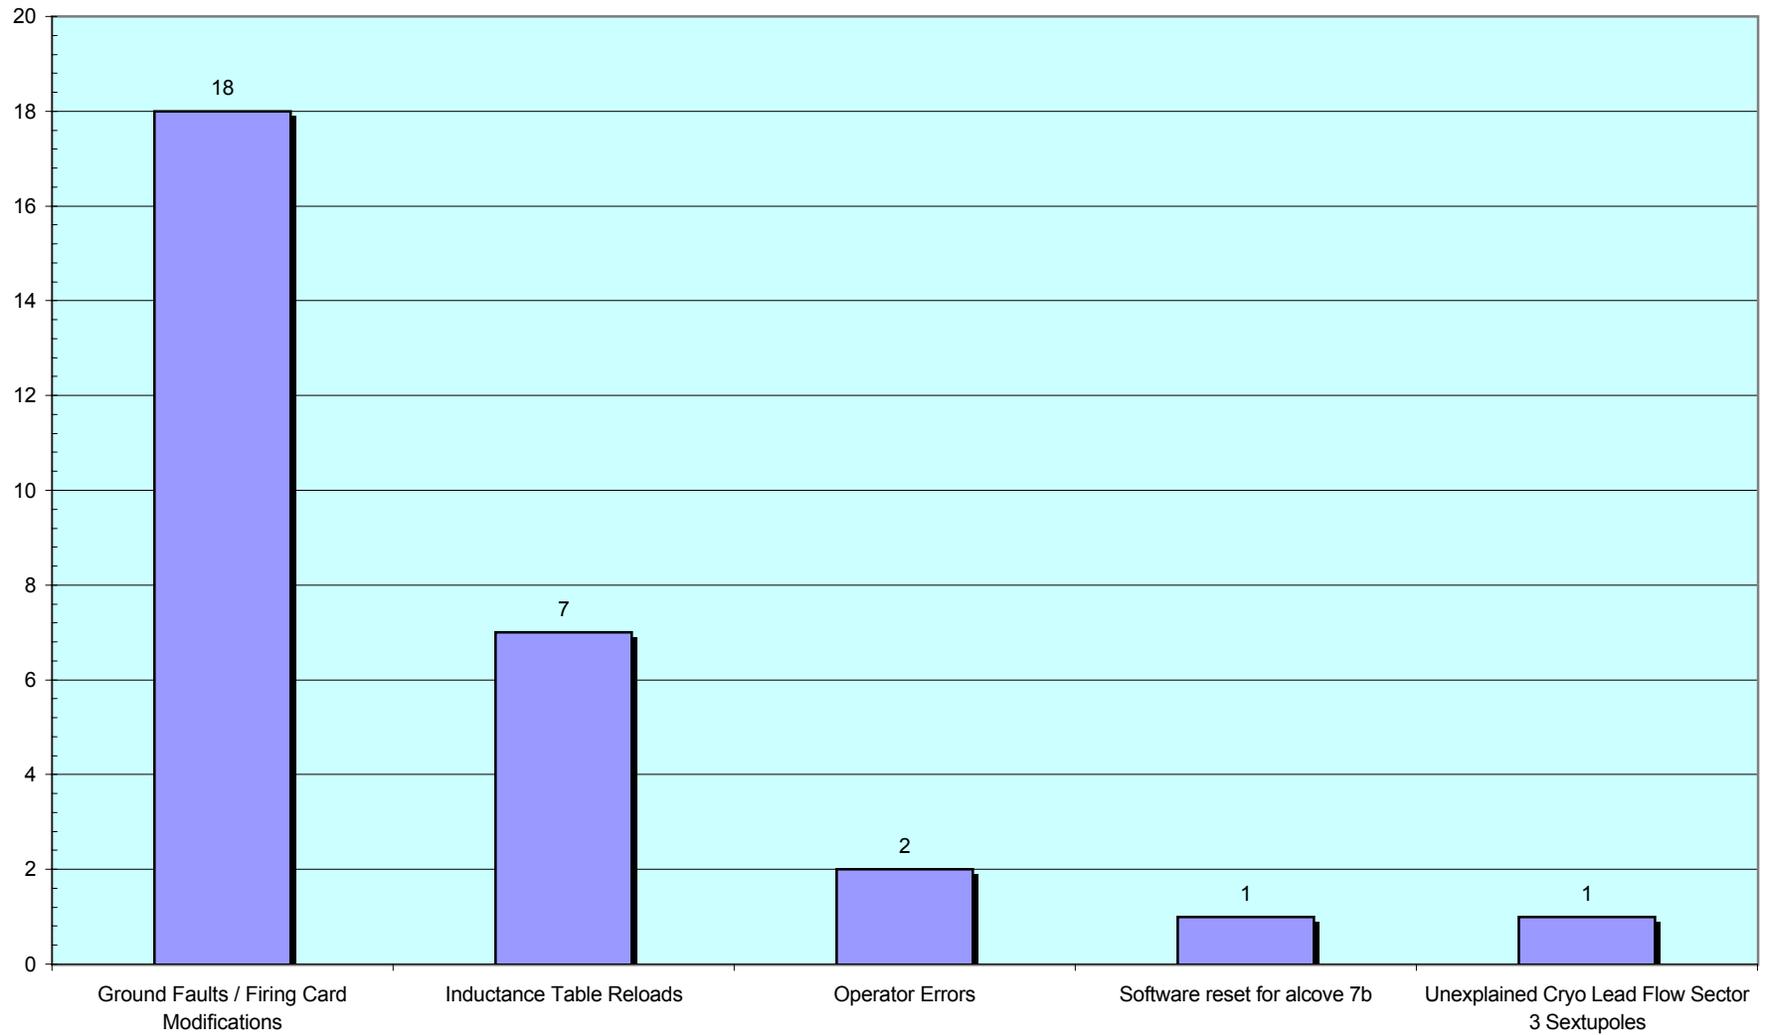
RHIC - Sextupole Power Supply Faults
for the Months of August 2001 - January 2002

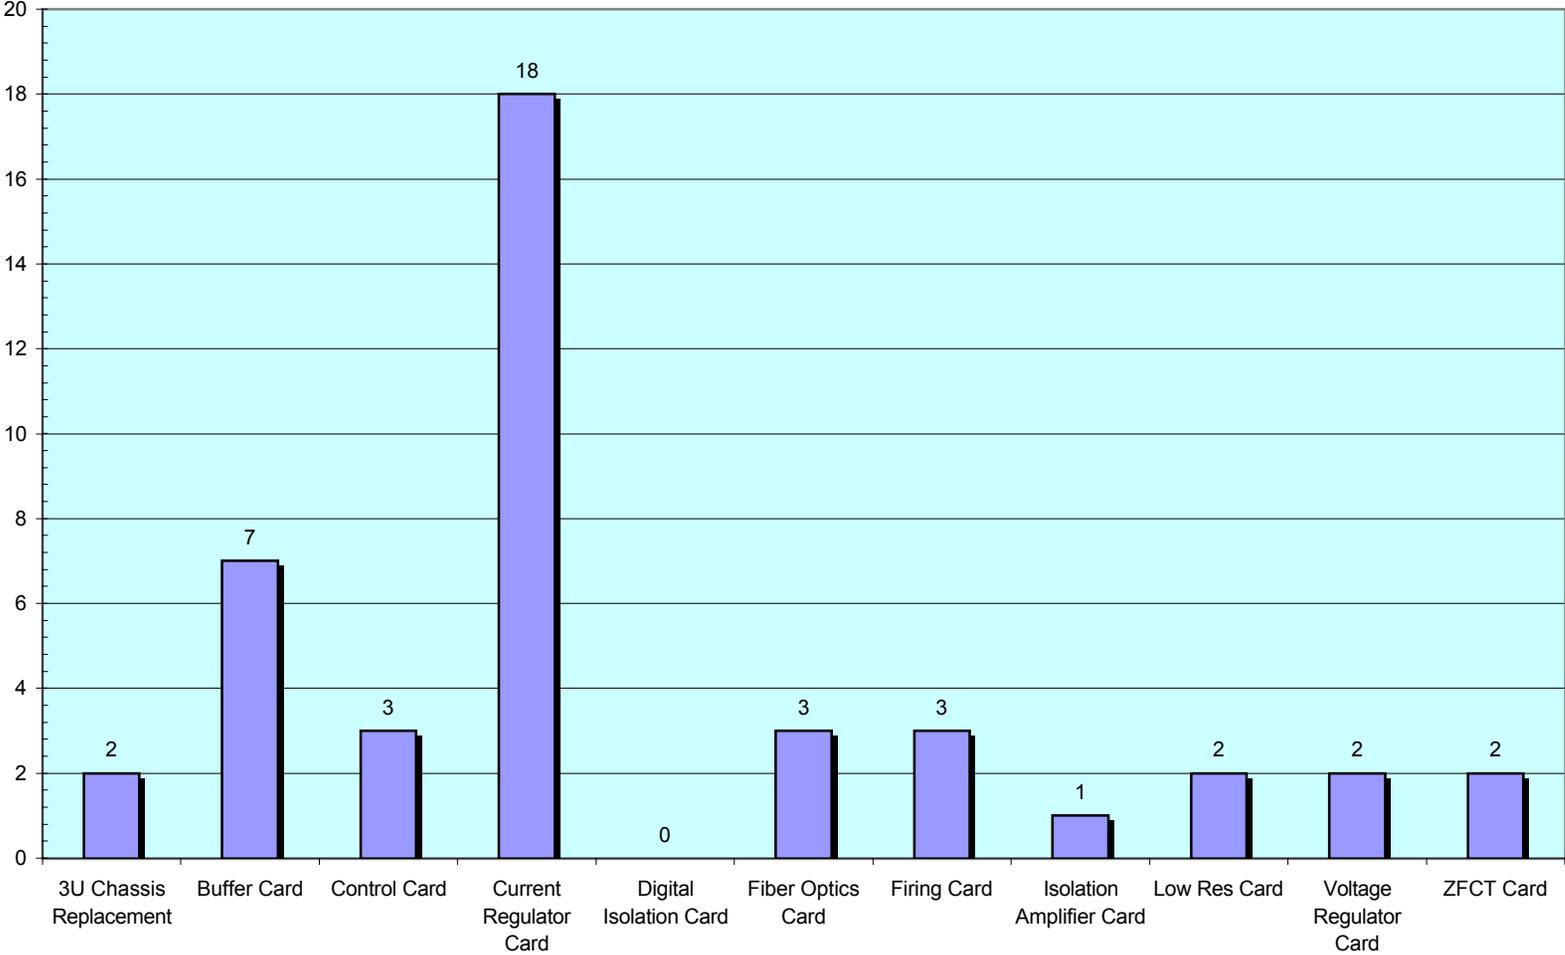
RHIC - Power Supply Card Failures
for the Months of August 2001 - January 2002

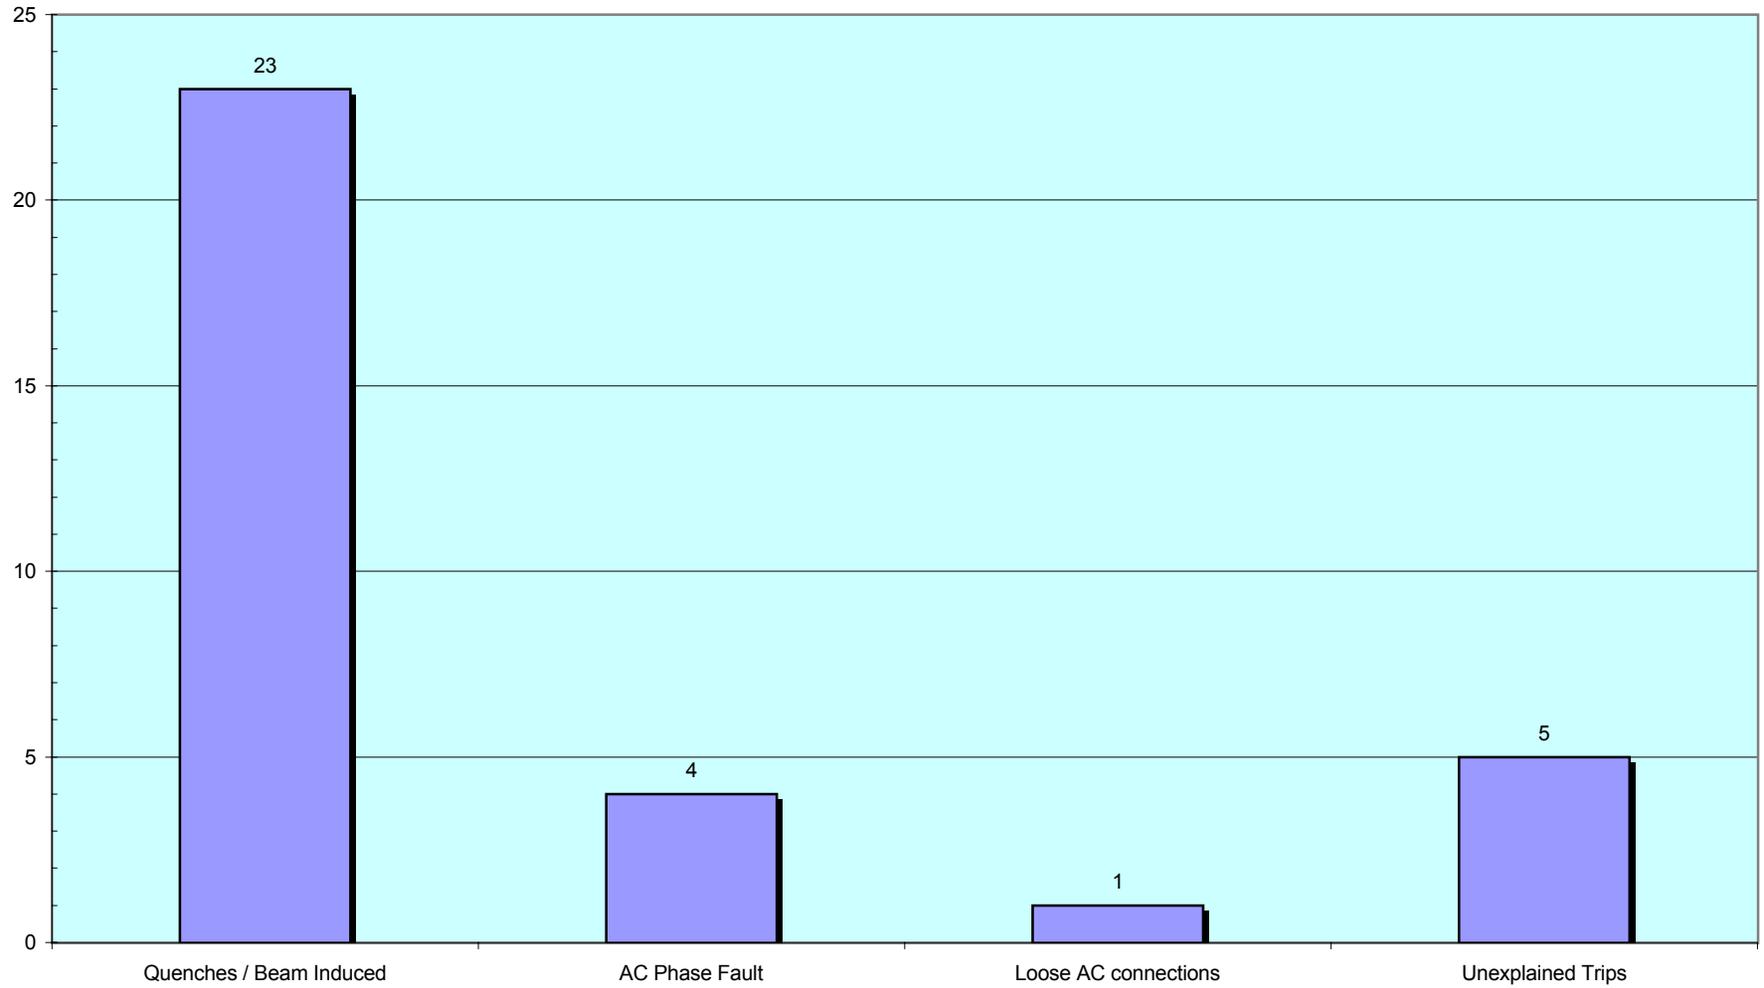
RHIC - Snake Power Supply Faults
for the Months of December 2001 - January 2002

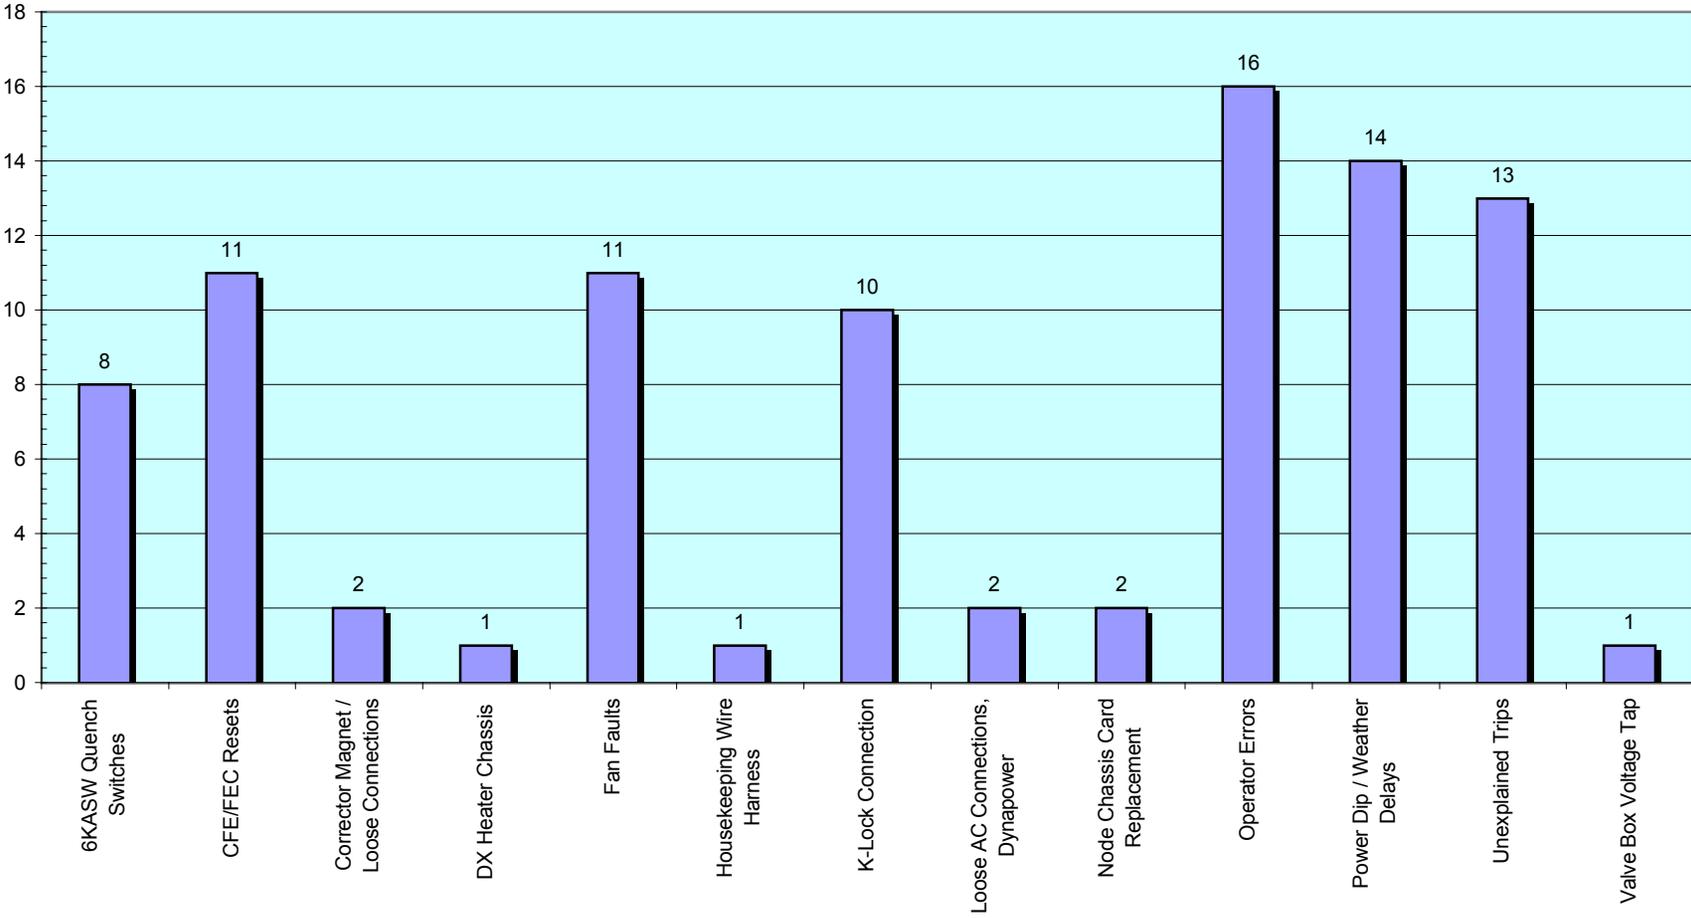
RHIC - Miscellaneous Faults
for the Months of August 2001 - January 2002

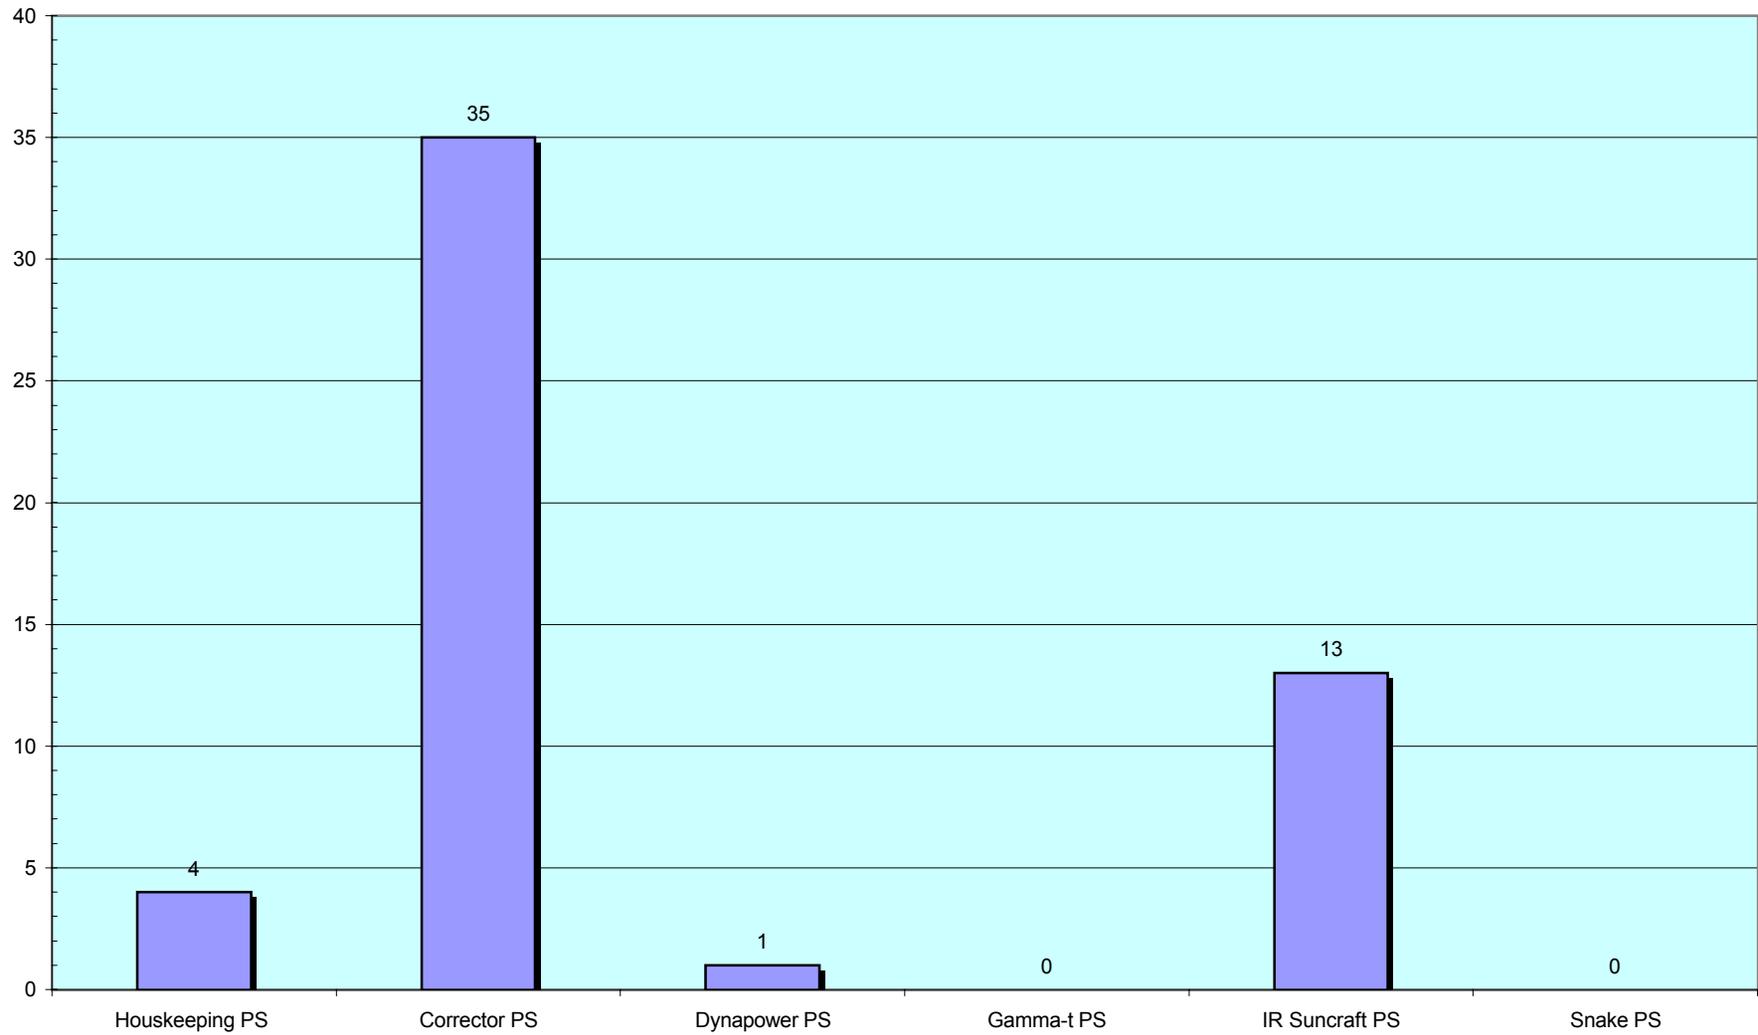
**RHIC - Power Supplies Replaced during the Run
for the Months of August 2001 - January 2002**

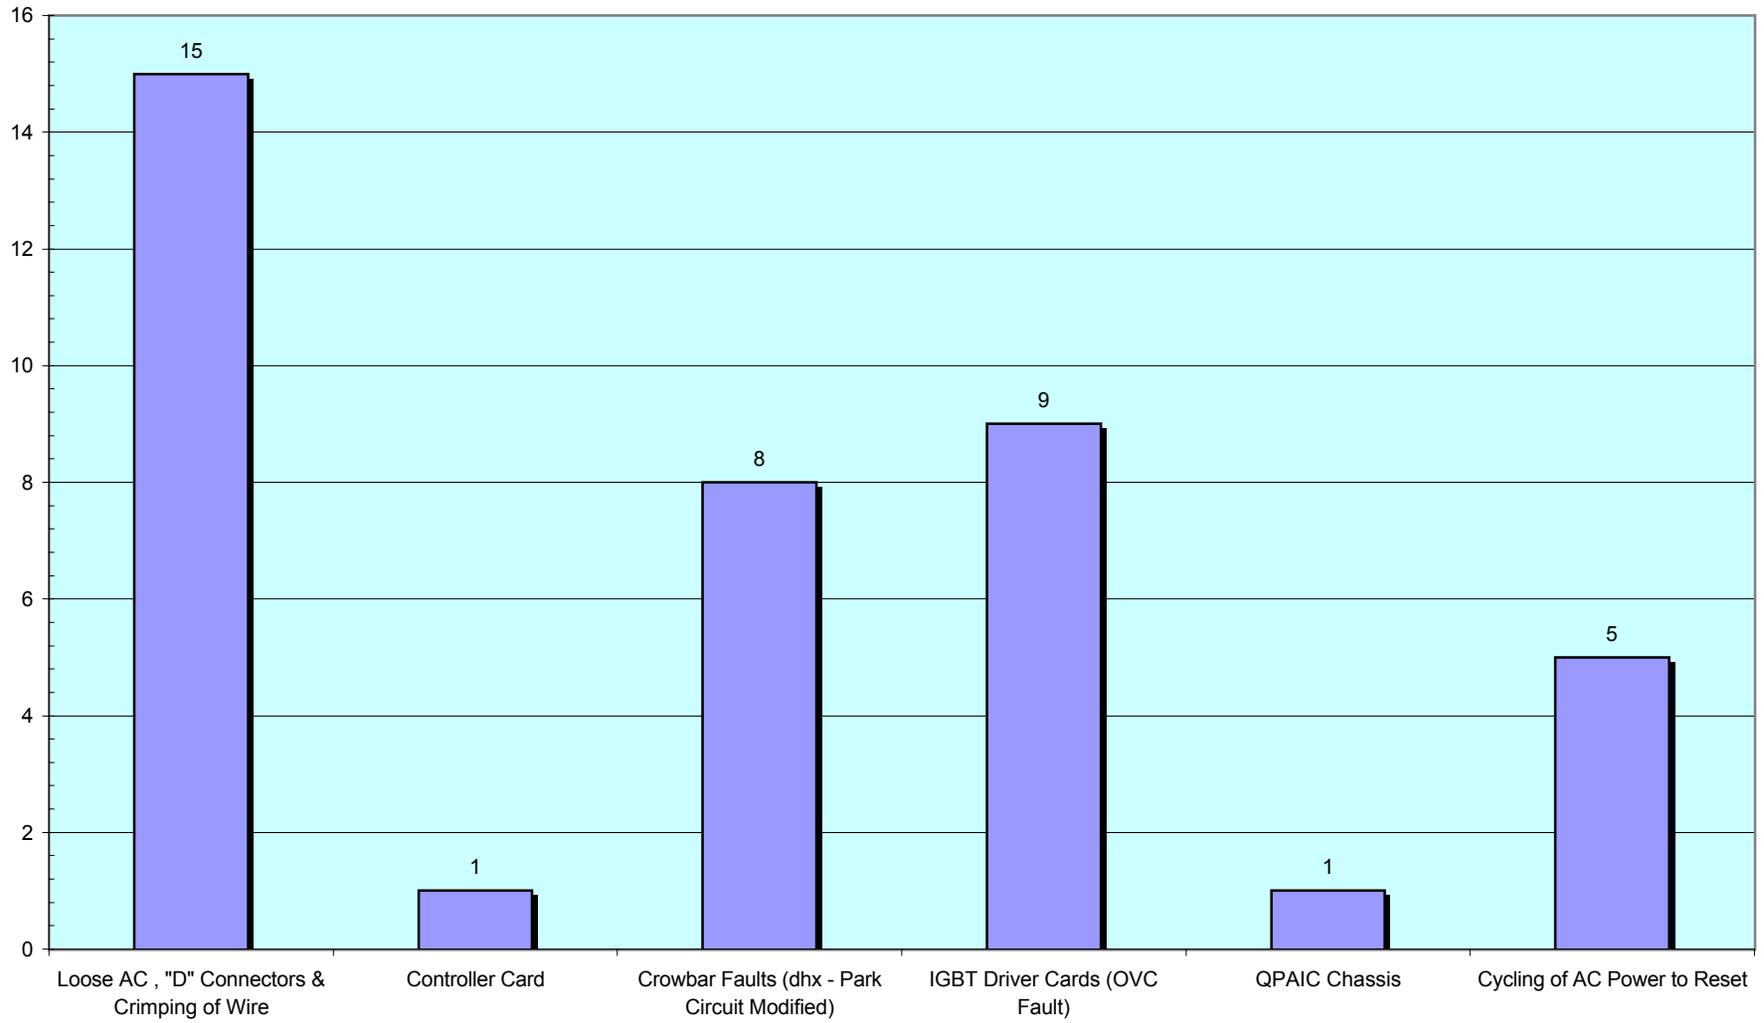
**RHIC - QPA Faults
for the Months of August 2001 - January 2002**

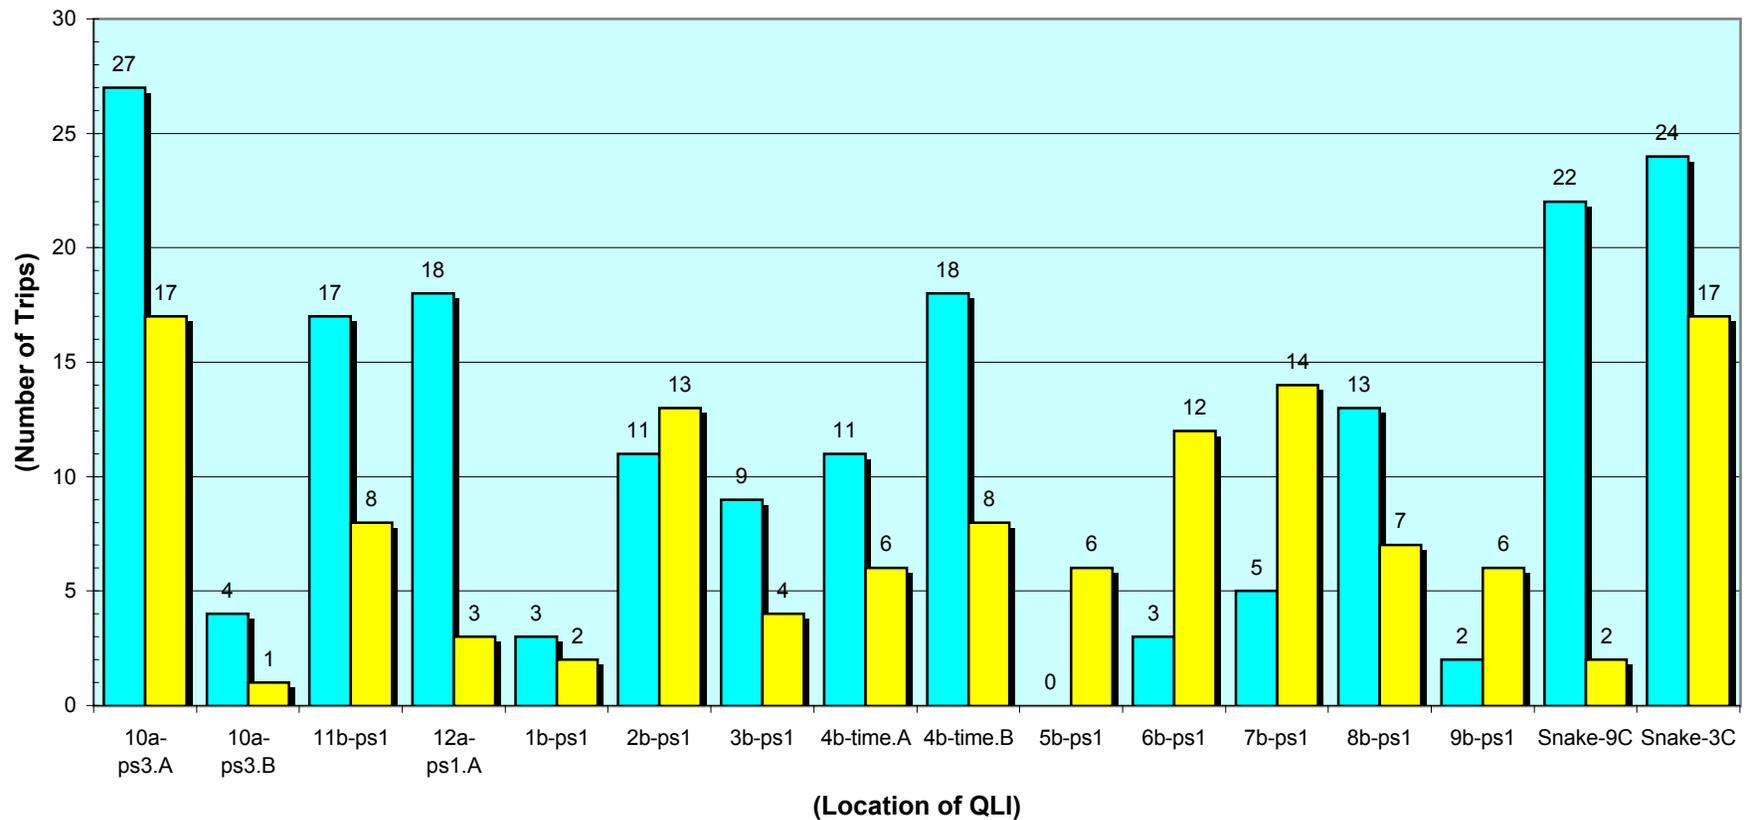
RHIC - Quench Link Interlock Events = 313

Number of Trips for Blue and Yellow Ring

(October 2001 - January 2001)

■ Blue Ring = 187 Total ■ Yellow Ring = 126 Total

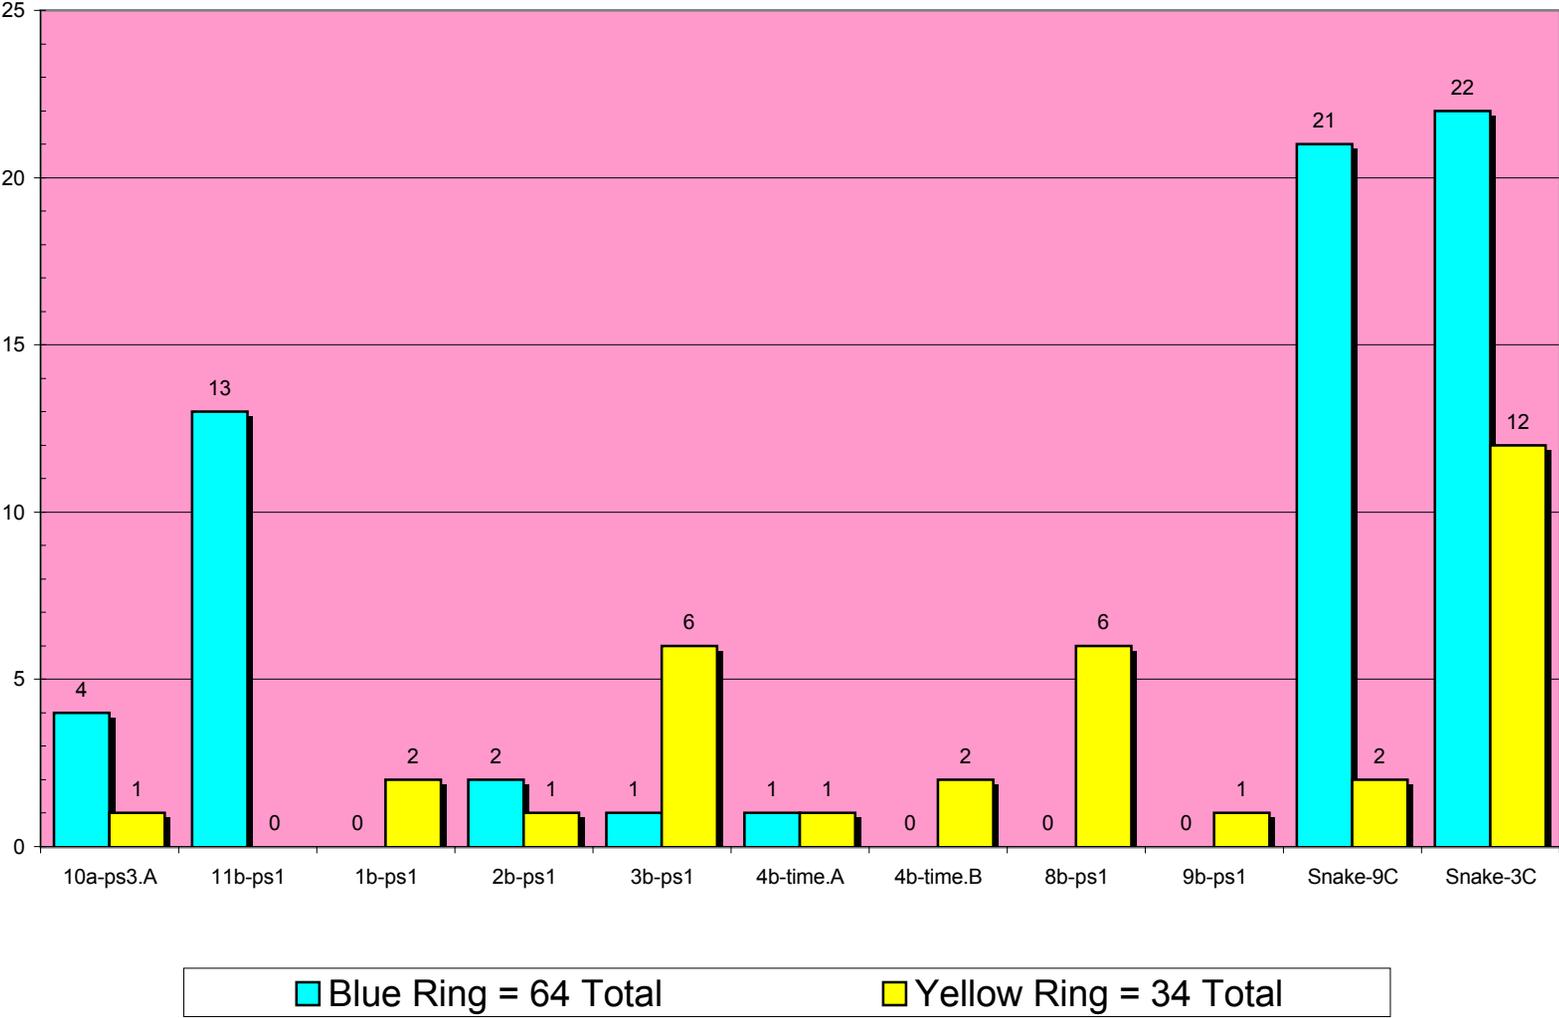
RHIC Real Magnet Quench Events = 98

for Blue & Yellow Rings (October 2001 - January 2002)

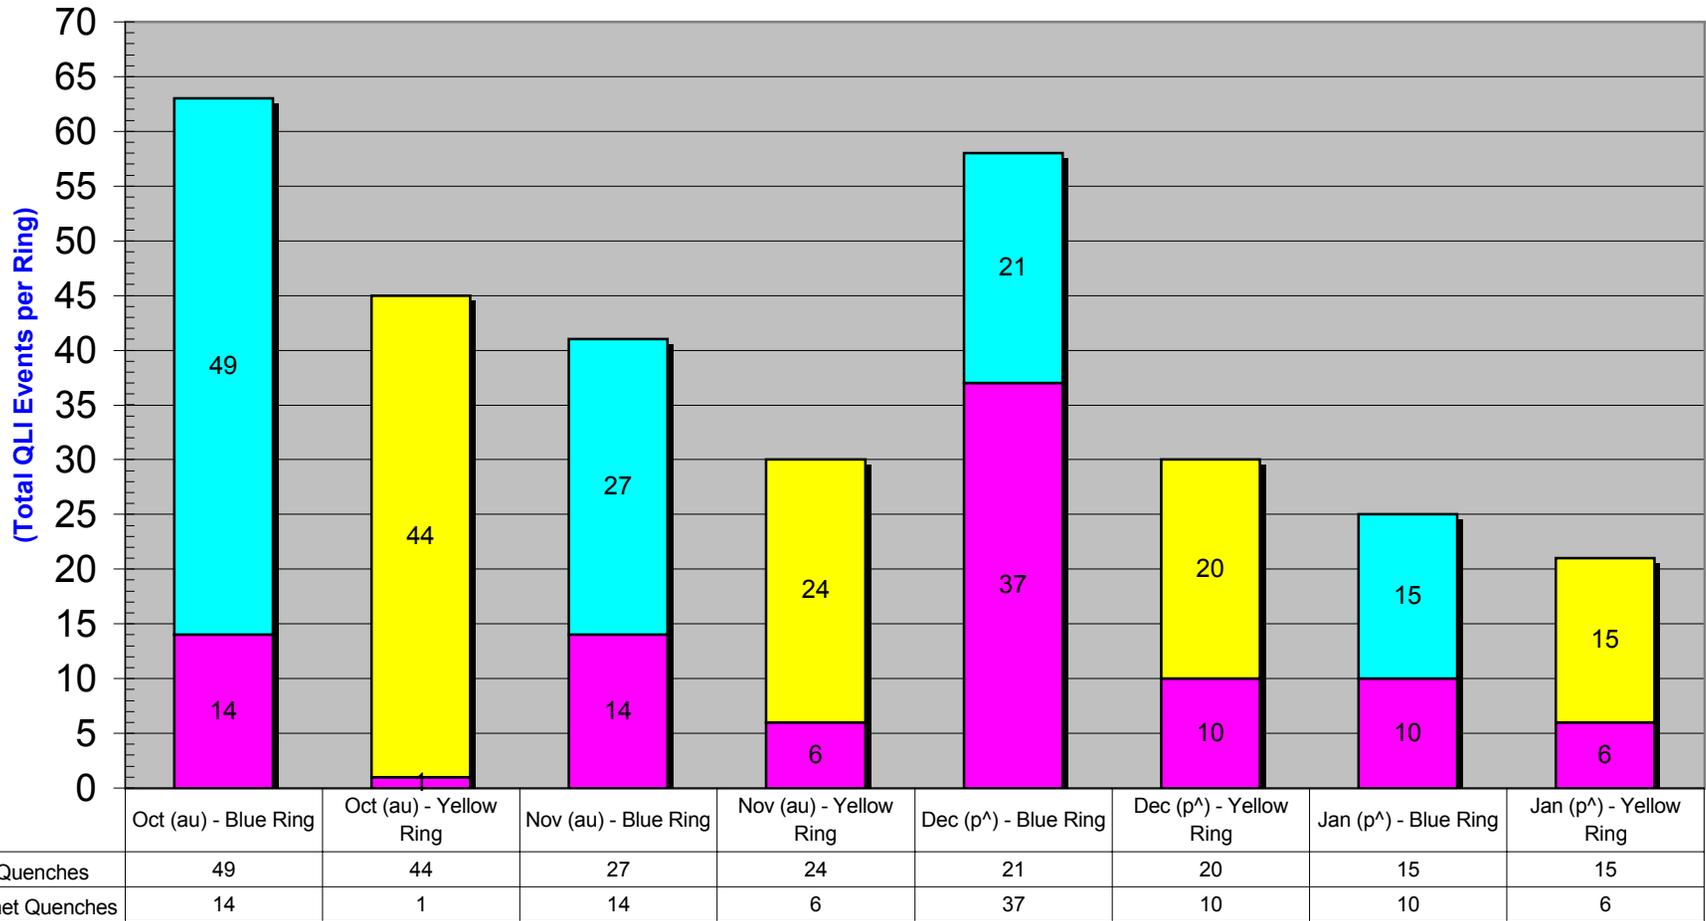
RHIC - Real vs Non-Real Magnet Quenches from October 2001 - January 2002
