BLIP Operations 3-27-12

Leaking AlBeMet vacuum window

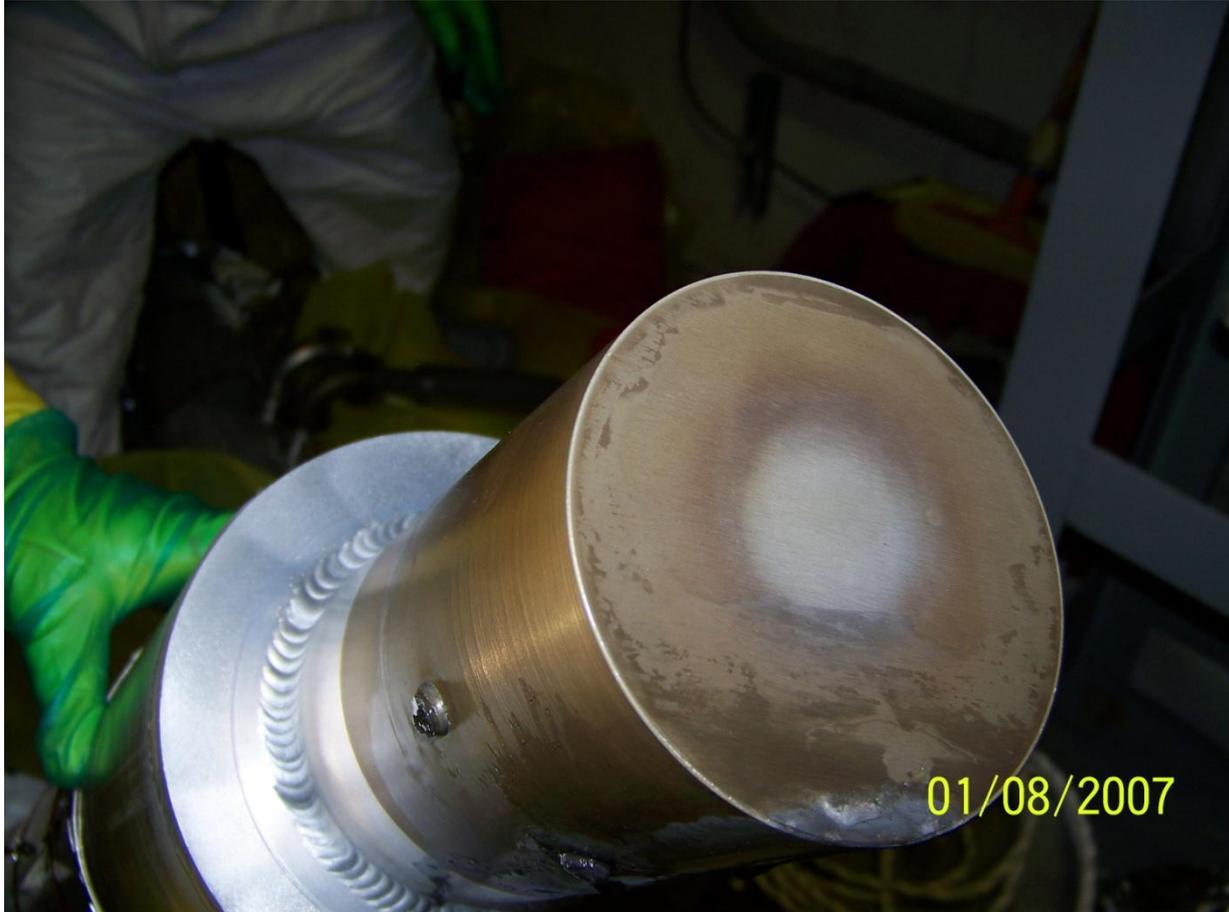
Front view AlBeMet window

- Status – not running
 - Average beam current zero. Weekly operations for zero hours.
- Issues
 - Shut down due to vacuum leak in AlBeMet window caused by apparent corrosion. The situation appears identical to the failure one month ago.

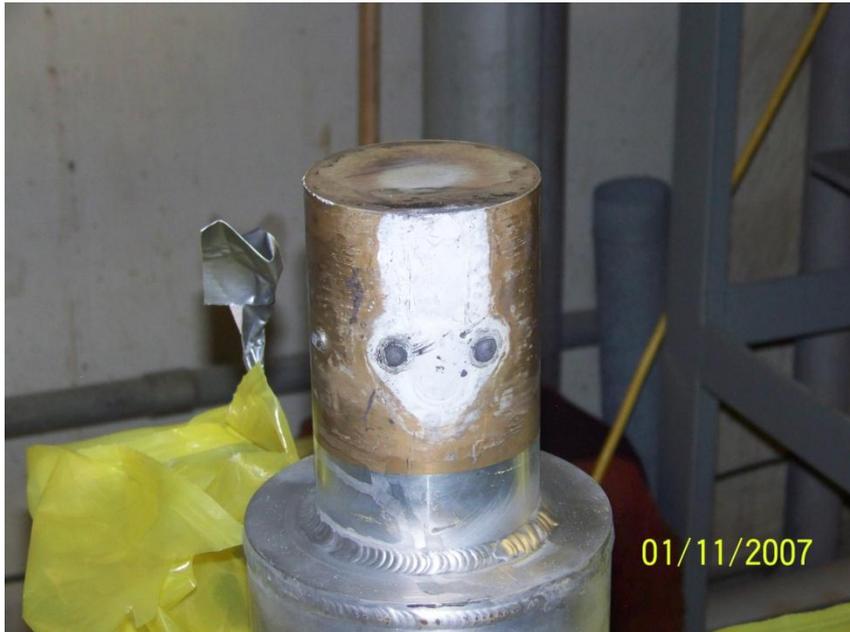
Bottom view

- During several beam line entries the vacuum window has been removed and closely inspected. It shows signs of corrosion at the bottom and dripping from above. The water window was wet but gamma ray assay of swipes of this surface and swipes of the ALBeMet window do not match the isotope content of the BLIP cooling system. Also checking of the water window removed last month in the hot cells in building showed no leakage. The weight of evidence now is that there is no leak from the cooling system. Therefore we will not replace the water window. Investigation into source of moisture continues.
- Approach for repair tomorrow is to treat the moisture symptom by installing a flow of dry nitrogen into the area of concern and putting a drip cover over the ALBeMet end cap.
