RHIC p-Carbon polarimeters: Run15

W. Schmidke
for the polarimetry group

Time Meeting
13.01.2015

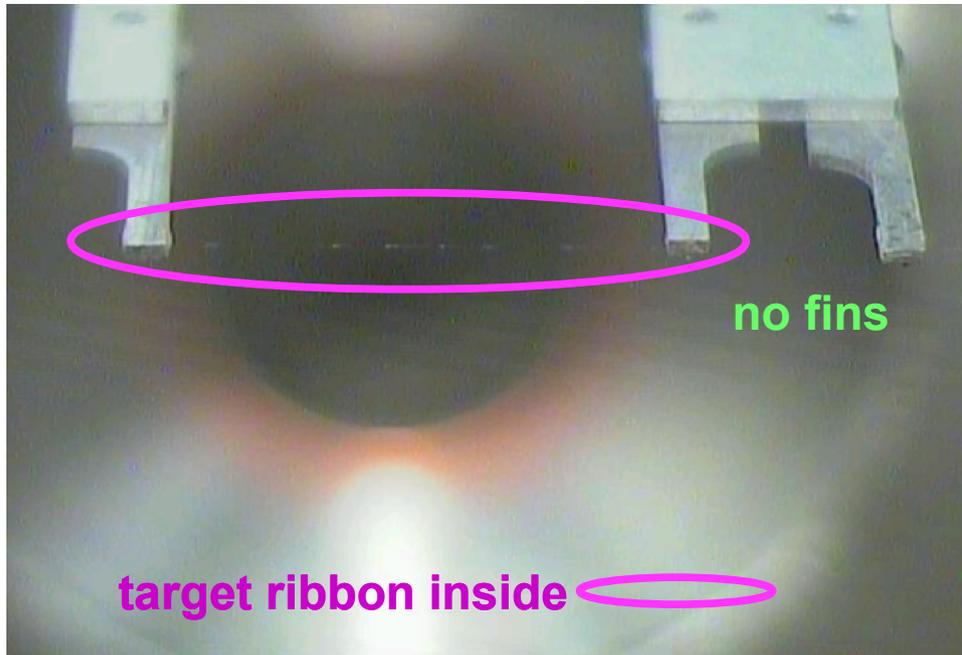
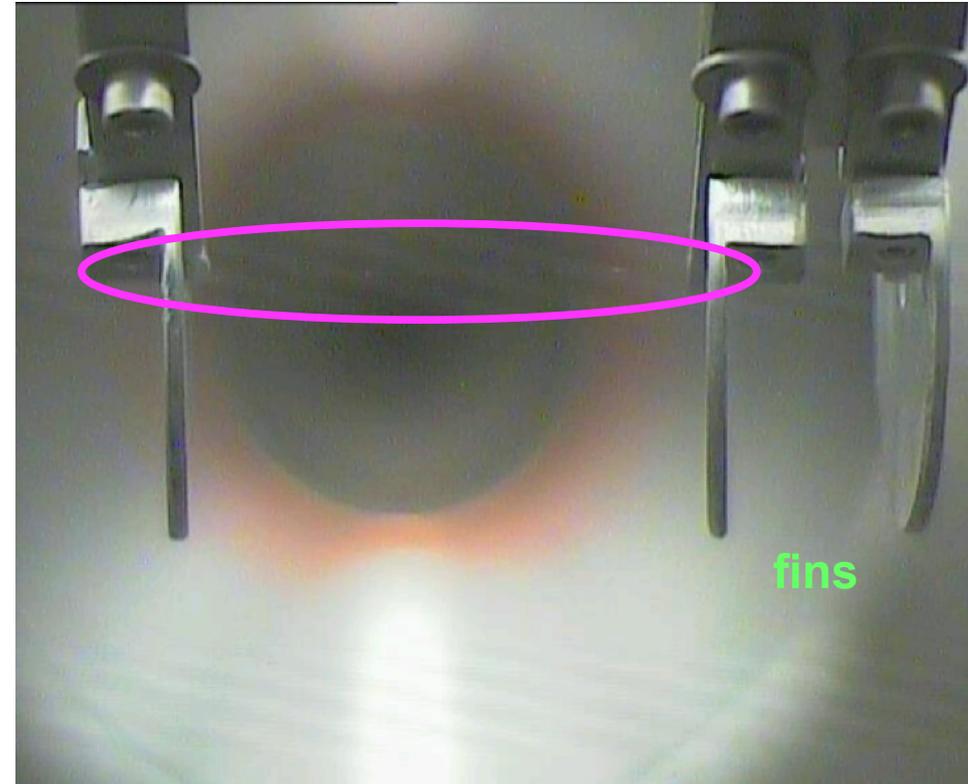
- Over years increasing $I_{\text{beam}} \Rightarrow$ reduced target lifetime
last two pp runs required two replacements all targets, big disruption

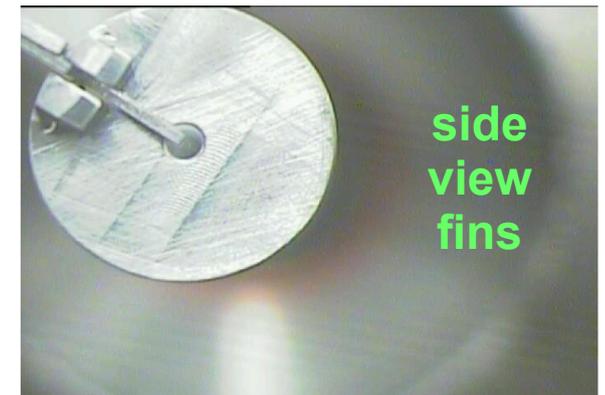
- EM simulation (J. Kewisch) showed beam charge induced high EM fields at target \rightarrow frame attachment (lightning rod)
- high fields \Rightarrow high current in target \Rightarrow heating
- Fix: install 'fins' (flat disks) at attachment point spread field lines, reduce fields

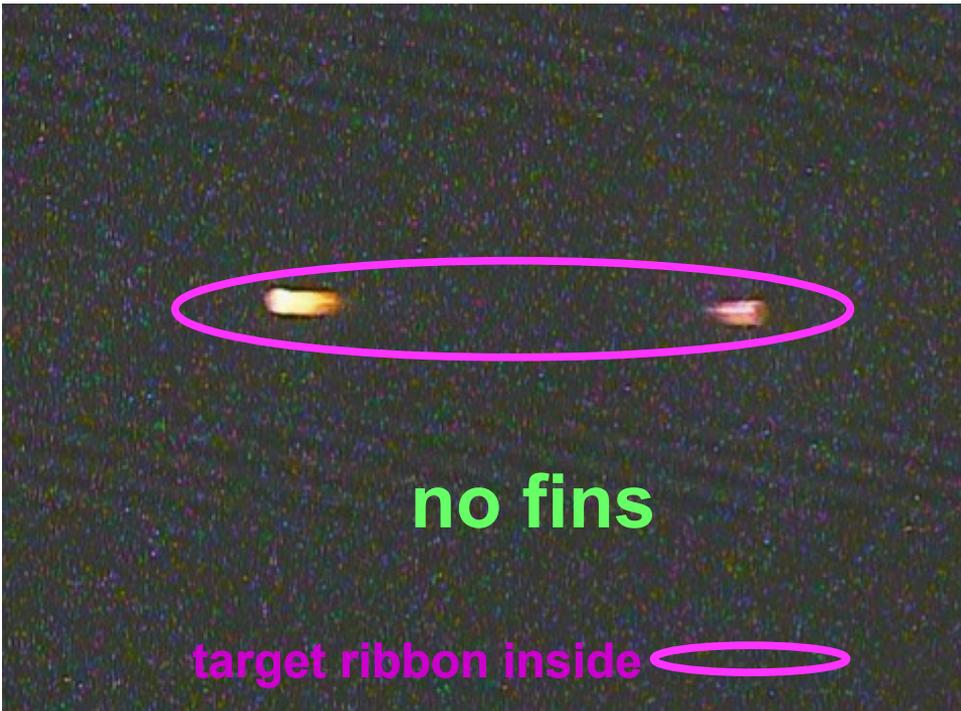
- Spring 2014: tested, move target *near* (not in) Au beam:

- Clear reduction in glowing (ohmic heating) at attachment point
- Also tested *in* He beam, also reduced glowing at ends

- Such fins installed for 32 of 48 targets in 4 pC polarimeters
(no room for fins other targets, hit chamber wall)

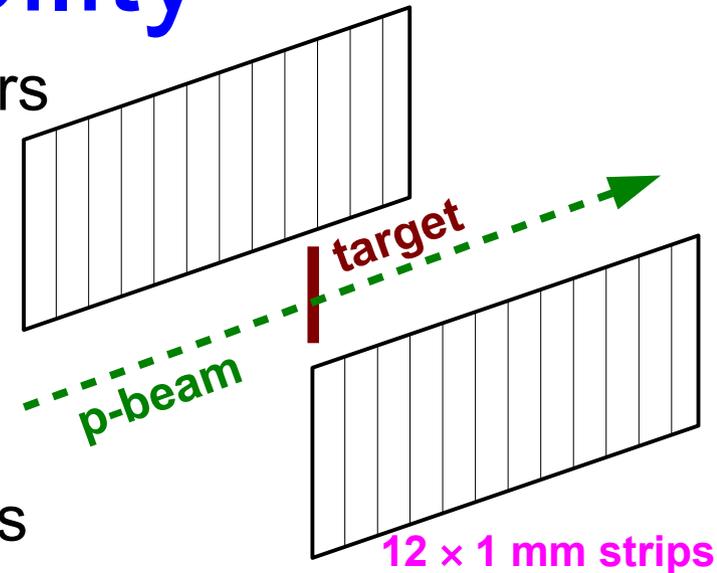
- Run13 used newer fine pitch (1 mm) Si detectors
- Each polarim. one pair detectors
longitudinally segmented:
- Useful info on target looseness,
material along target → detector path (E loss)
- But: 1 mm detectors showed large
gain instabilities, correlated w/ beam operations
- Were able to correct: $\text{gain} \leftrightarrow I_{\text{bias}}$ correlation,
frequent α gain calibrations (end of fills)
- But this is not nice, extra uncertainties introduced

- Keep less stable pair 1 mm detectors, longitudinally segmented
- Use older 2 mm pitch detectors for other 4 detectors each polarim.
 - pitch too coarse for target looseness etc. measurement
 - but over years experience 2 mm detectors have stable gains
