Take 5 for Safety

E. Lessard
May 5, 2015

BNL Arc Flash Accident 2006

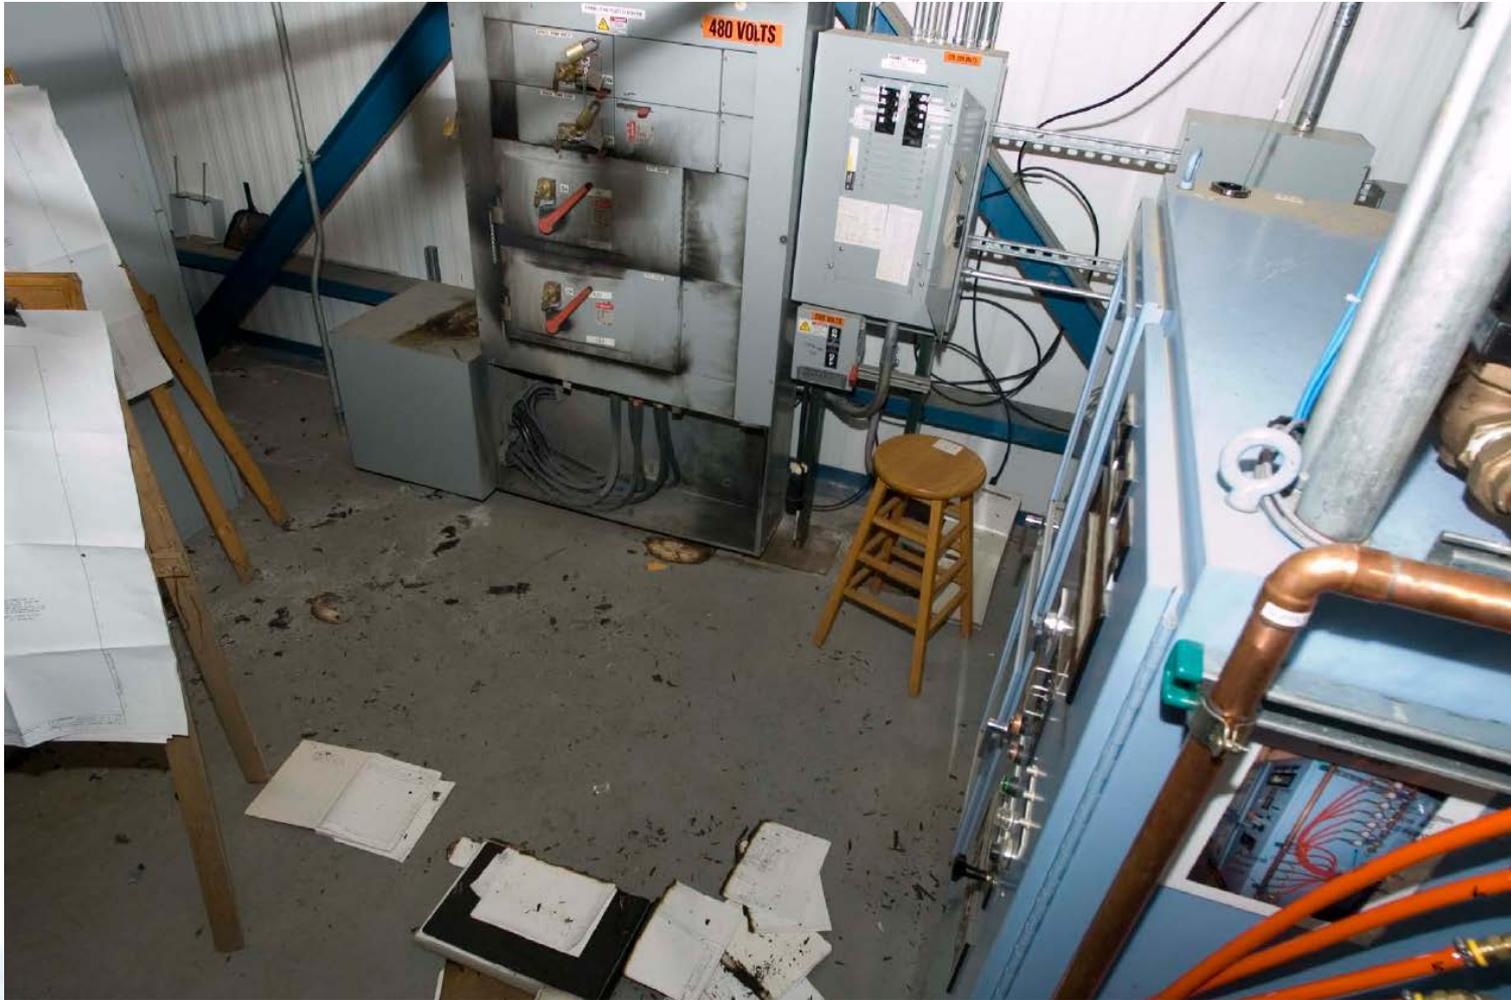
- **April 14, 2006 at ~1020**
- **C-AD Building 1006A Mechanical Loft at STAR**
- **Engineer operates 480 V 400 amp disconnect switch**
- **Arc flash injuries:**
 - **1st degree burns to head, face, chest, and hands**
 - **1st and 2nd degree burns to forearms**
- **Switch panel destroyed**

- **Converted from an ungrounded 480-volt power system to a high-resistance grounded system**
- **Increased the sensitivity of ground-fault detecting relays**
- **Connected all ground-fault monitoring devices to remote alarms in the C-AD Main Control Room**
- **Improved the rigor of testing, commissioning and operational readiness reviews for electrical systems**
- **Verified all equipment necessary for safe and reliable operation of the system meets design standard**
- **Developed, trained, and implemented formal work controls to address receipt of initial ground-fault alarms at Main Control Room**
- **Required the existing preventive maintenance inspection program to include fused-disconnect switches and ground-fault relays**
- **Perform pre-job briefings before jobs that involve the operation of circuit breakers for power distribution**

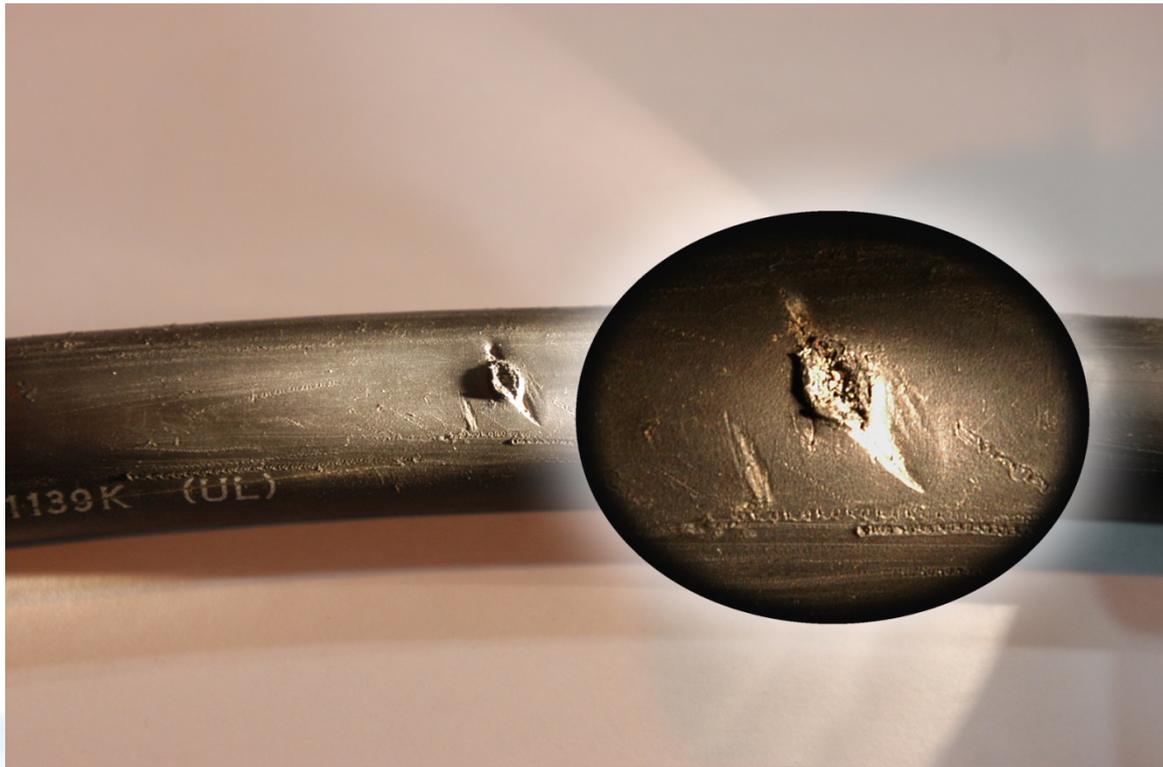
- **High transient voltage**
 - Arcing ground fault on ungrounded delta system
- **Damaged phase C supply cable**

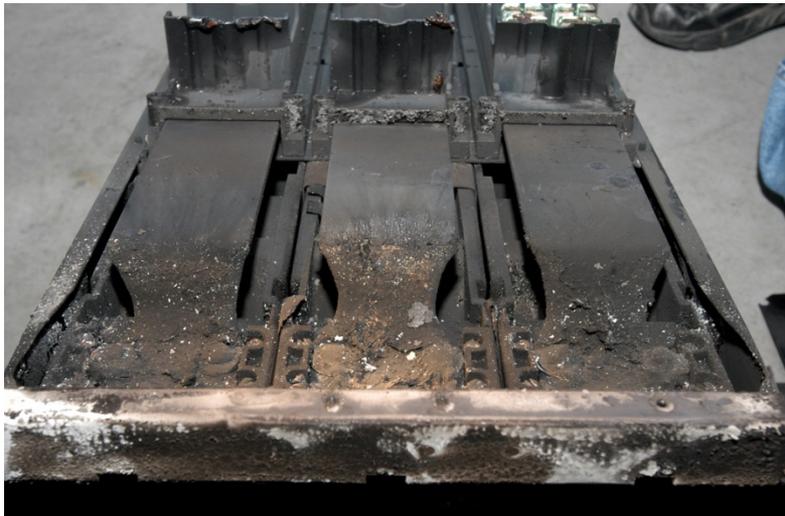
Damaged switch

- Assumed the 480 V switches mechanically failed and replaced or took out of service these types of switches (NOTE: GE recalled these type Spectra switches several years after the accident)
- Implemented Human Performance (HU) Training and HU Practices
- Implemented NFPA 70E PPE requirements

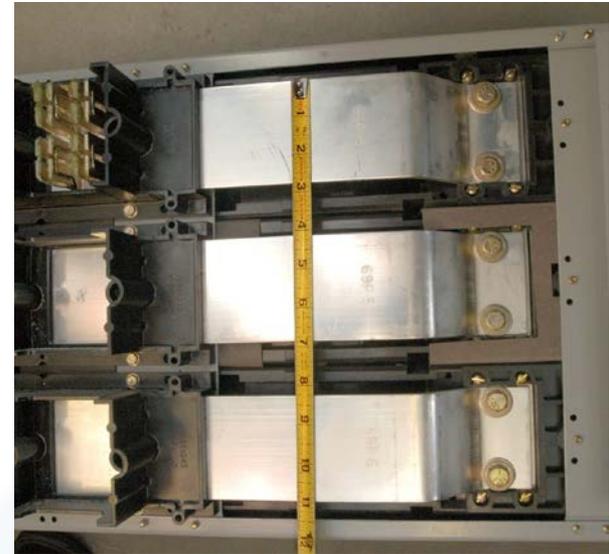
Undamaged switch

Foreign object across phases
