Closing Open ERL Items

D. Beavis

July 16, 2104

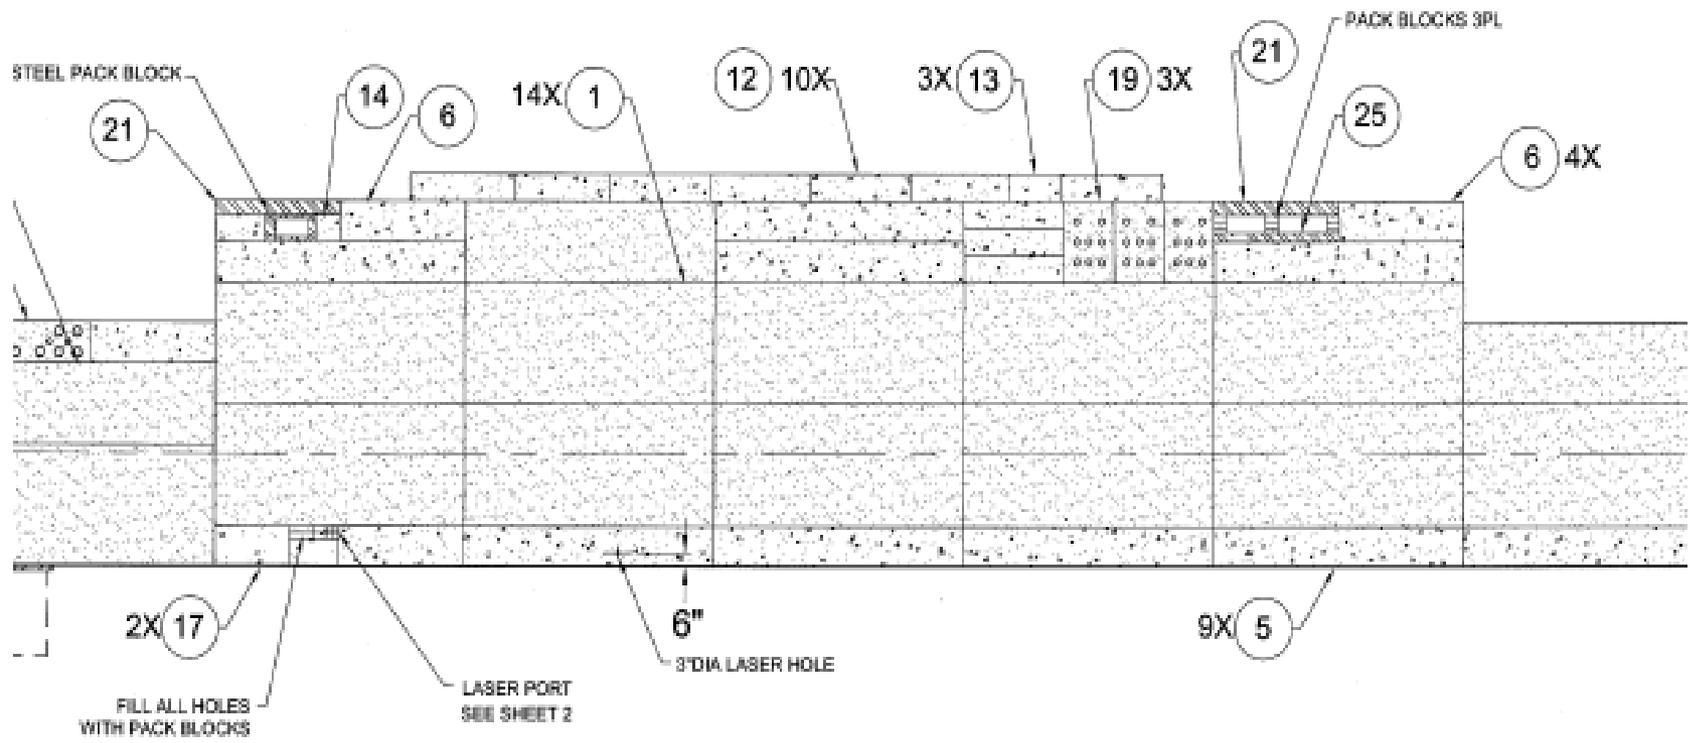
East wall looking from outside

Vertical seams on side walls

- Requested that the vertical seams have four inches of Pb for the ones that can have brems losses directly across.
- There are additional vertical seams high
 - Some not much of an issue
 - Others on wall for second floor of the condo (utility building) More a problem for ring. Only a small section of low energy transport is an issue
