IceBallMaint1x21x03

The Ice ball teams went around to check for Ice Balls on 1/21/03. Rich C and Fred went through sectors 10, 11, 12, and 1. They did not find any problems. Jeff went through sectors 2,3,4 and 5. He did not find any problems. Gregg went through sectors 6 and 7. He did not find any problems except that the RED lead of the warm up heater cable was sticking out of the terminal block of the 7DX magnet. The photos below show how this red cable should be connected on a good DX magnet tree:

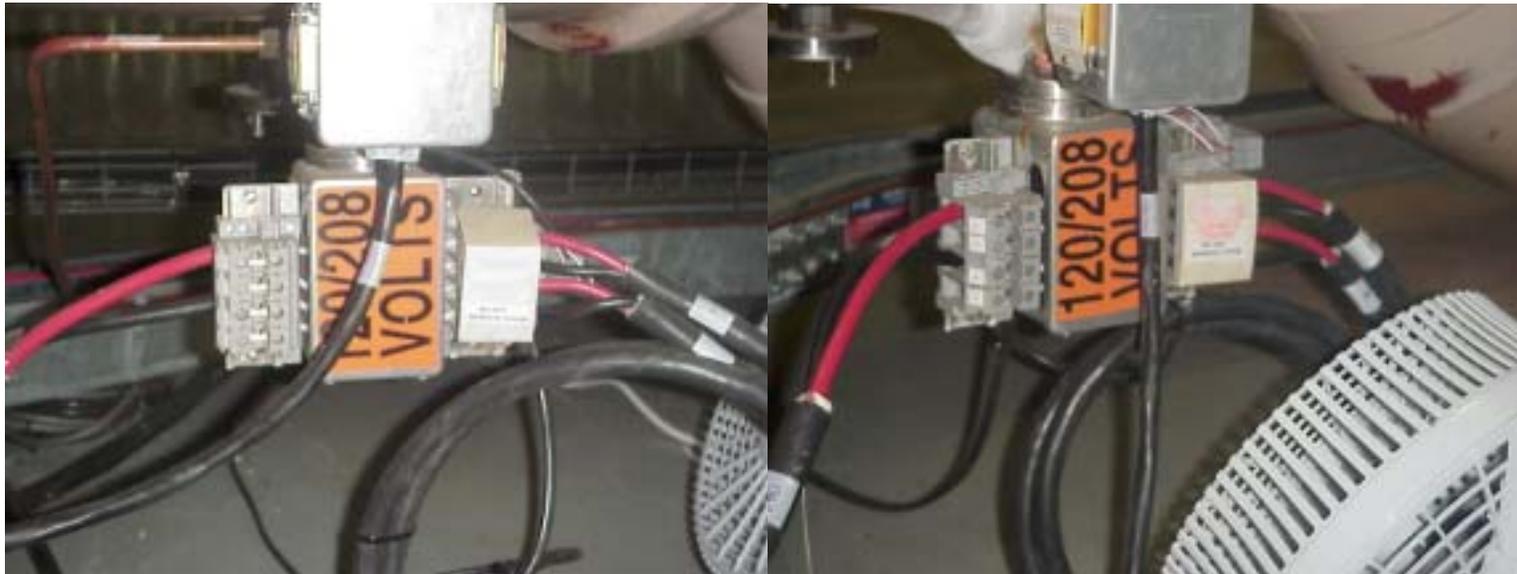
The red cable on the terminal block on the left in this photo (12DX and 11DX) was hanging out in the air on the 7DX magnet. This is the warm up heater cable. The 2 cables on the right hand terminal block were both connected. These are the cables from the Dx Heater power supplies. The next time we go in we will re-connect the 7DX warm up heater RED cable. Joe went through sectors 8 and 9 and did find a problem with the O9Q17 magnet tree. PK went in and found the thermostat was not working so it has been bypassed and will be replaced on the next maintenance day. To get to this magnet you enter gate 10GE1 and make a left. It is a yellow magnet.

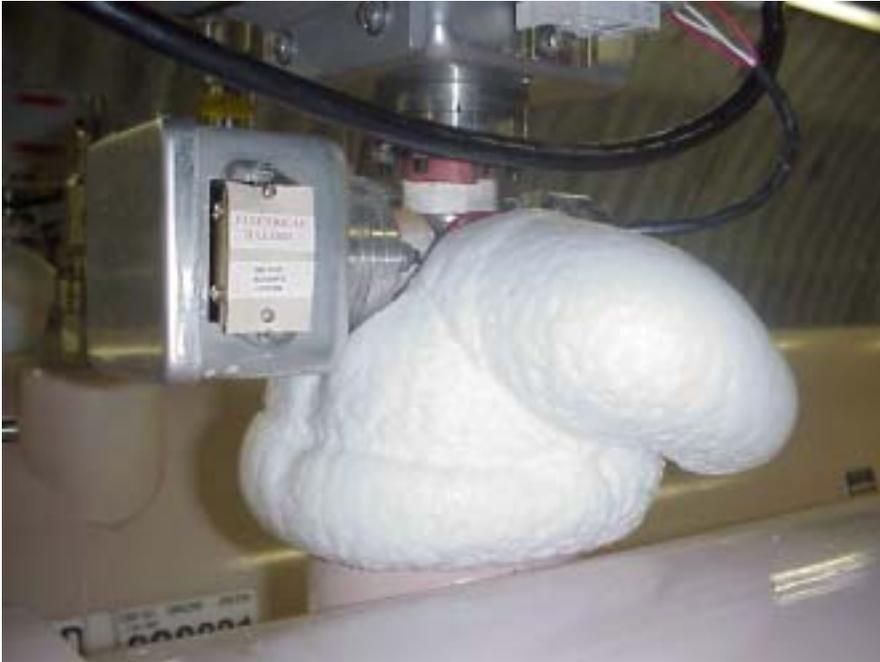
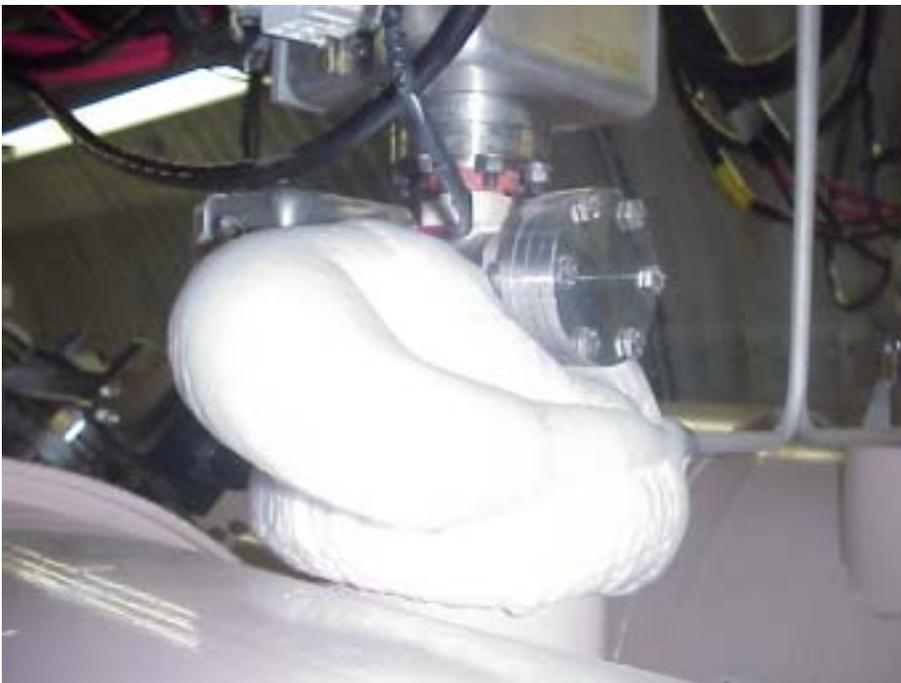
There are some photos that follow which show some of the magnets in Q16-Q20 in sector 12 which had ice on them last Wed 1/15/03. There was a loose neutral wire on one of the trees that PK and Gregg fixed. These photos show that the heaters are working for sure a week later.

These 2 photos above show a good tree without insulation around the return gas line. This is magnet I12D19Q20.

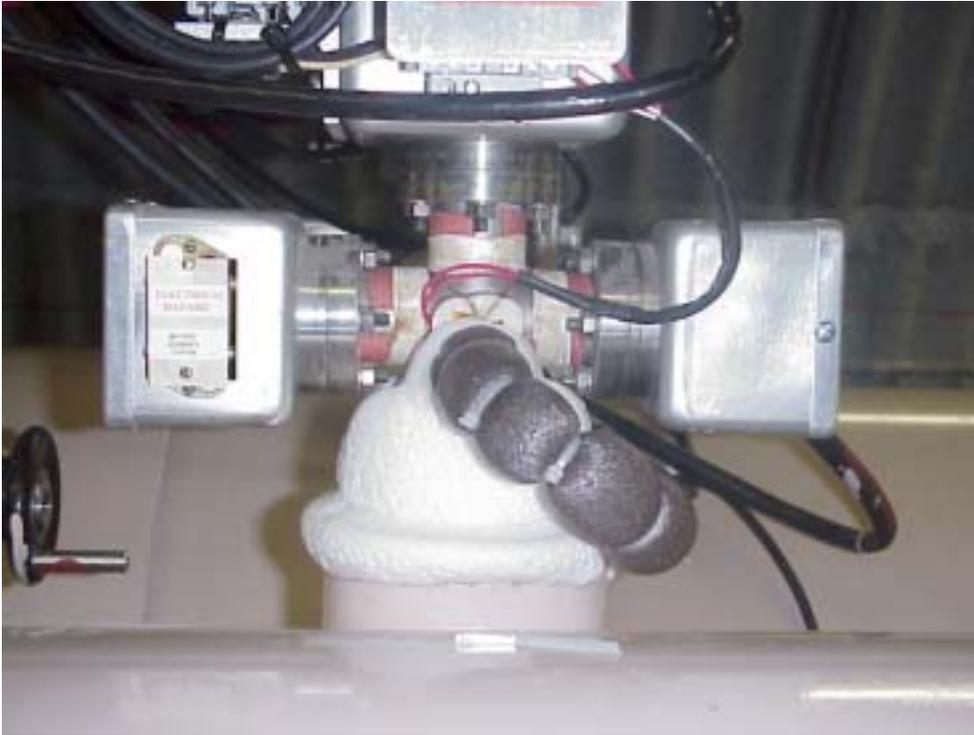
The photo above shows a good tree with insulation around the return gas line. This is the blue Q19 in sector 12.

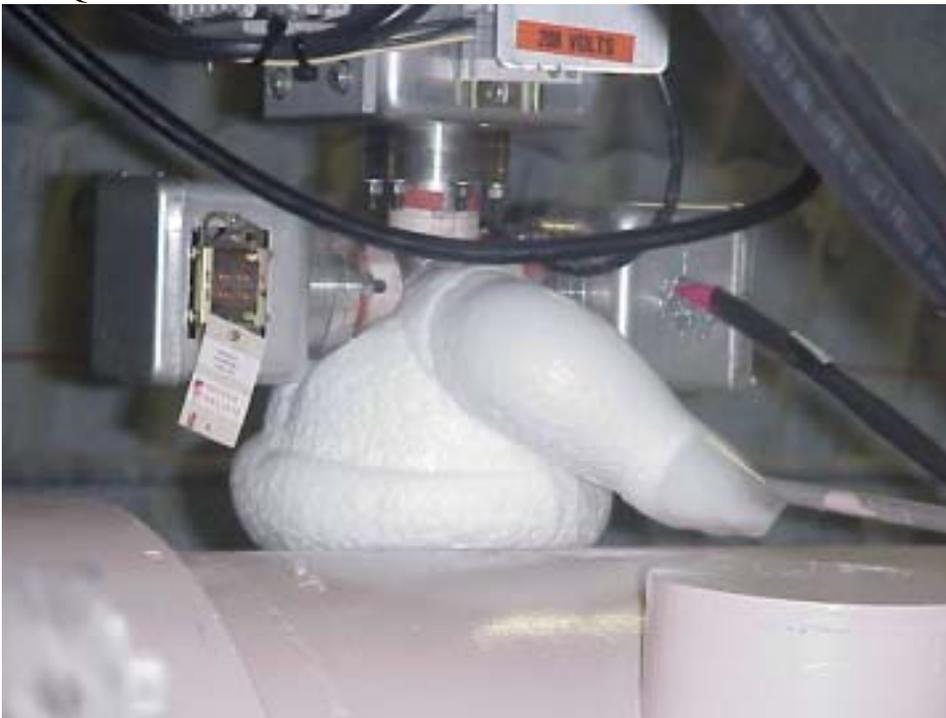
The photo above shows a good tree without insulation around the return gas line. A cover also needs to be replaced where you measure the volt taps. This magnet is the yellow Q19 in sector 12.

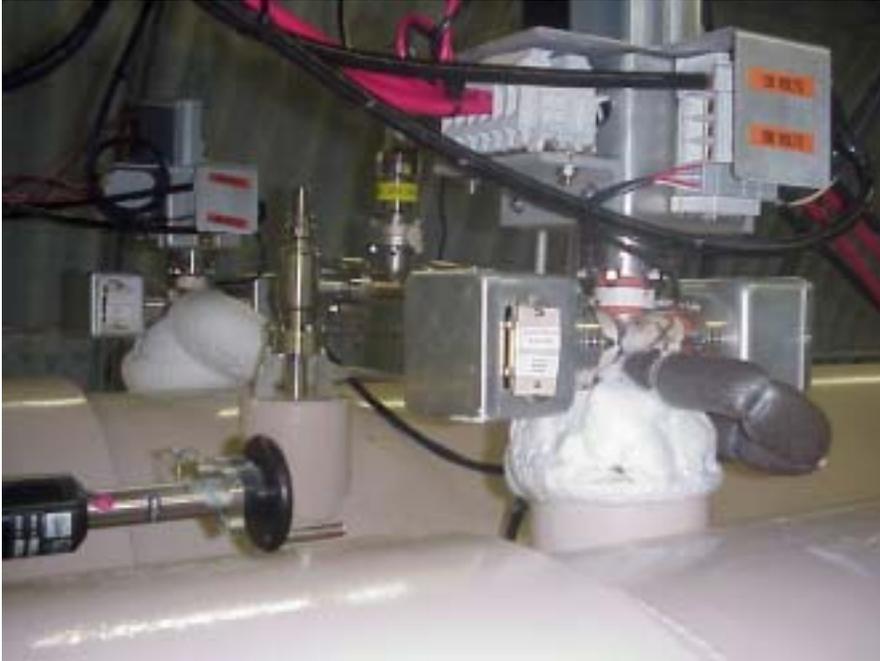
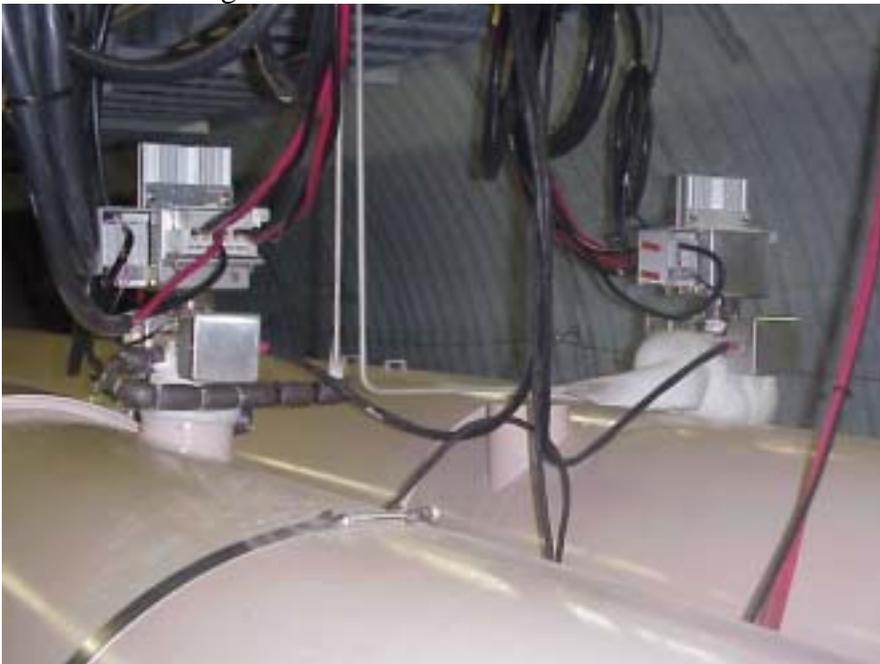
The photos, above and below show 2 good trees. One without the gas return insulation and one with the gas return insulation.

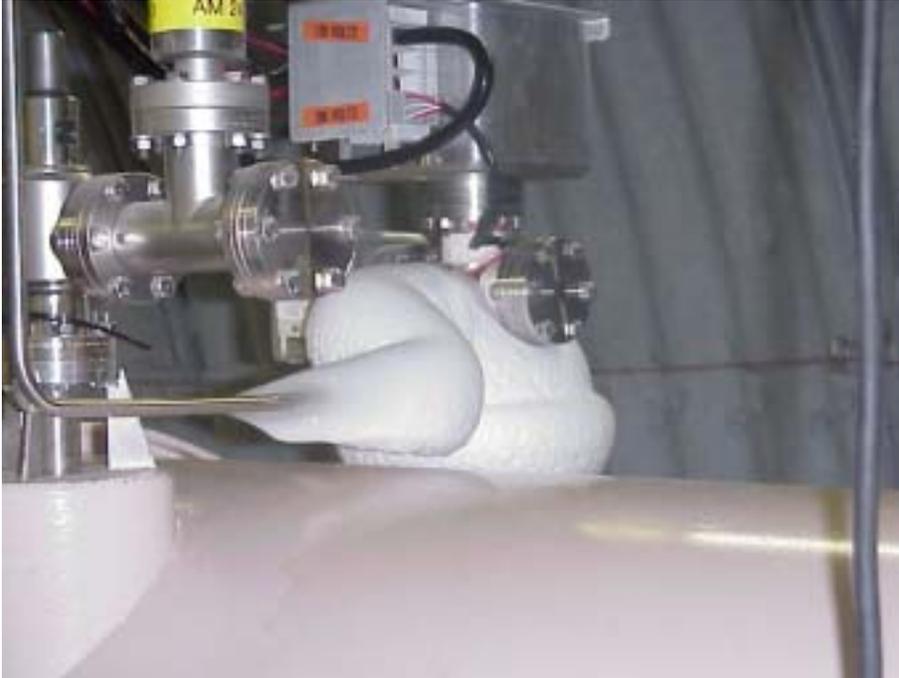
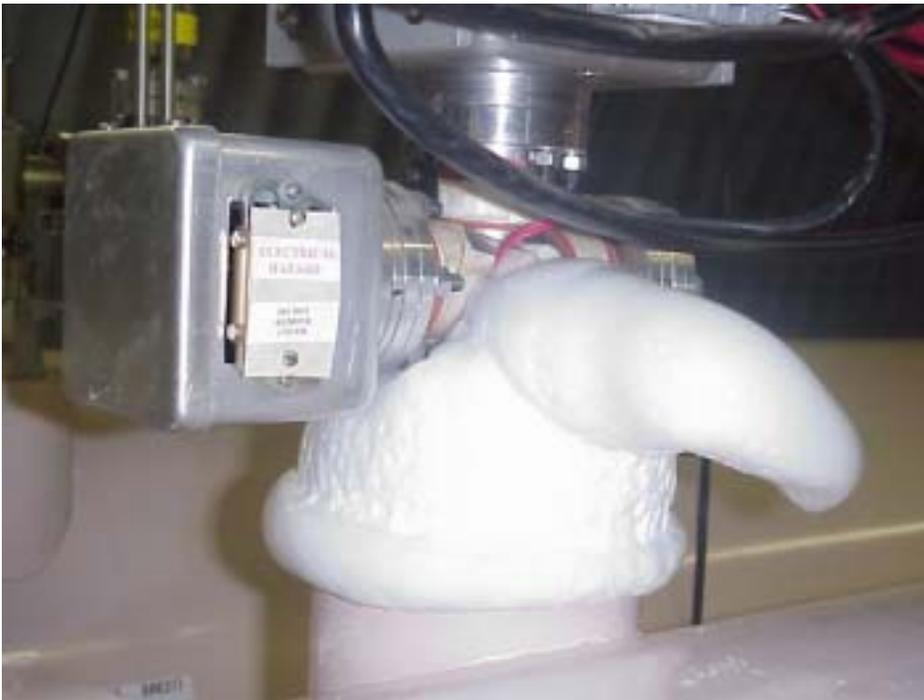
The photos, above and below show a good tree without the gas return.

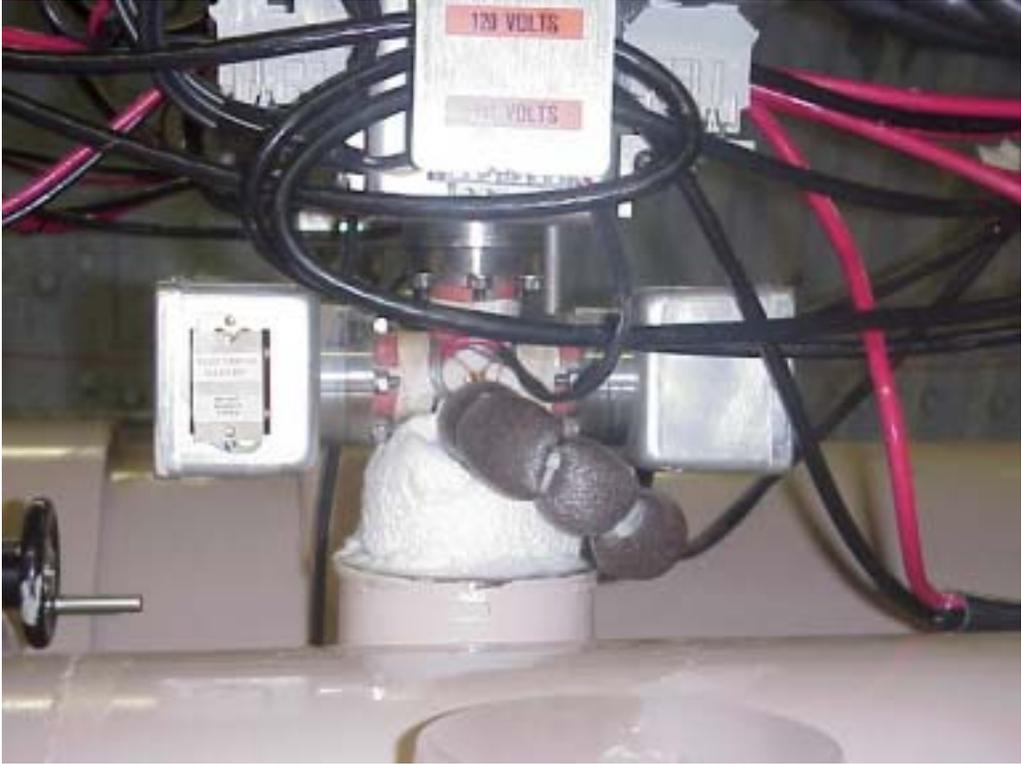
This photo, above, shows a good tree with the return gas line insulated.
