# CeC PoP Experiment

# Inspection of Cryostat for 704 MHz Cavity

# 704 MHz Cavity Repair

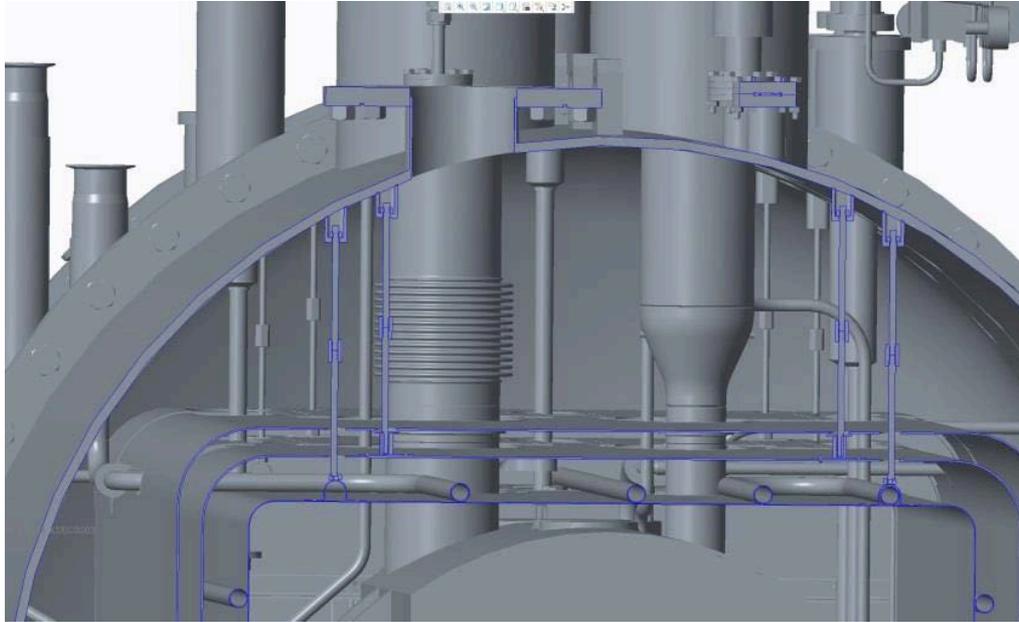
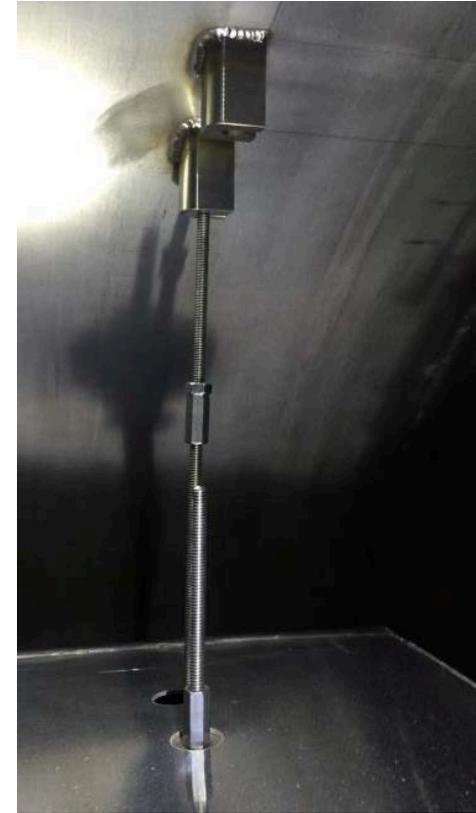
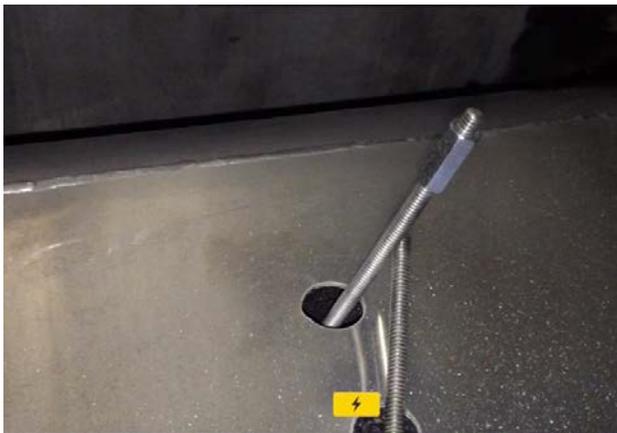
The rods holding the magnetic and cryogenic shields became disconnected. Multiple leaks between separate volumes were found. We need to open cryostat and restore the configuration.

The leaks were found and fixed.  
Final check is under way.  
Special thanks Cliff Brutus,  
Roberto Than, Victor Soria, Rich  
Anderson, Rob Karl, Michael  
Mapes, and others

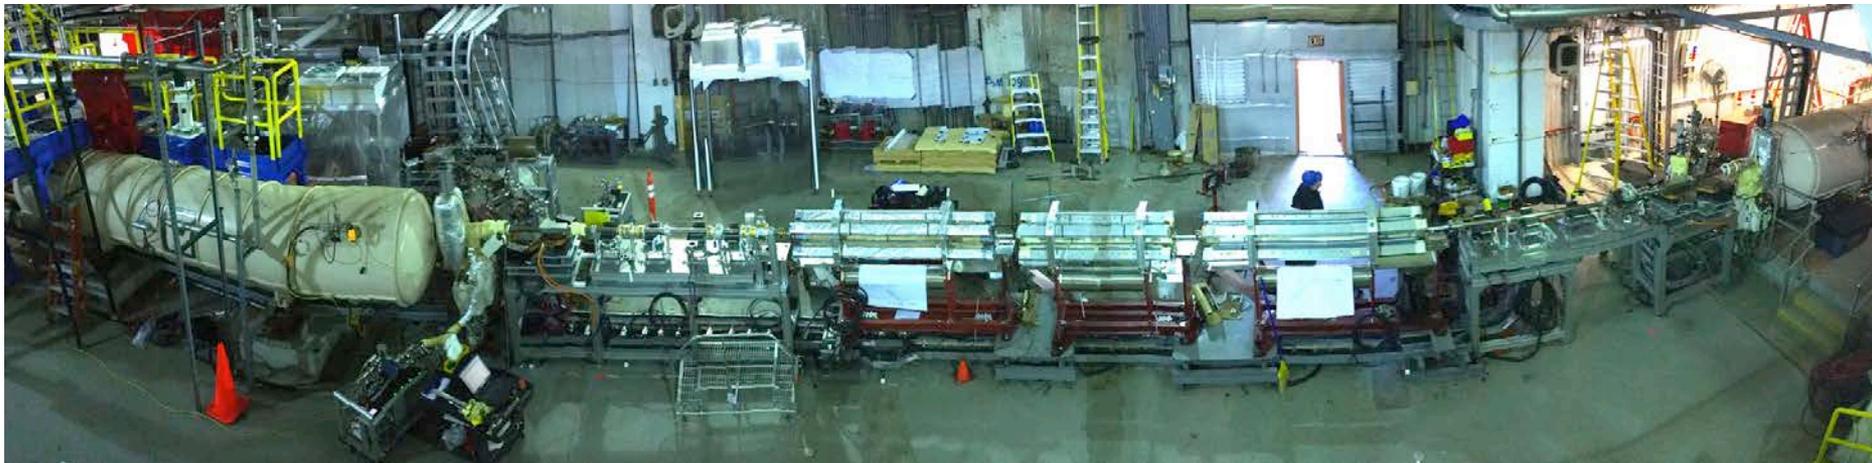
# Installation Progress

- Baking of the common section is finished
- The infrared viewport was installed and baked
- Support for the high power beam dump put in place
- Cryogenic equipment was shipped from manufacturer and received
- Beam line to high power beam dump installed
- Beam profile monitor in front of low power beam dump installed

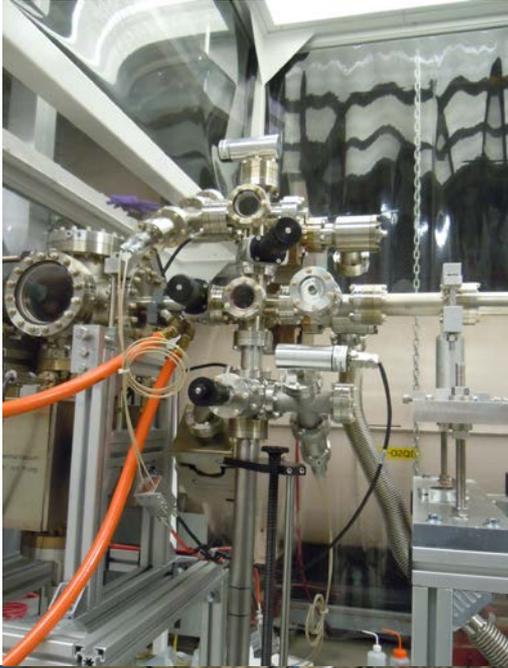
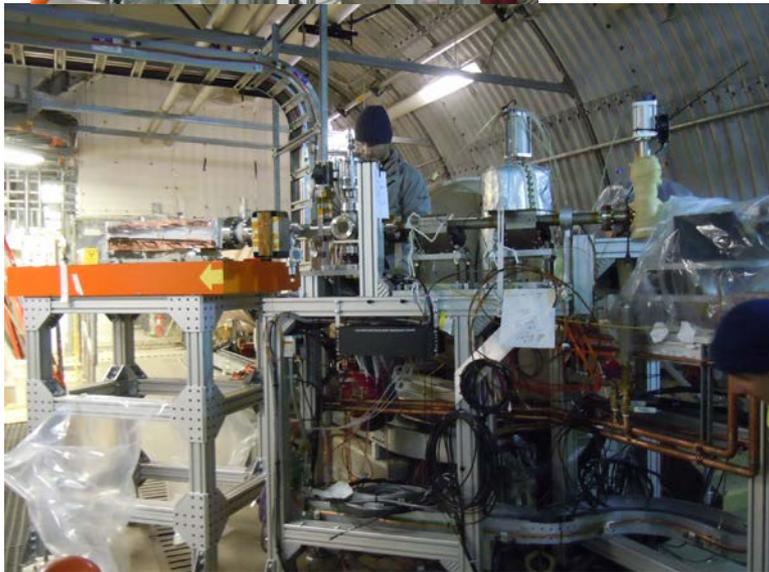
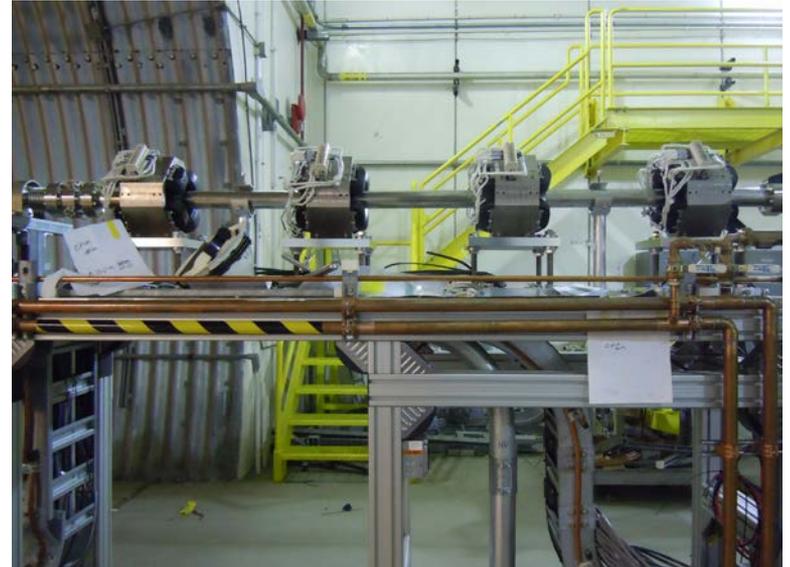
# Installation Progress (continued)

New cathode launch mechanism was installed.  
704 MHz waveguide was tested  
High power beam dump beamline installed
