BLIP Operations – 118 days of operation

Target box failure

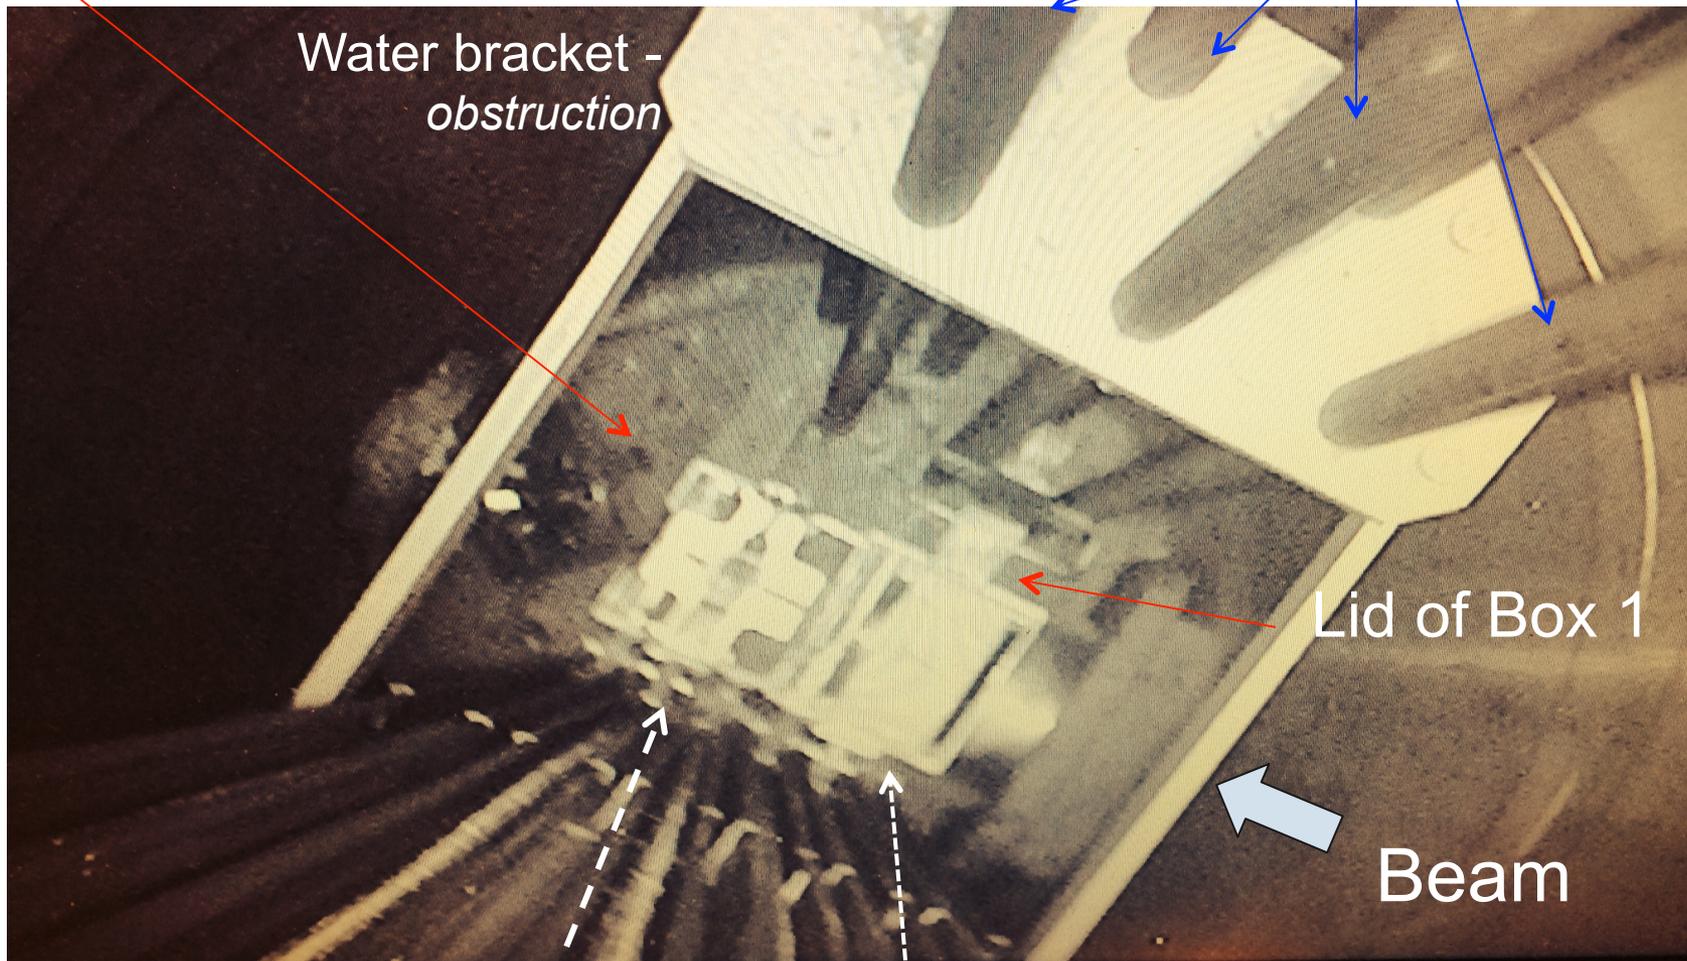
- **Safety** – target box failure after beam dump tuning.
 - Resulted in ability to load thorium target at 180 MeV rescheduled.
- **Production**
 - Both Arronax and BNL target being processed this week.
- **Target box repaired (after hot-box entry)**
- **116 MeV beam on.**
 - Replace RbCl targets from previous week.

Water supply

Degrader that was launched out of box

Water bracket - obstruction

Lid of Box 1

Beam

Box 2

Box 1

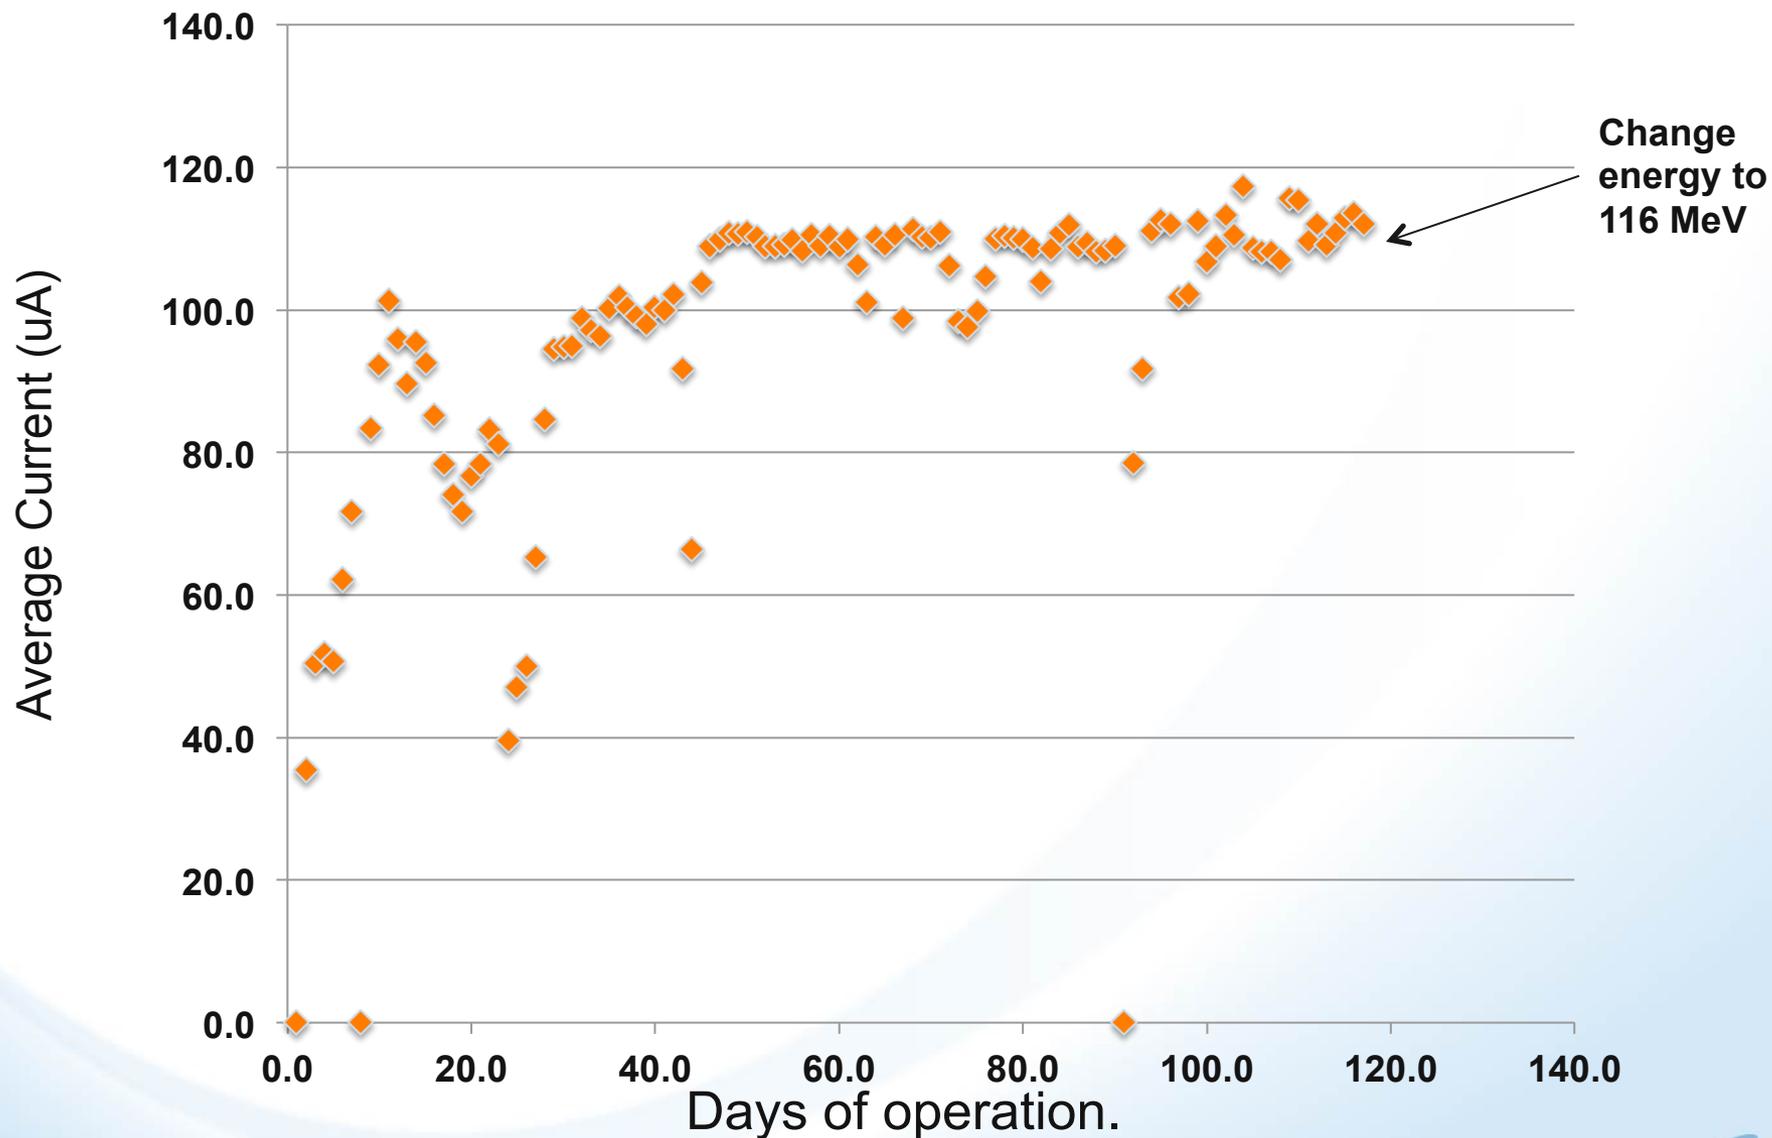
Current delivered to BLIP 18 Dec – Apr – 15

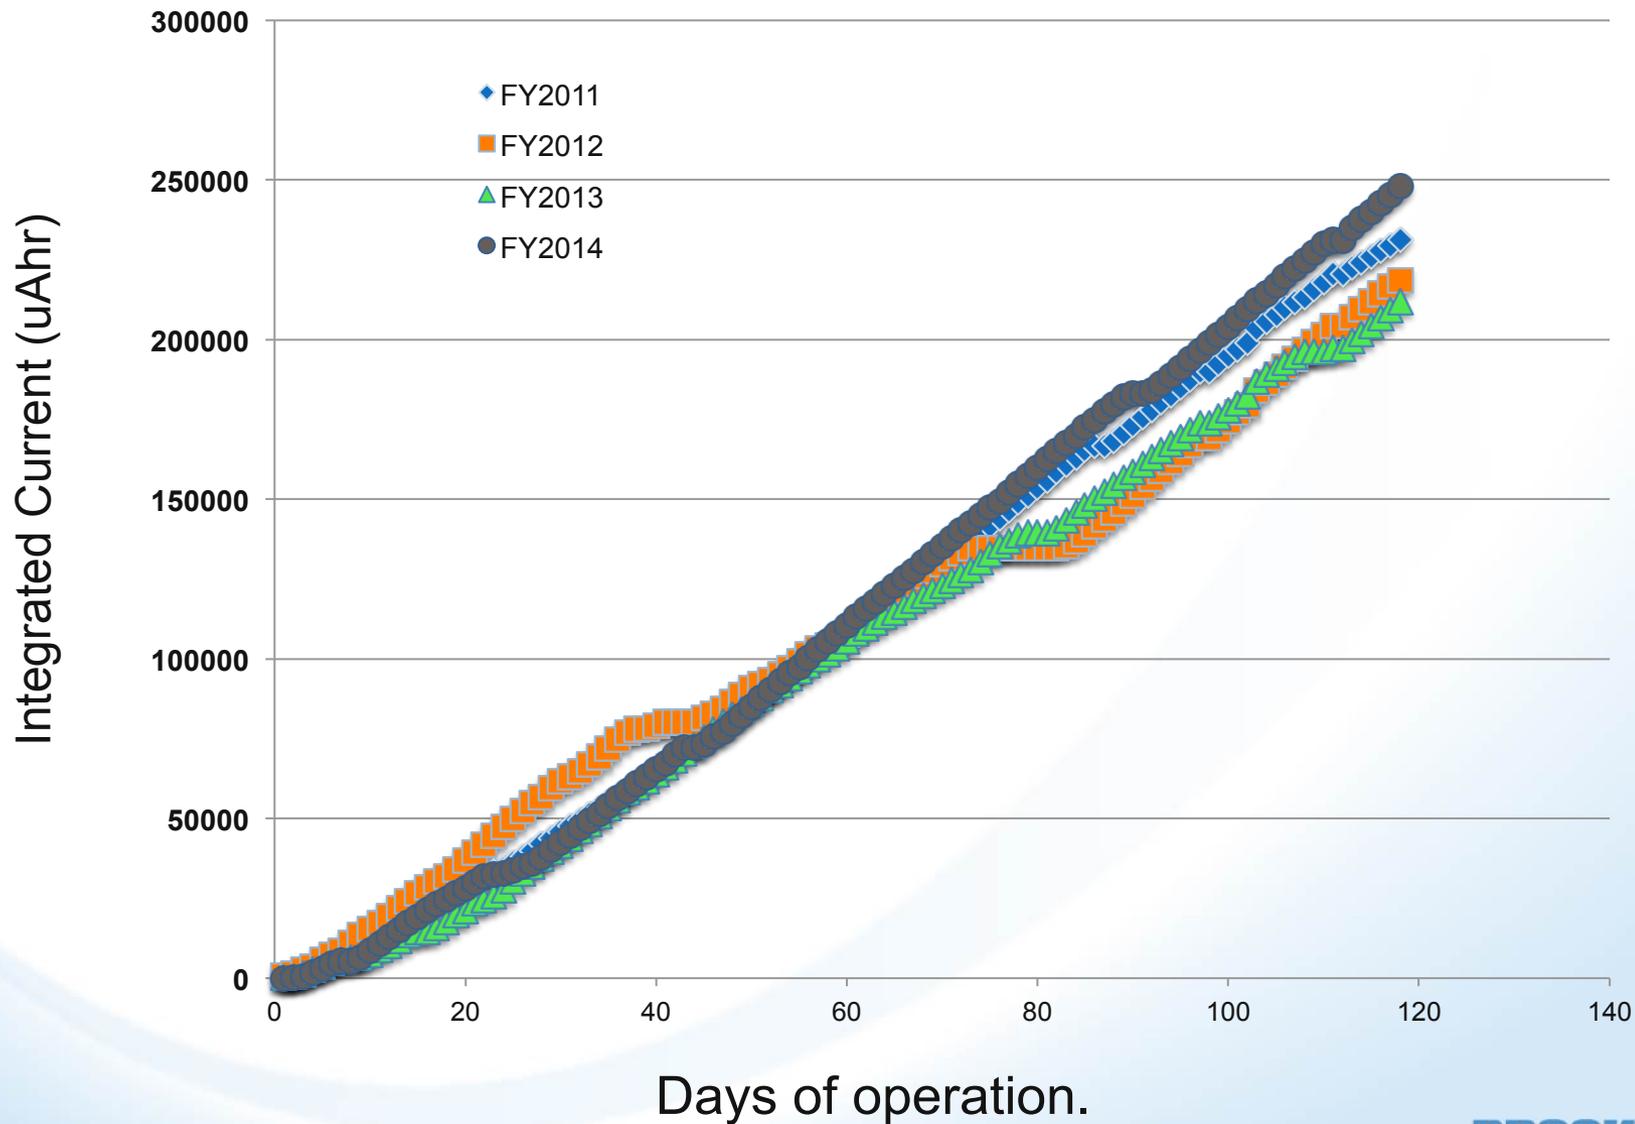
Total Integrated Current at BLIP vs Days of Operation
