Take 5 for Safety

Arc Flash Event at INL Involving Situational Awareness Barrier

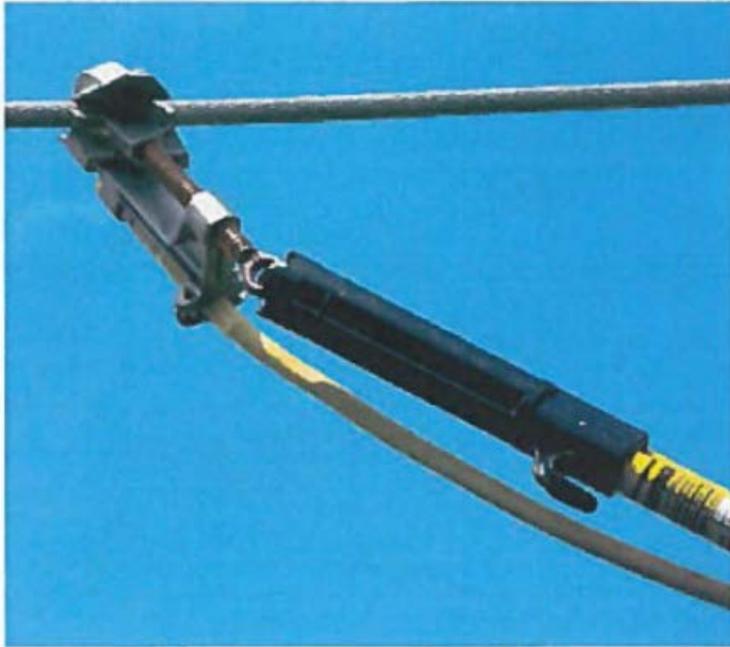
Figure 1- Shotgun Hot Stick

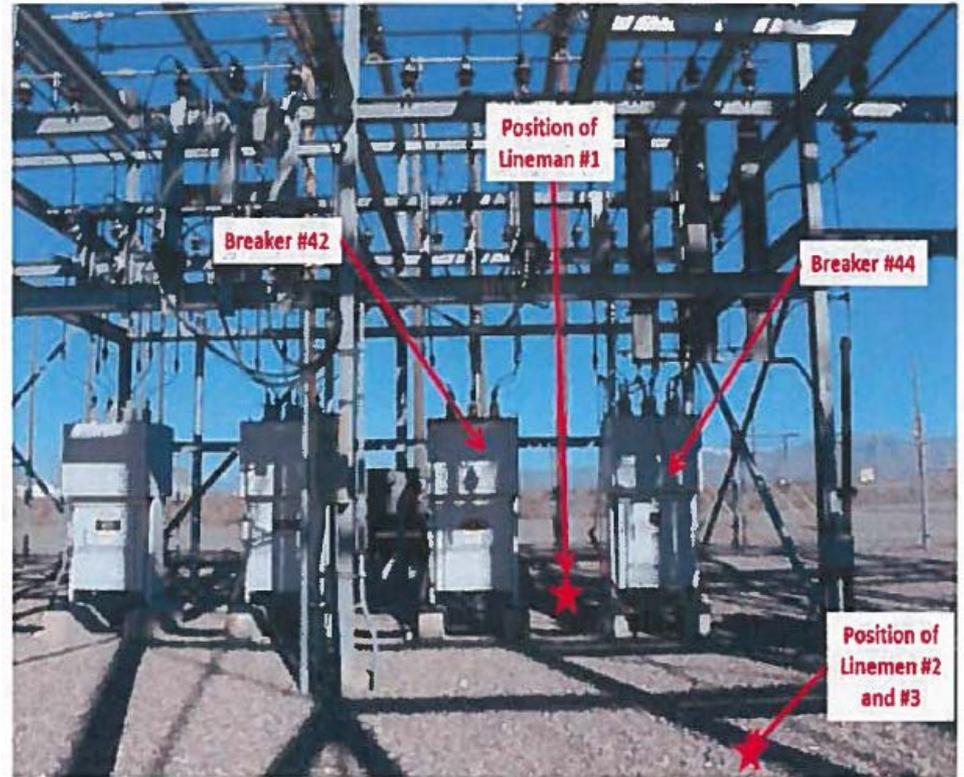
Situational Awareness Barrier – L2 Warns L1 When L1 is Within 2 feet of the B42 Electrical Line, Which is Live

Figure 2 - Position of Linemen during Work Evolution

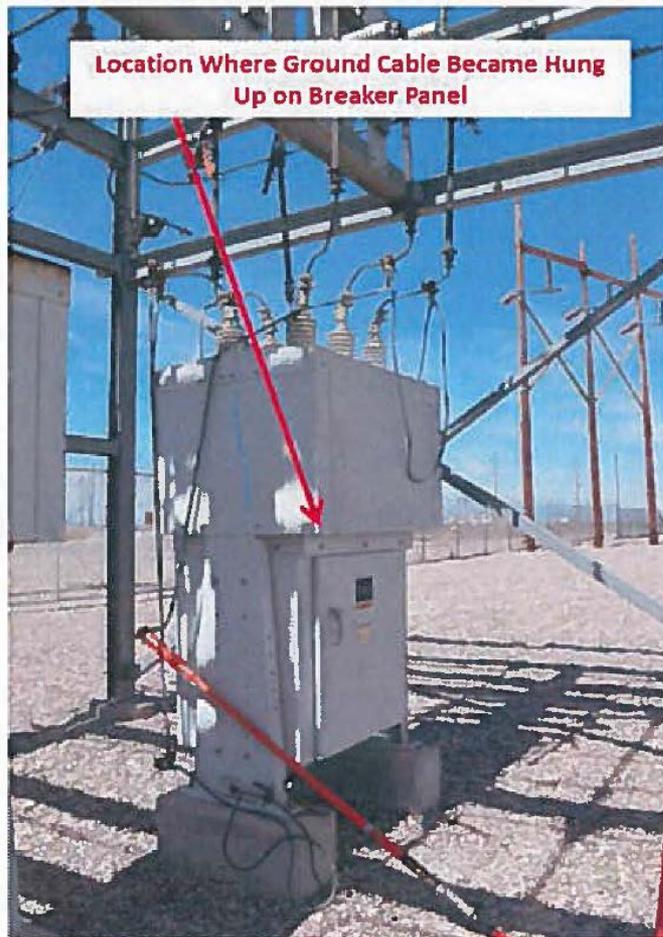
Figure 3 - Location Where Ground Cable Became Entangled on Breaker Panel

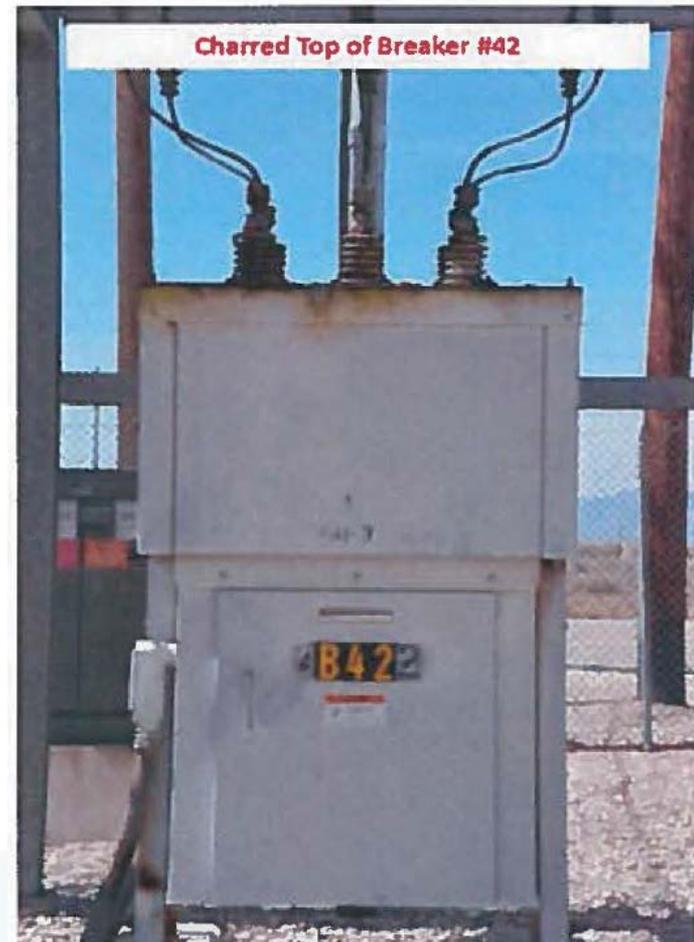
Figure 5 - Charred Top of Breaker B42
