CeC PoP Experiment

January 19, 2016

Inspection of Cryostat for 704 MHz Cavity

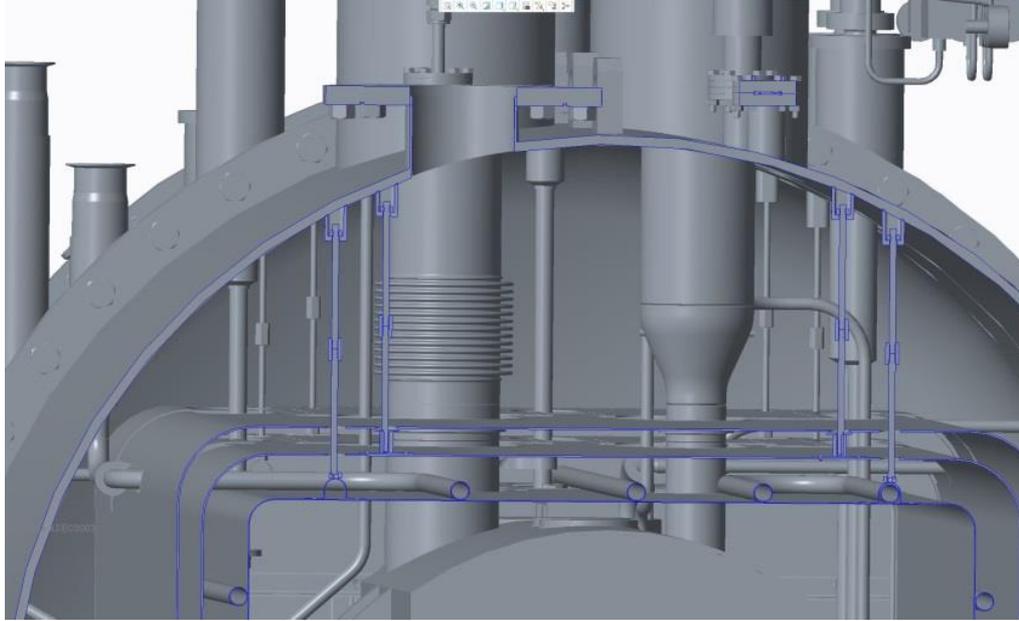
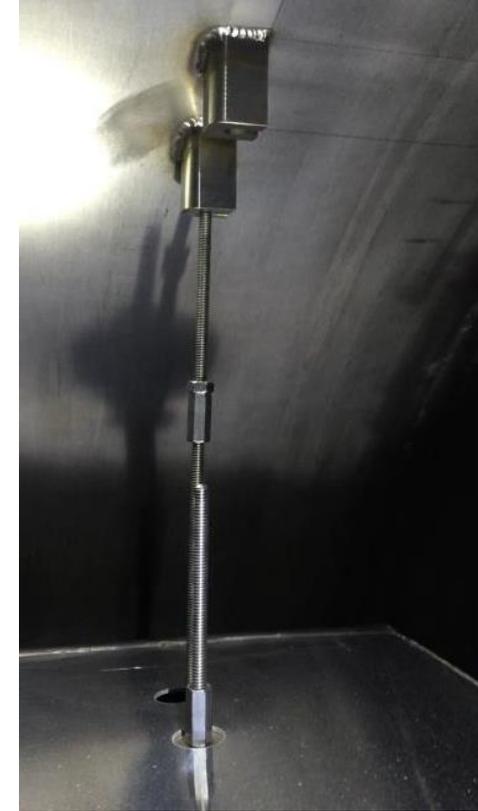
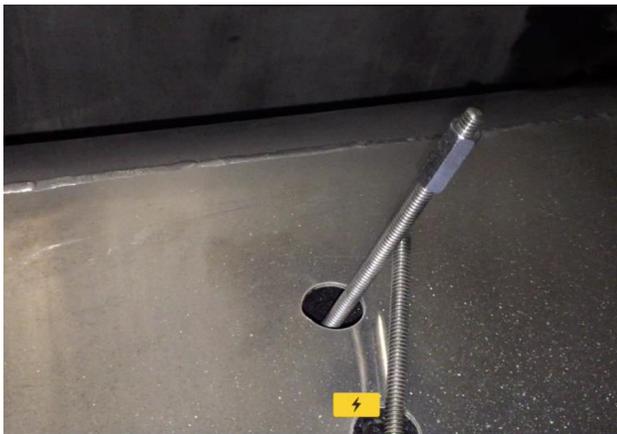
The rods holding the magnetic and cryogenic shields became disconnected. We need to open cryostat and restore the configuration.
