B10 D19 Diode Repair

March 29, 2016

Injured Party Blue Dipole Sector 10, S/N DRG592

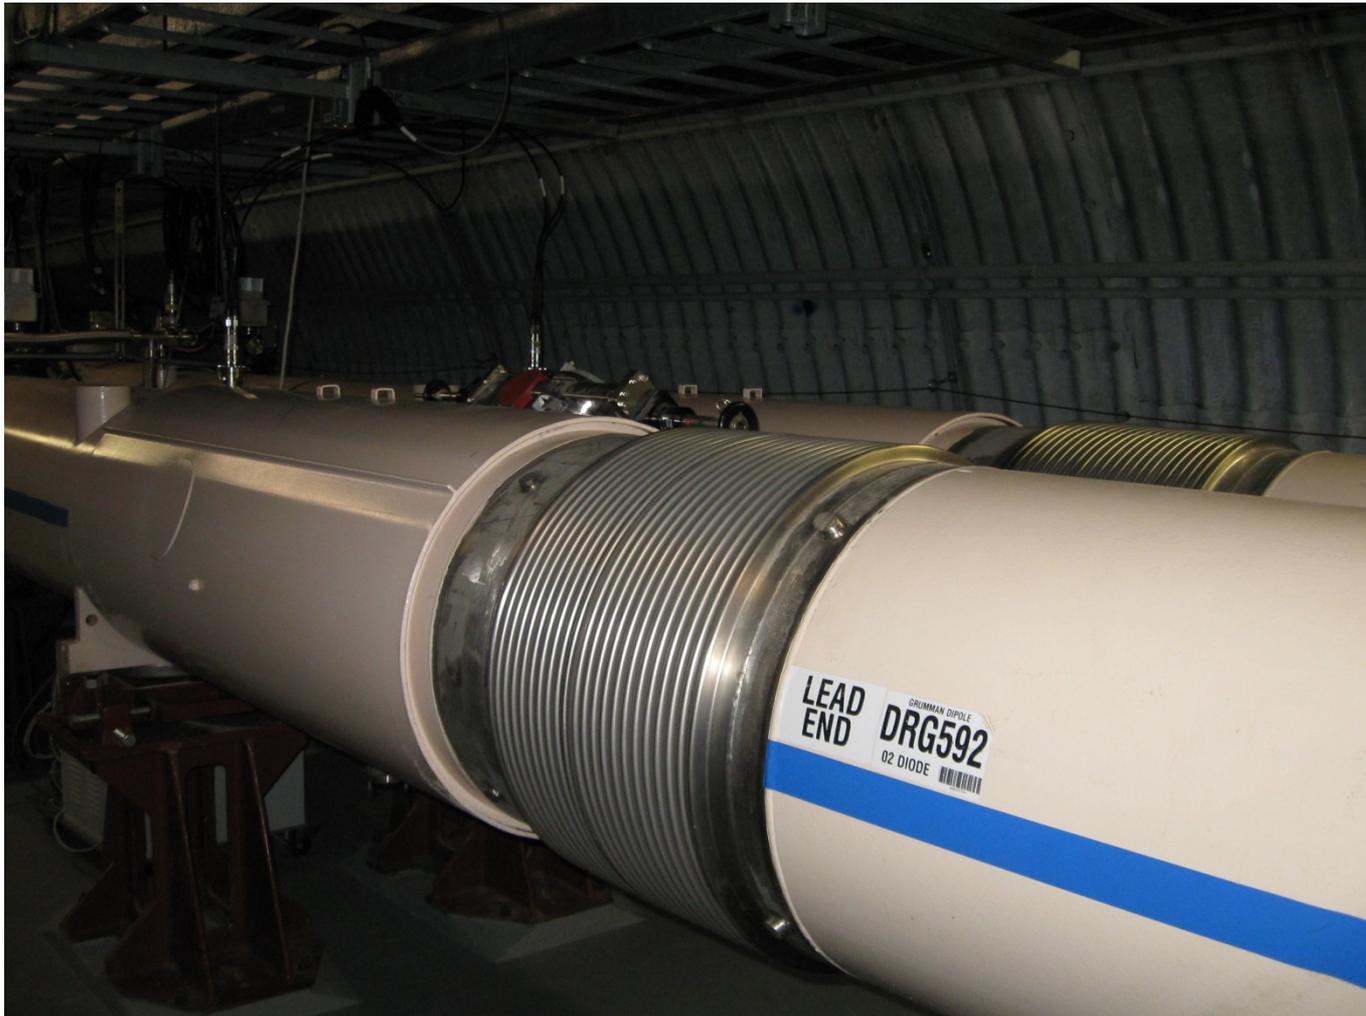
Once permits are in place outer shell in removed. Due to HP assay jigsaw was used instead of grinding wheel.

End volume exposed after the outer shell (vacuum vessel) is cut , the MLI blankets & heatshield removed and the end cage blanket cage taken out.
HP survey/assay & protocol required at Outer Shell, H/Shield and at End Volume

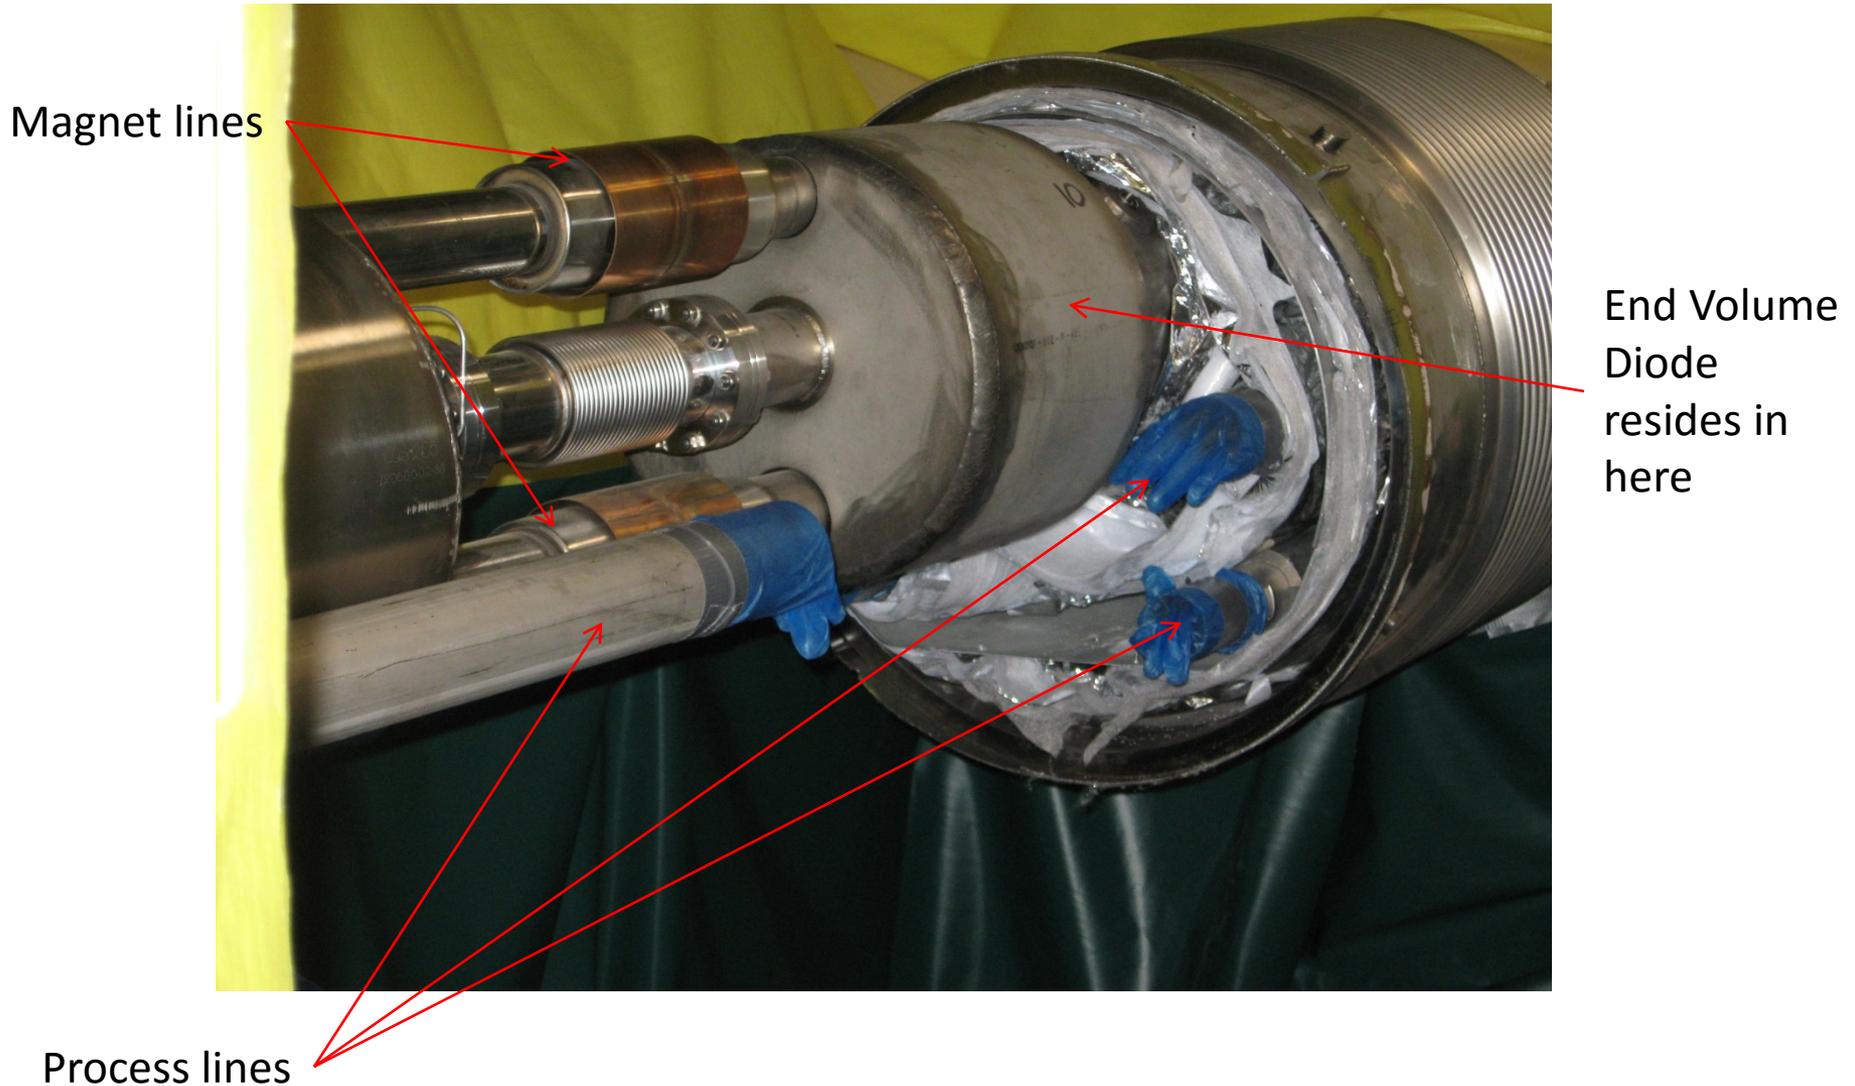
A split ring (Wach's) cutter is used to turn away the old weld. Thursday (1:45AM) it was discovered cutter did not fit due to slight "egg" shape of the EV. Required reworking of the cutter.

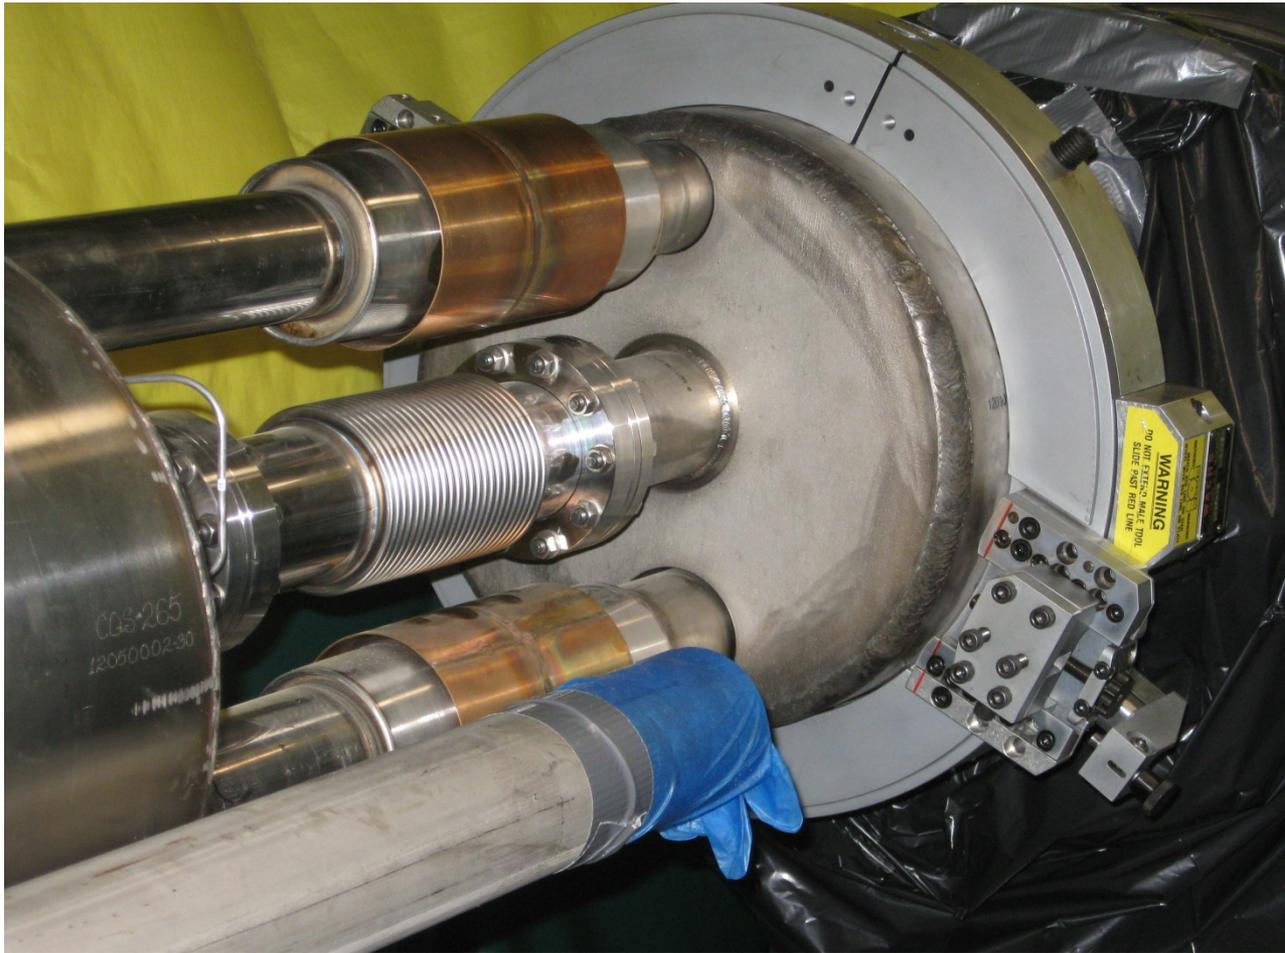
Note gaps between cutter and EV. The EV shape would not allow proper sitting of the cutter.

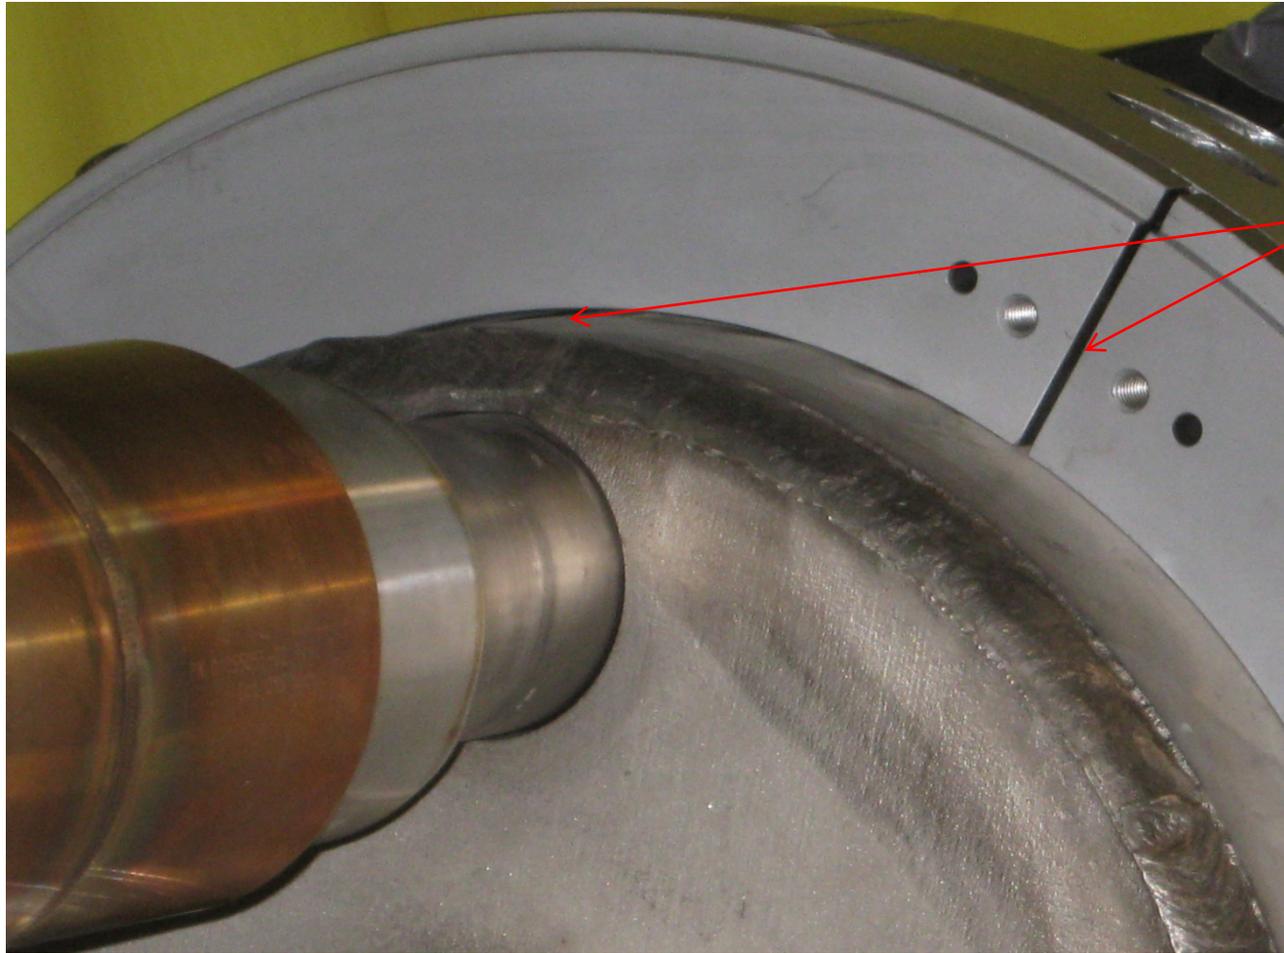
Gaps

Reworked Wach's cutter in action

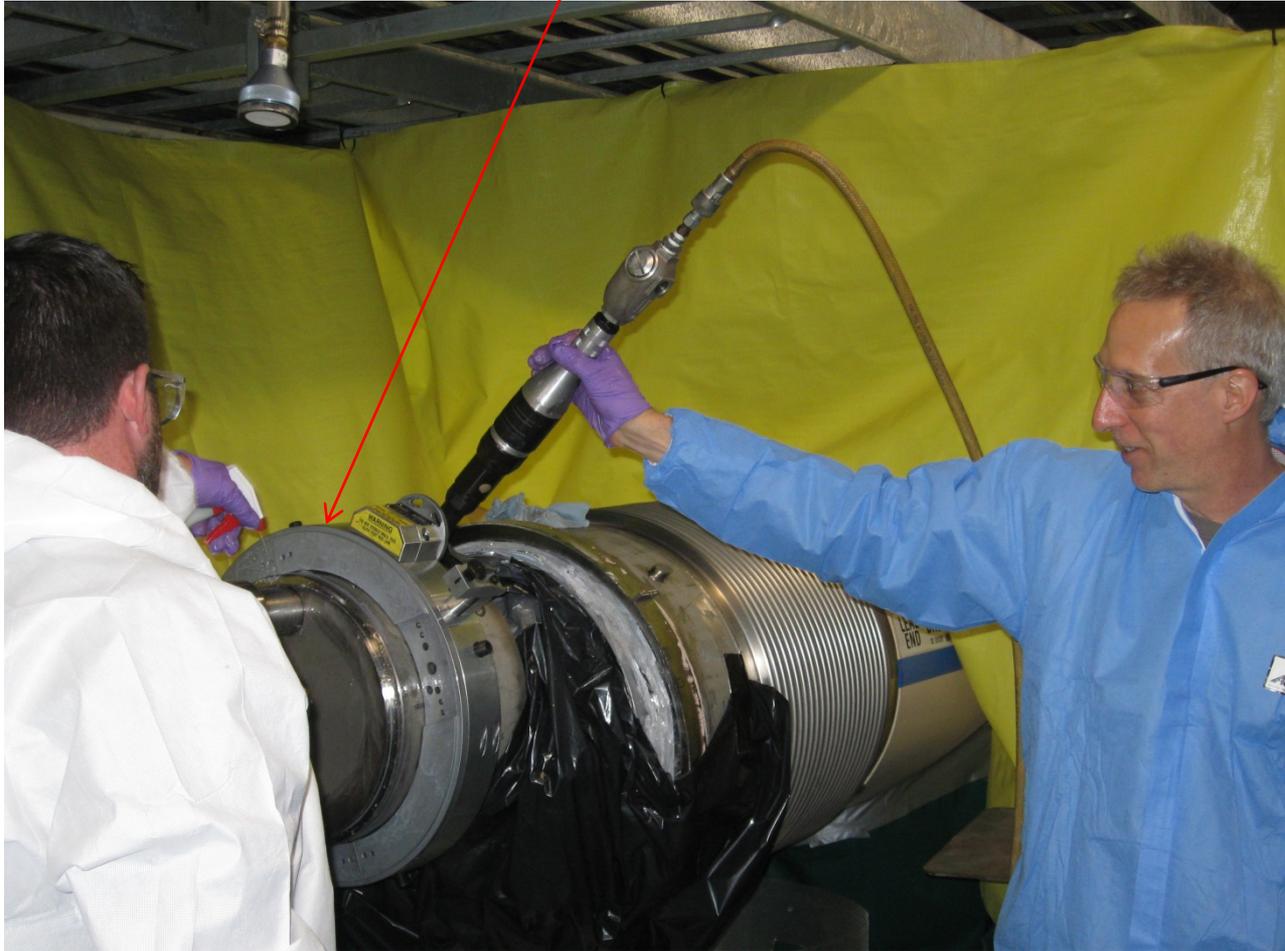
Close-up of cutting tool – after first step of weld removal

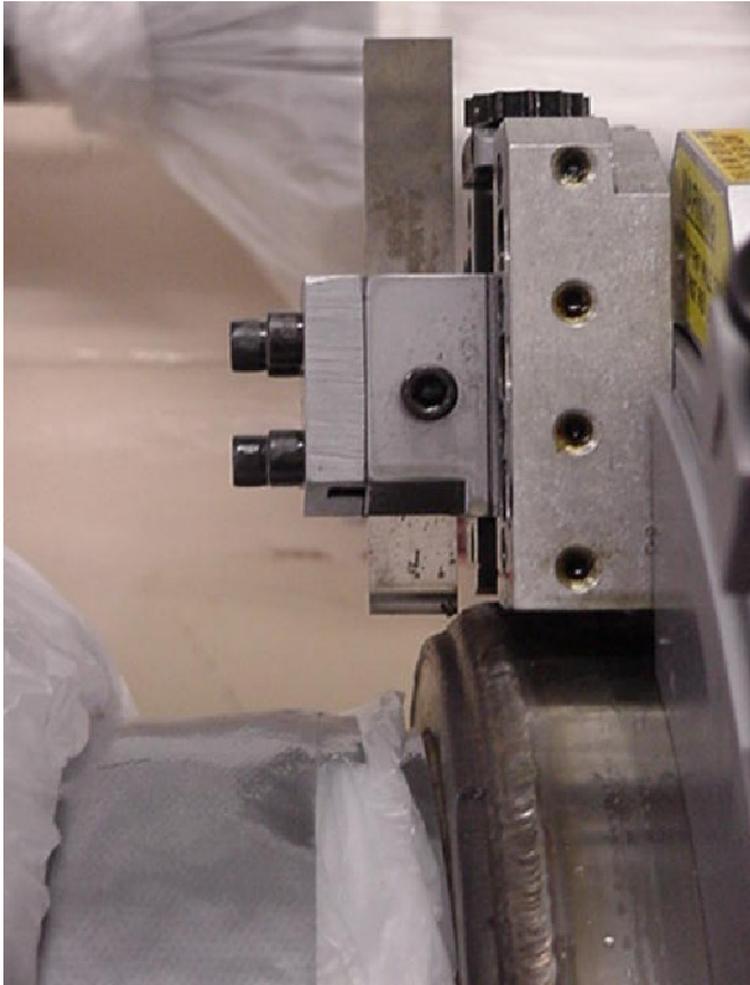
End volume cut free – ample persuasion required

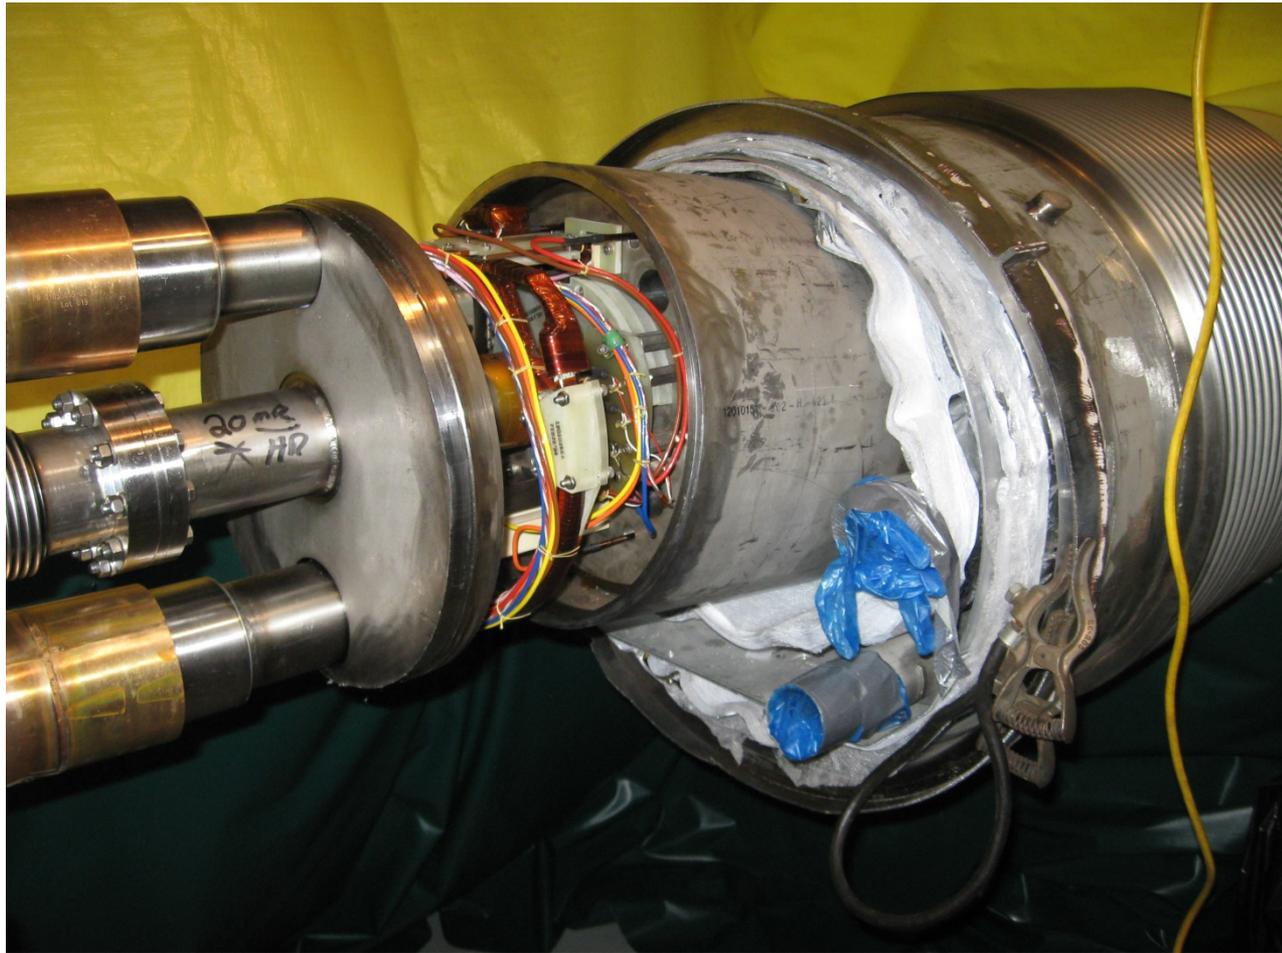
All process lines must be removed to allow rotation of the cutter head

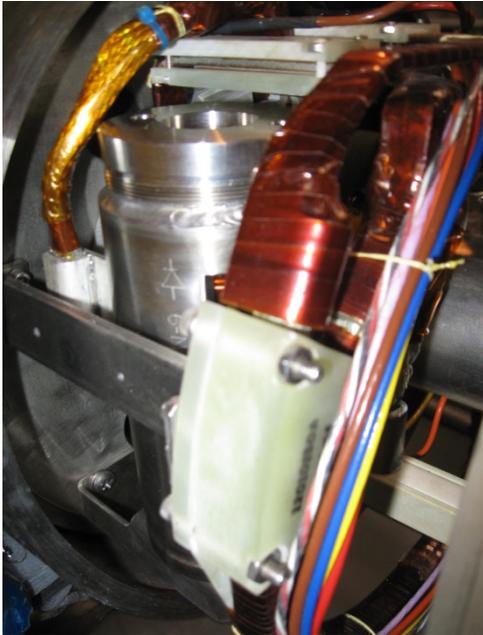
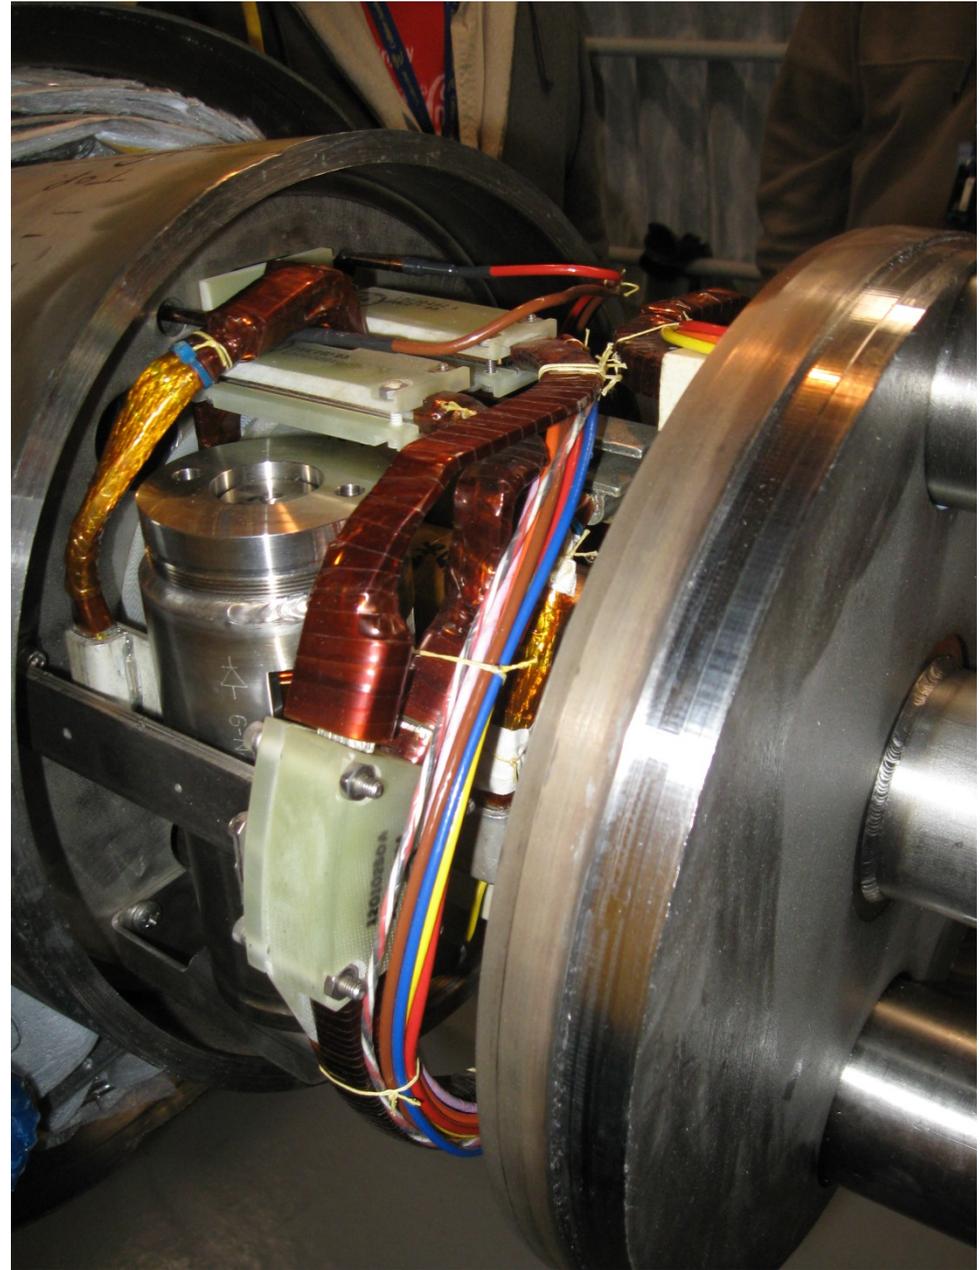
Damaged Diode

This type is held in place by 10-32 machine screws connected to metal braid.

Close-up

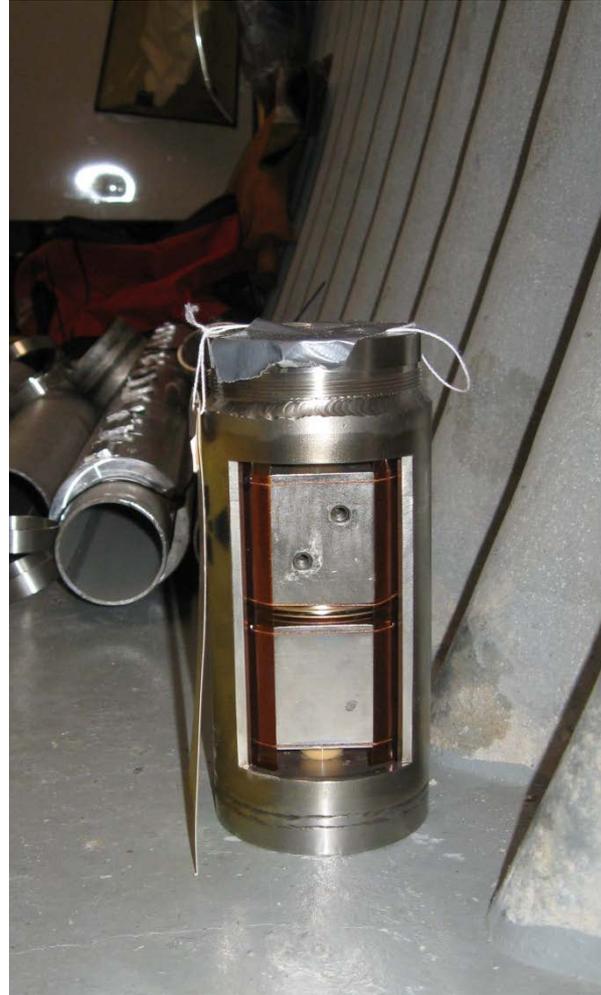
Removed diode
on tunnel floor.

4 mR at contact

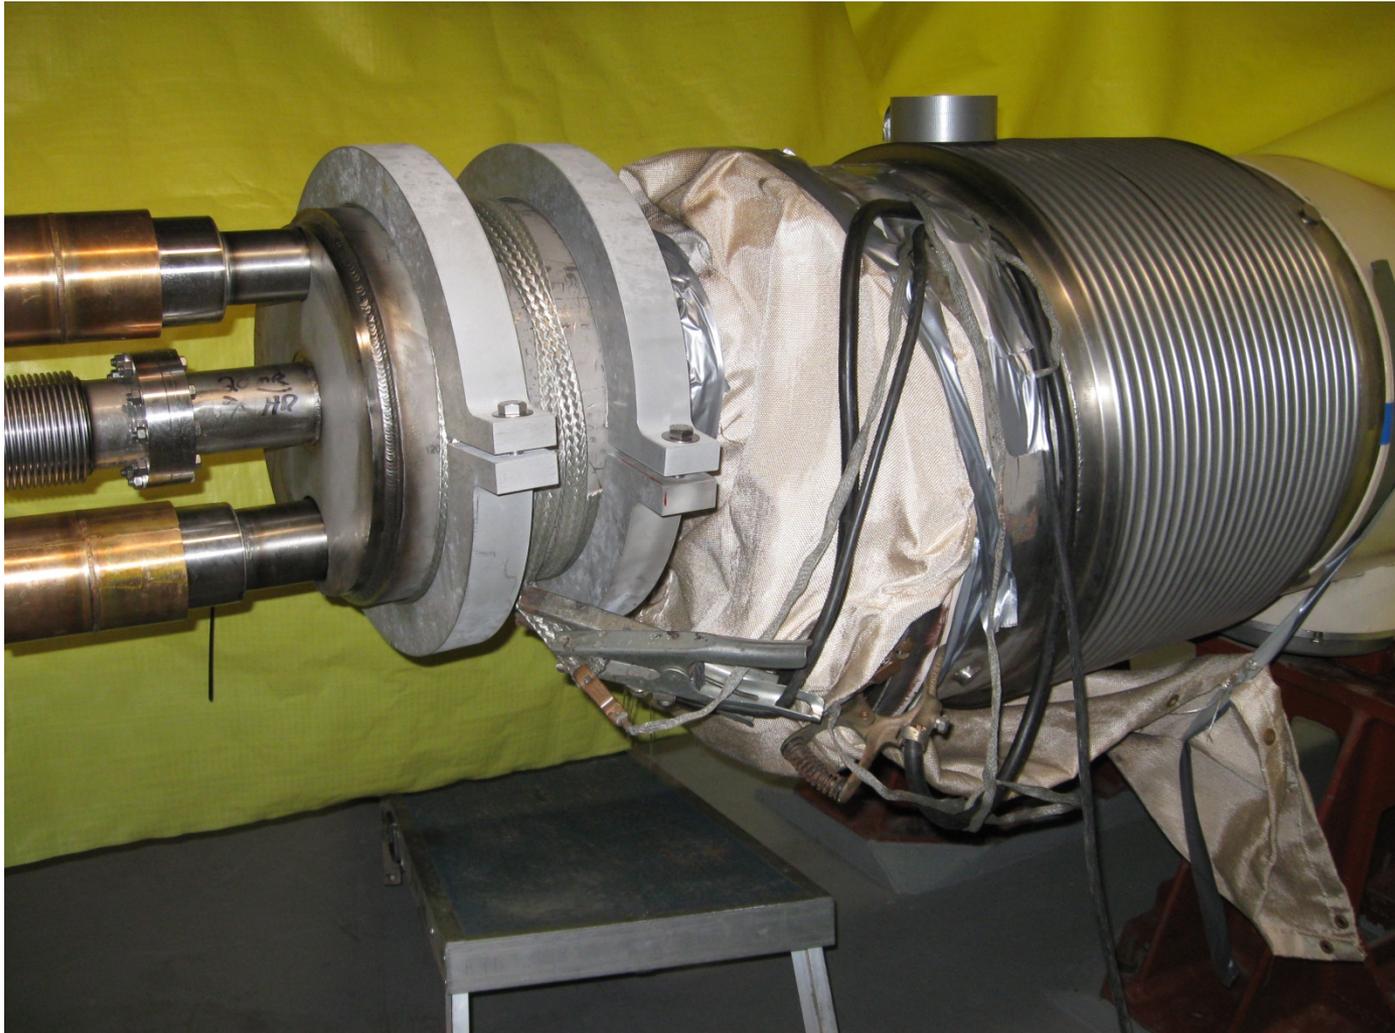
New diode install and welding process begins.
Magnet covered with welding blanket to protect insulation.

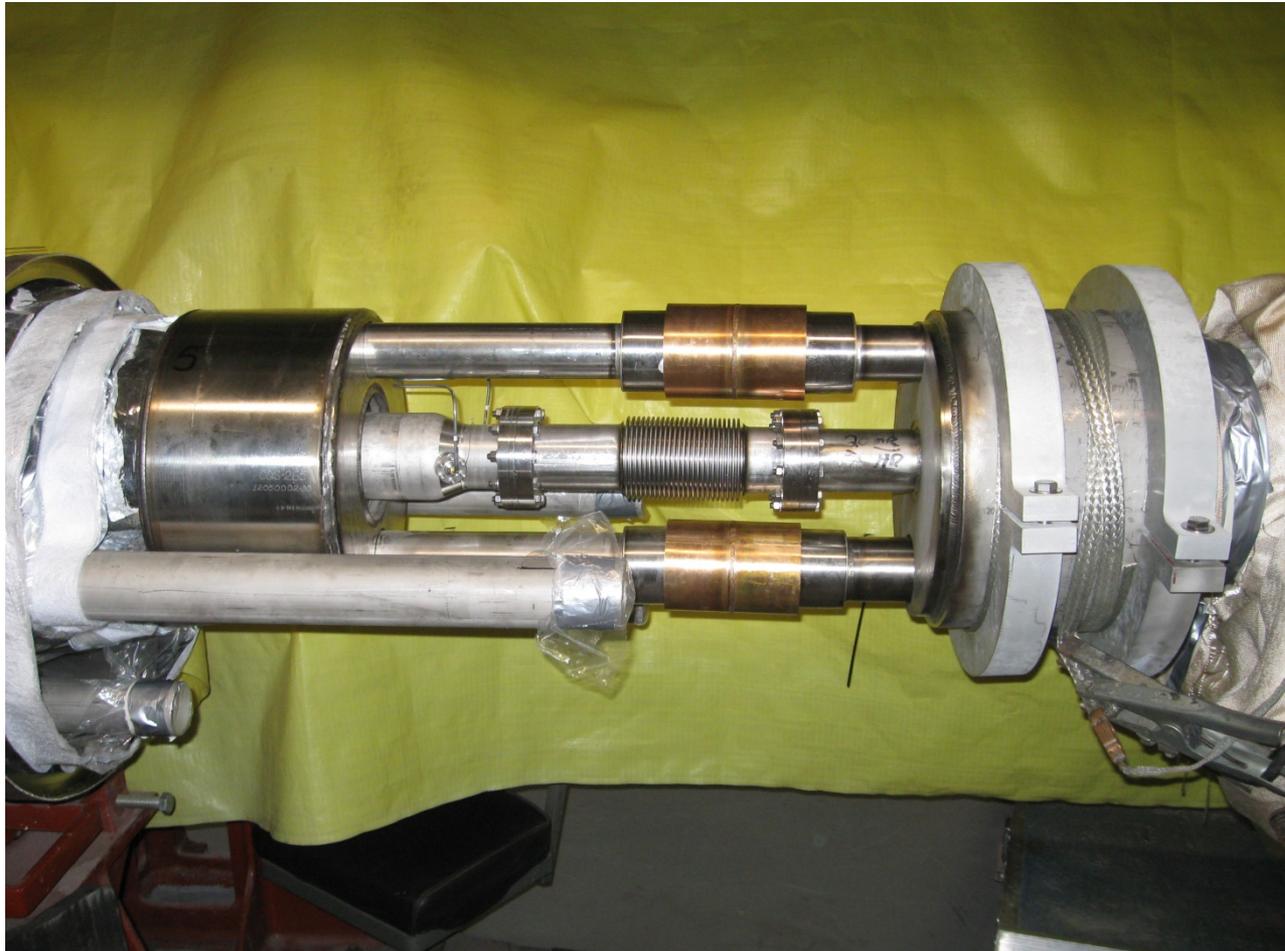
Multi-pass welds are required but temperature must be controlled to avoid damage to diode and Omega joint.

Aluminum “cooling rings” used to speed temperature drop.

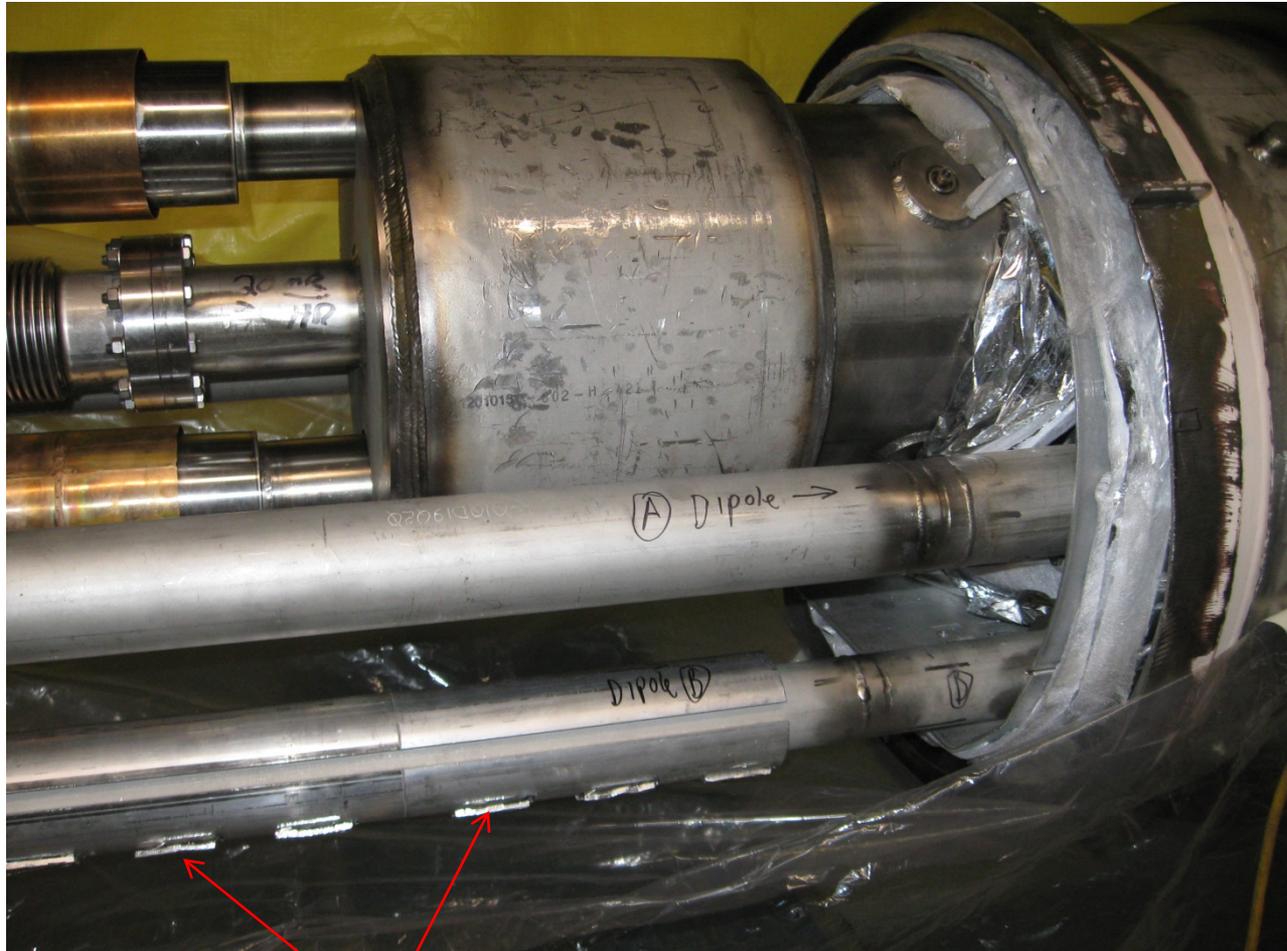
EV and process (RUSH) lines re-assembled

Heatshield welded to these rectangles

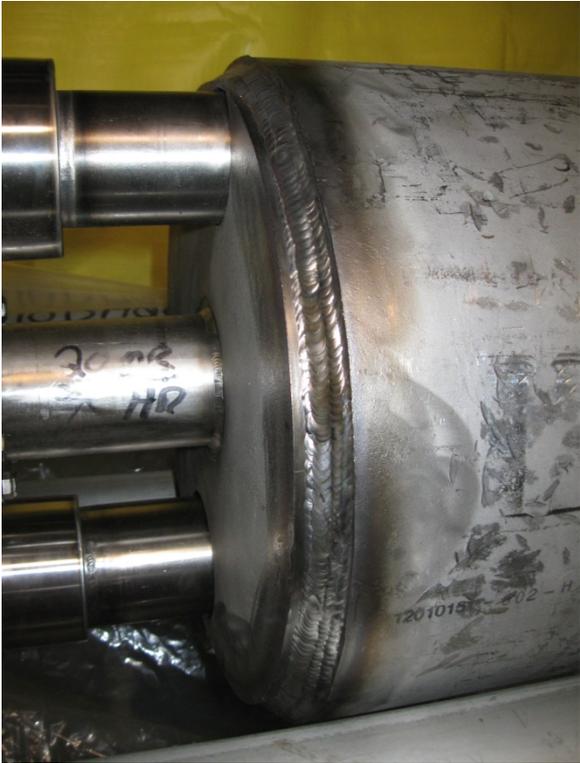
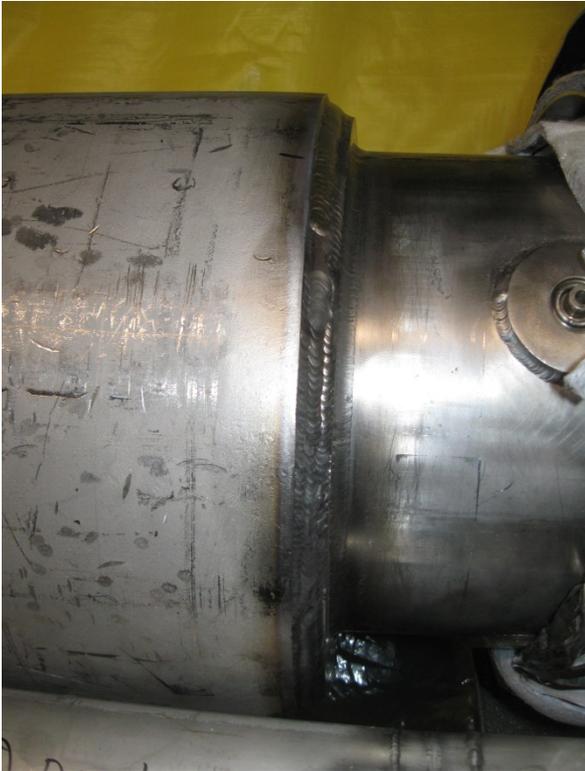
Completed EV welds – 7-9 passes

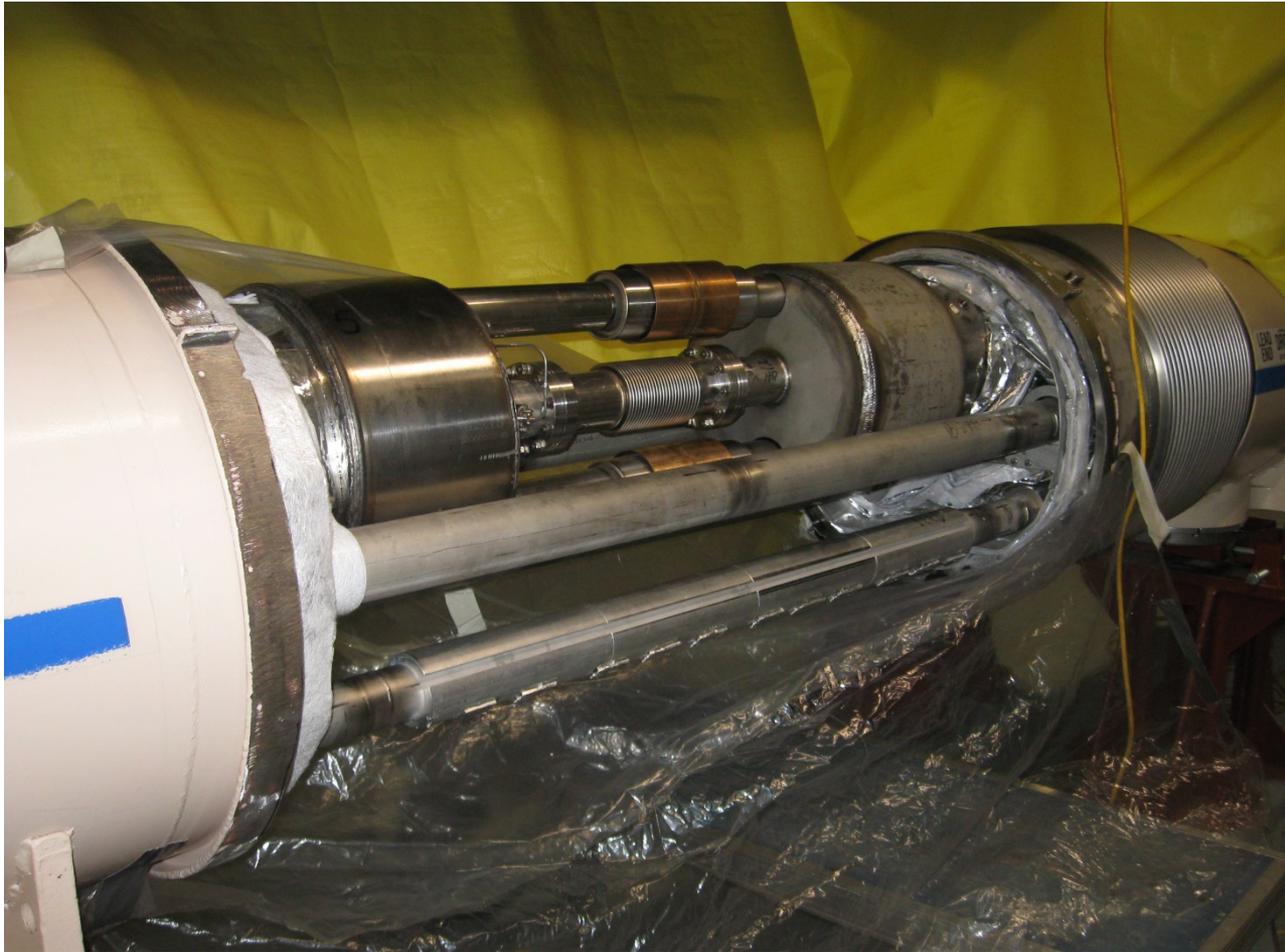
Interconnect piping complete.
Next steps MLI blankets and heatshield replaced.

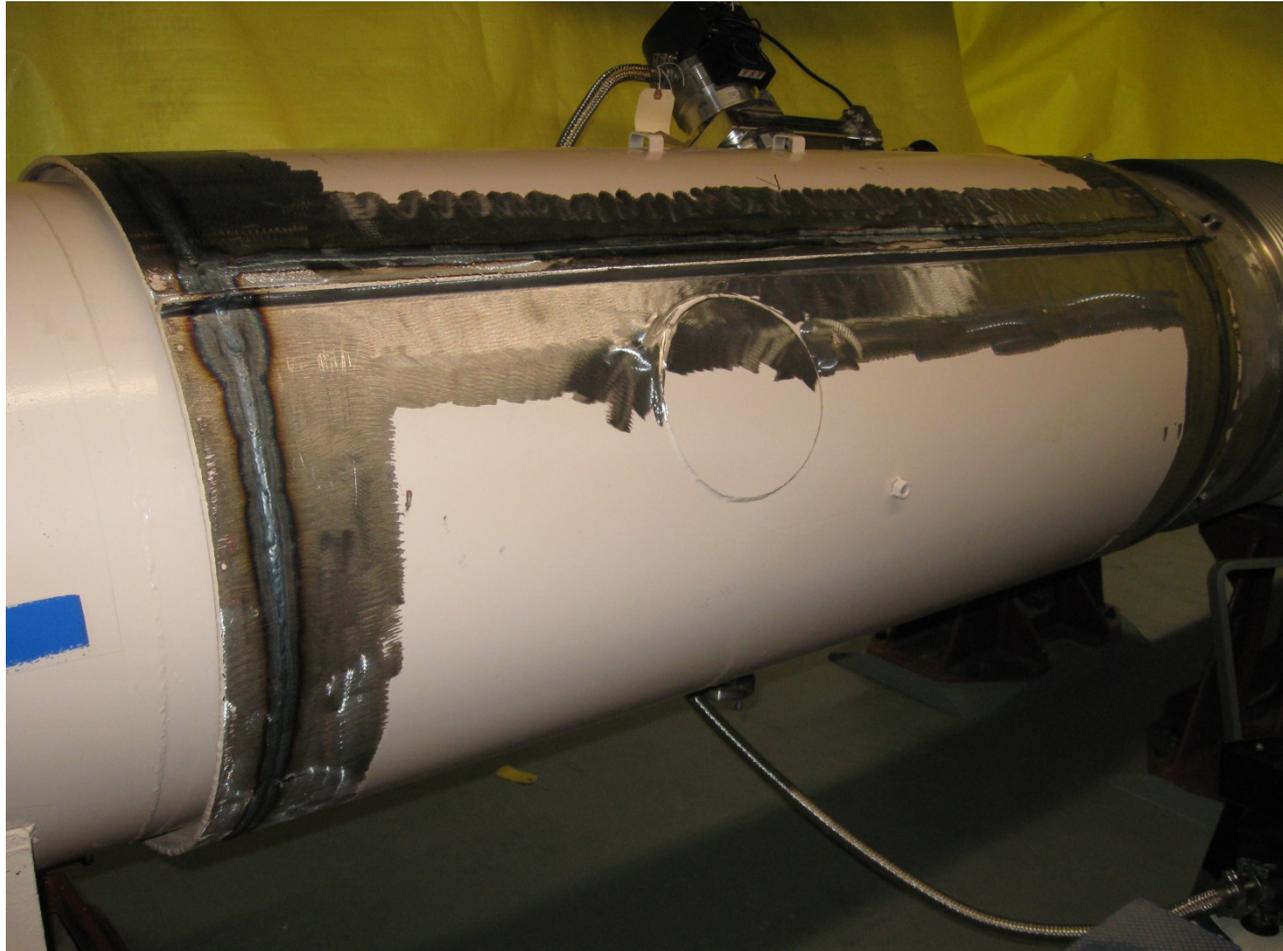
Outer shells welded back in placed

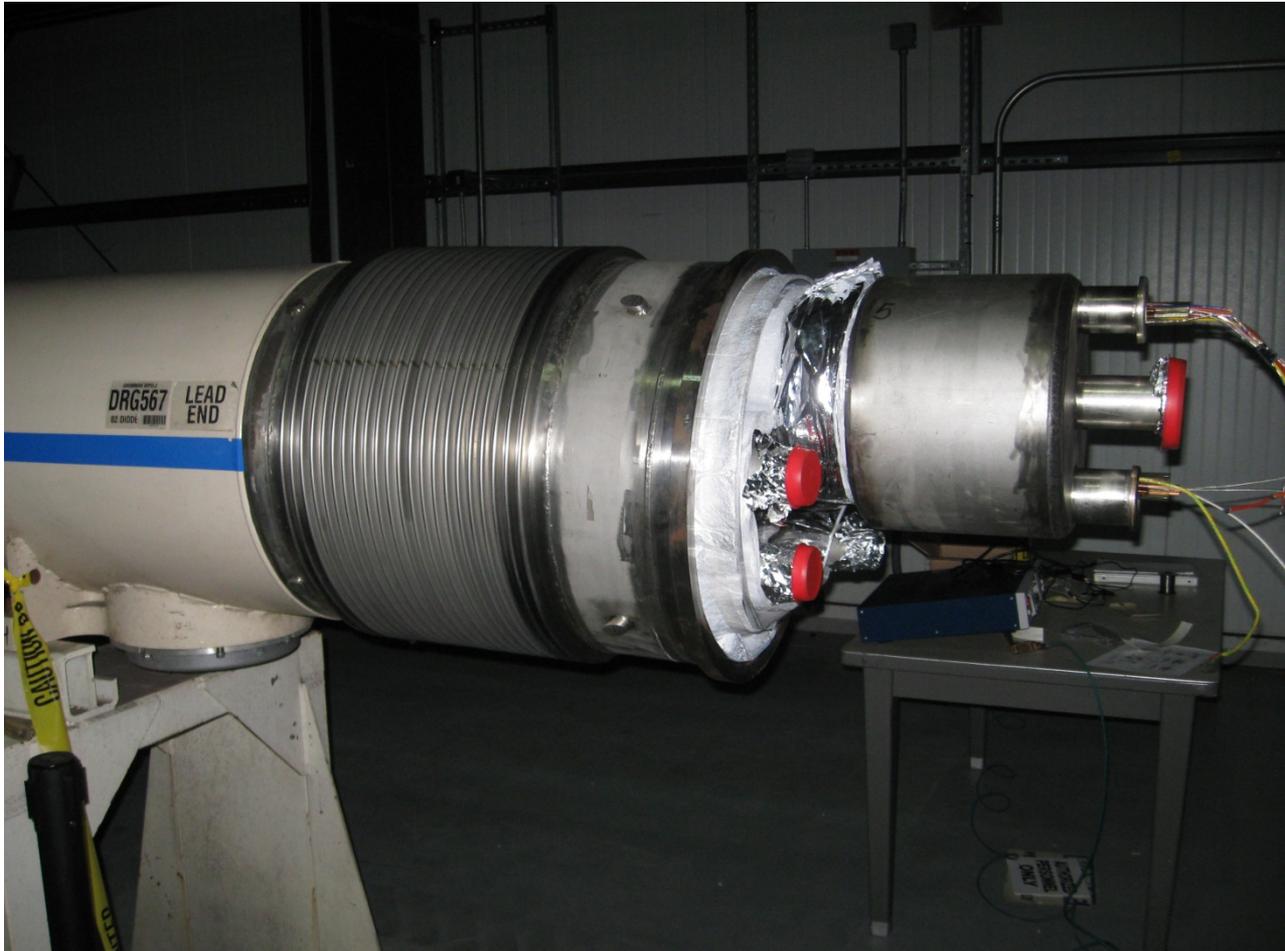
SC Magnet Division prepared spare dipole in case it was needed.
