Alternating Gradient Synchrotron Department
BROOKHAVEN NATIONAL LABORATORY
Associated Universities, Inc.
Upton, New York 11973

AGS/EP&S/Tech. Note No. 132

May 24, 1989

Shielding Block Lug Failures

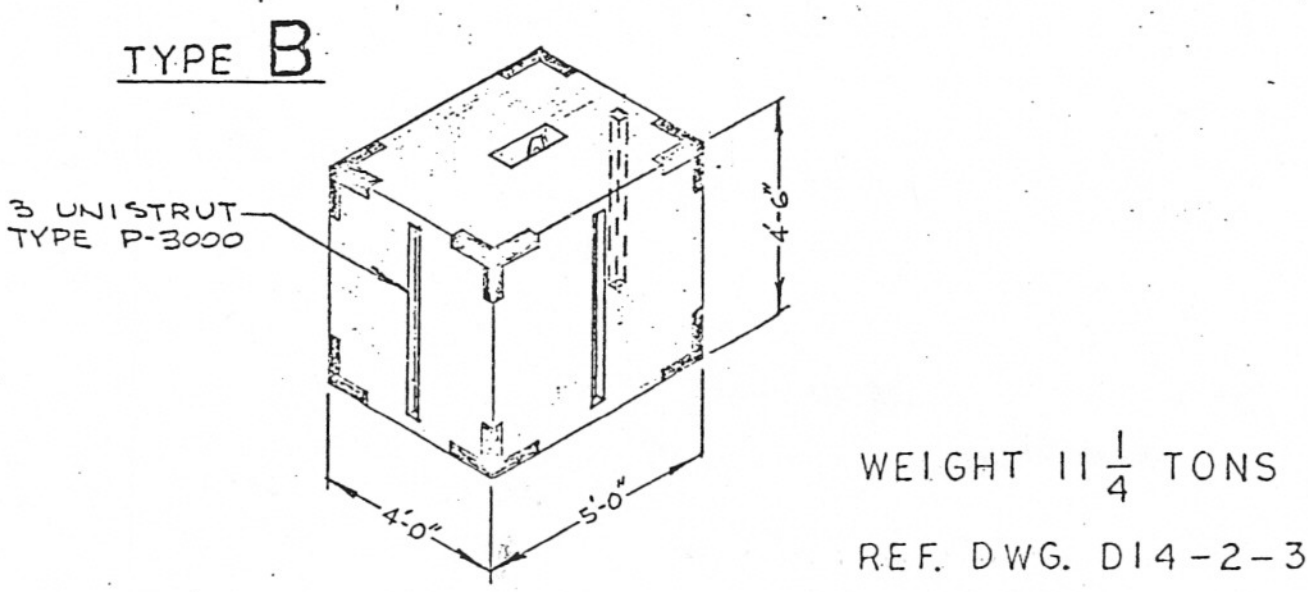
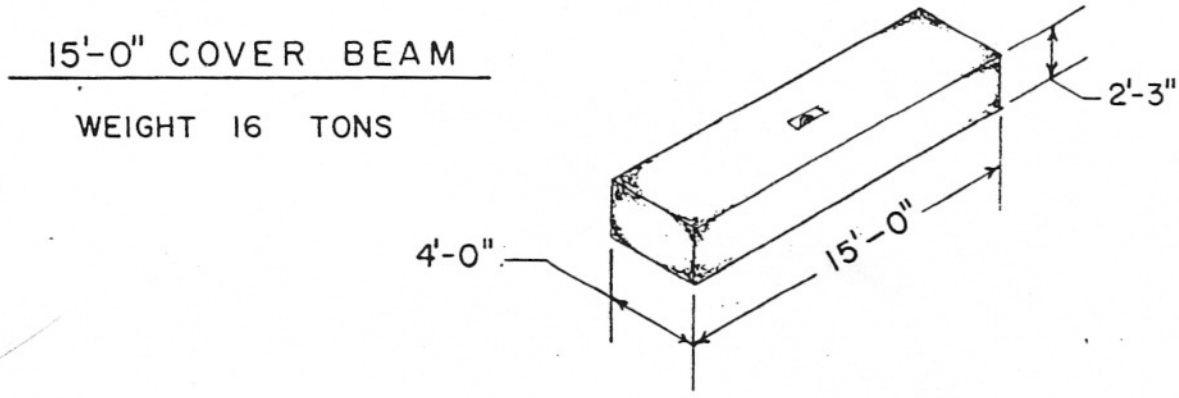
The first failure occurred in the Target Building while lifting a B-block over the AGS ring. The block was raised to virtually the highest point possible with the crane and then a horizontal traverse was begun. At this point, the lug failed causing the block to fall onto the AGS roof.

The second failure occurred over the B cave in EEBA. Fifteen-foot roof beams were being lifted to expose the cave below. One beam was wedged between adjacent beams and, when lifting was attempted, became stuck with a tilted orientation. Further attempts to free the beam resulted in the lug breaking.

Fig. 1. Blocks that failed.

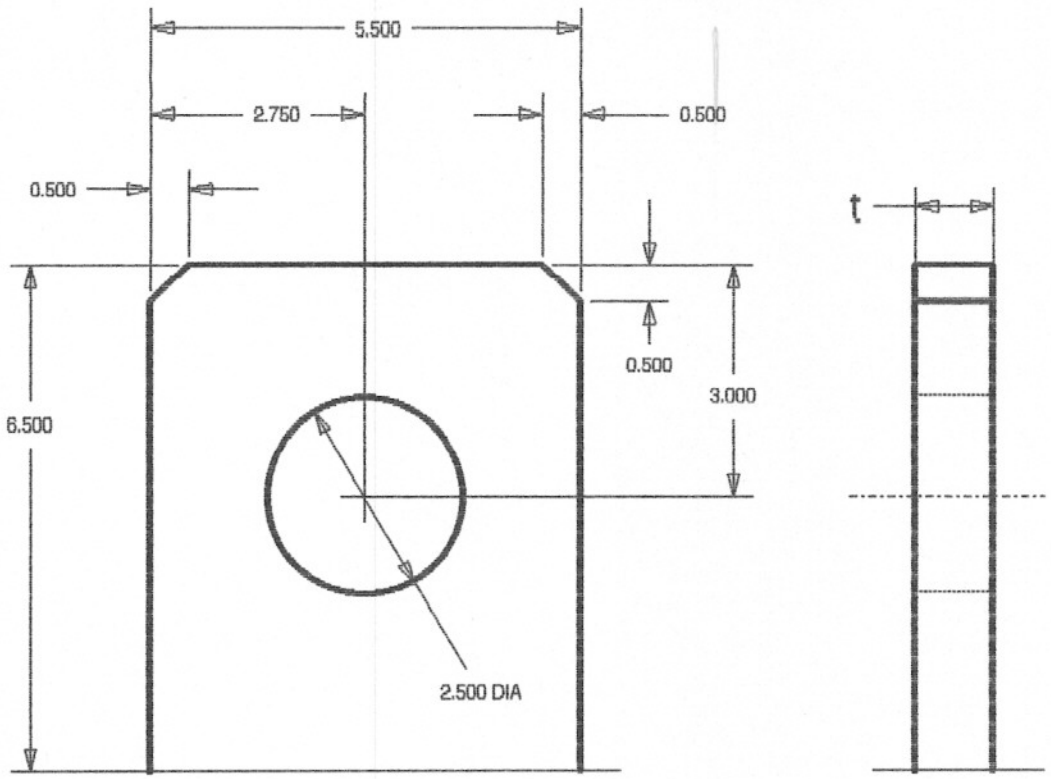
Stress analysis was carried out to determine whether the loads imposed on the lugs were sufficient to cause failure. Hand calculations showed that for "ideal" vertical lifts and considering stress concentrations around the lifting hole, the tensile stresses imposed were about 22,000 psi for the two lugs. This is about one third of the ultimate tensile strength of the material, not enough to cause failure but certainly not

The results of the tests indicates that the failed lug material was very similar to ordinary mild carbon steel (tensile strength ~68000 psi, yield strength ~35000 psi) with one important exception: the notch toughness determined by the Charpy Impact test was unusually low. This indicates that the material has a high ductile-to-brittle transition temperature which means that at temperatures normally encountered by AGS shielding blocks, the lug may behave in a brittle fashion.

The results of the qualitative spectrographic and quantitative chemical analysis indicated that the material possesses an extremely low silicon and aluminum content indicating the material to be a rimmed (non-killed) steel. Non-killed steels inherently

exhibit little or no toughness and this is consistent with the fact that a visual examination by metallurgical experts determined that the two lugs in question experienced a classical brittle failure.

Fig. 2. Shielding block lifting lug.

The third item deals with modifying the shielding block lugs themselves. Metallurgists have determined that there are no metallurgical processes which will strengthen the existing lug material. In addition, reinforcing the lugs by welding additional material to them was tried but this solution was rejected when it was determined that the reinforced blocks were, in many cases, less strong than those blocks which were not reinforced. It is judged that reinforcement is not necessary, however, since the other solutions described above are adequate to assure safe block handling.

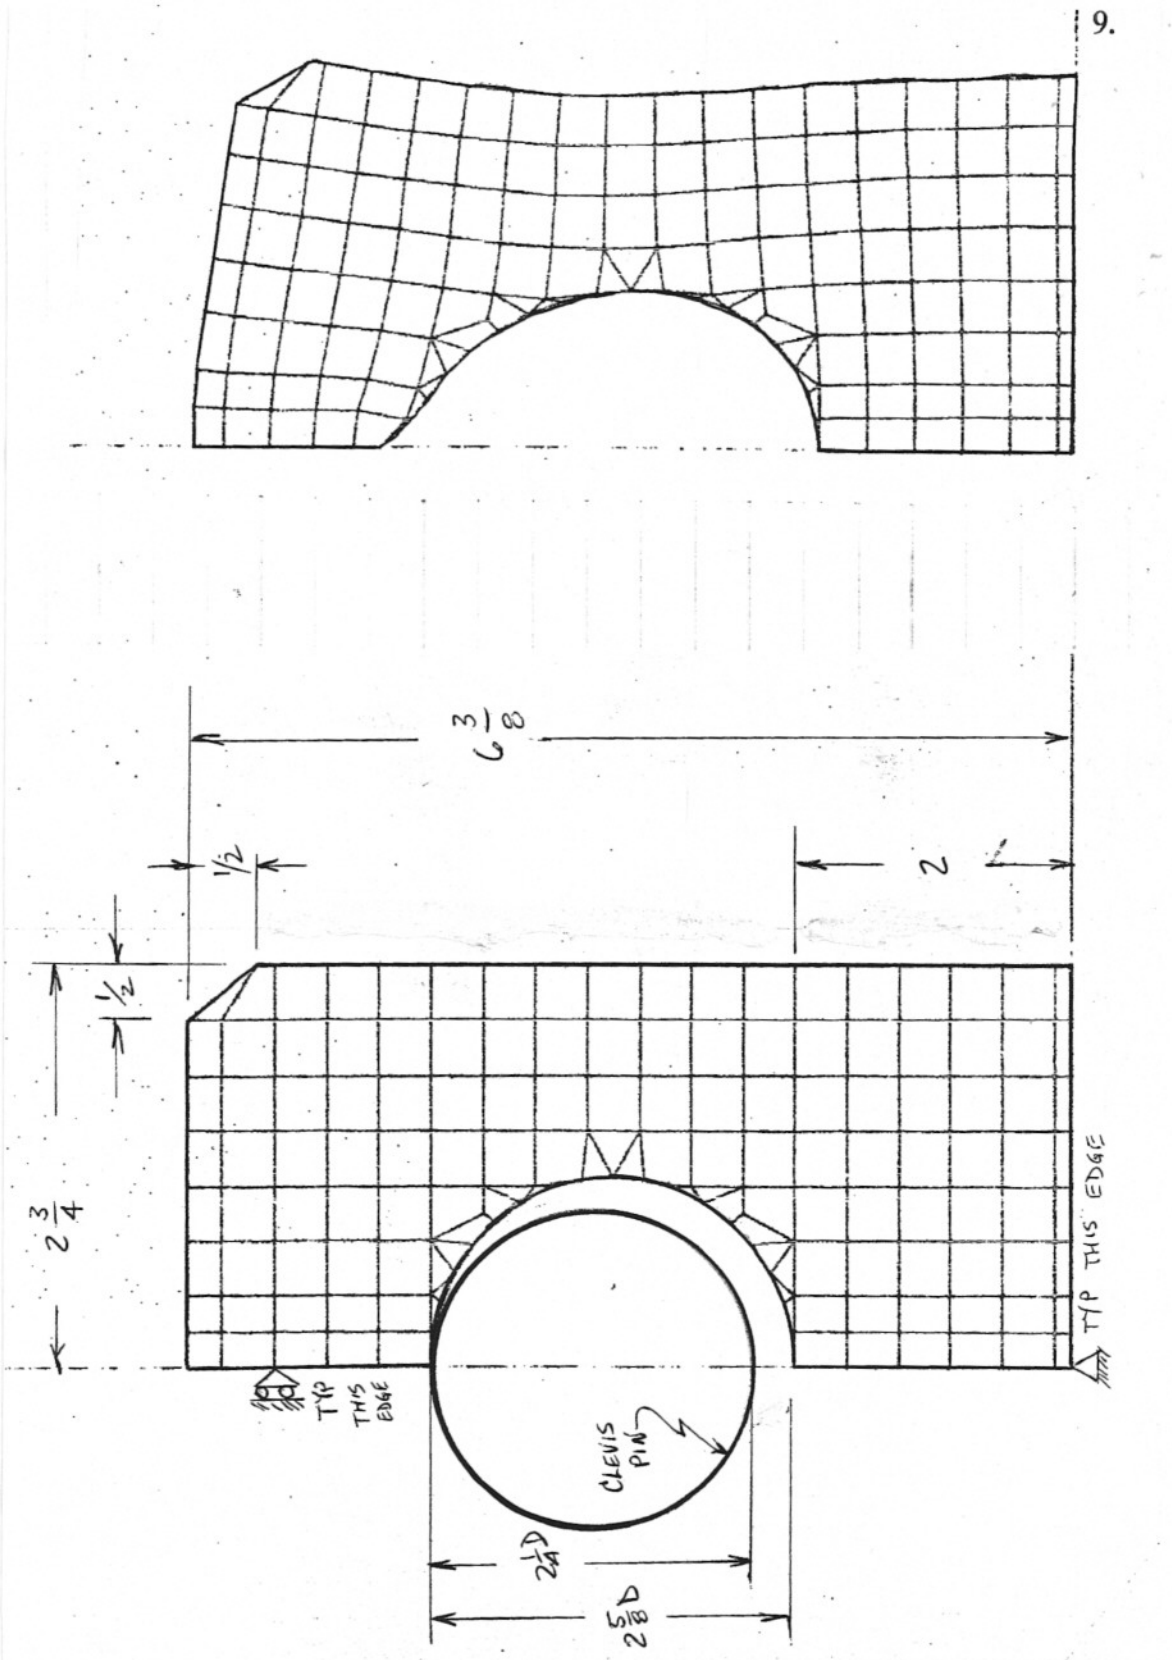
a generous safety margin either. A finite element computer code called MESS (Mechanical Engineer's Stress) was used to analyze a two-dimensional model of the B-block lug. A representative view of the model and its exaggerated shape under loading is shown in Fig. 3. The results of this analysis showed the von Mise's (total) stresses in the lug at the point of failure were about 25,500 psi which is close to the hand calculated values.

Fig. 3. Finite Element Model of lug and exaggerated model distortion under loading.

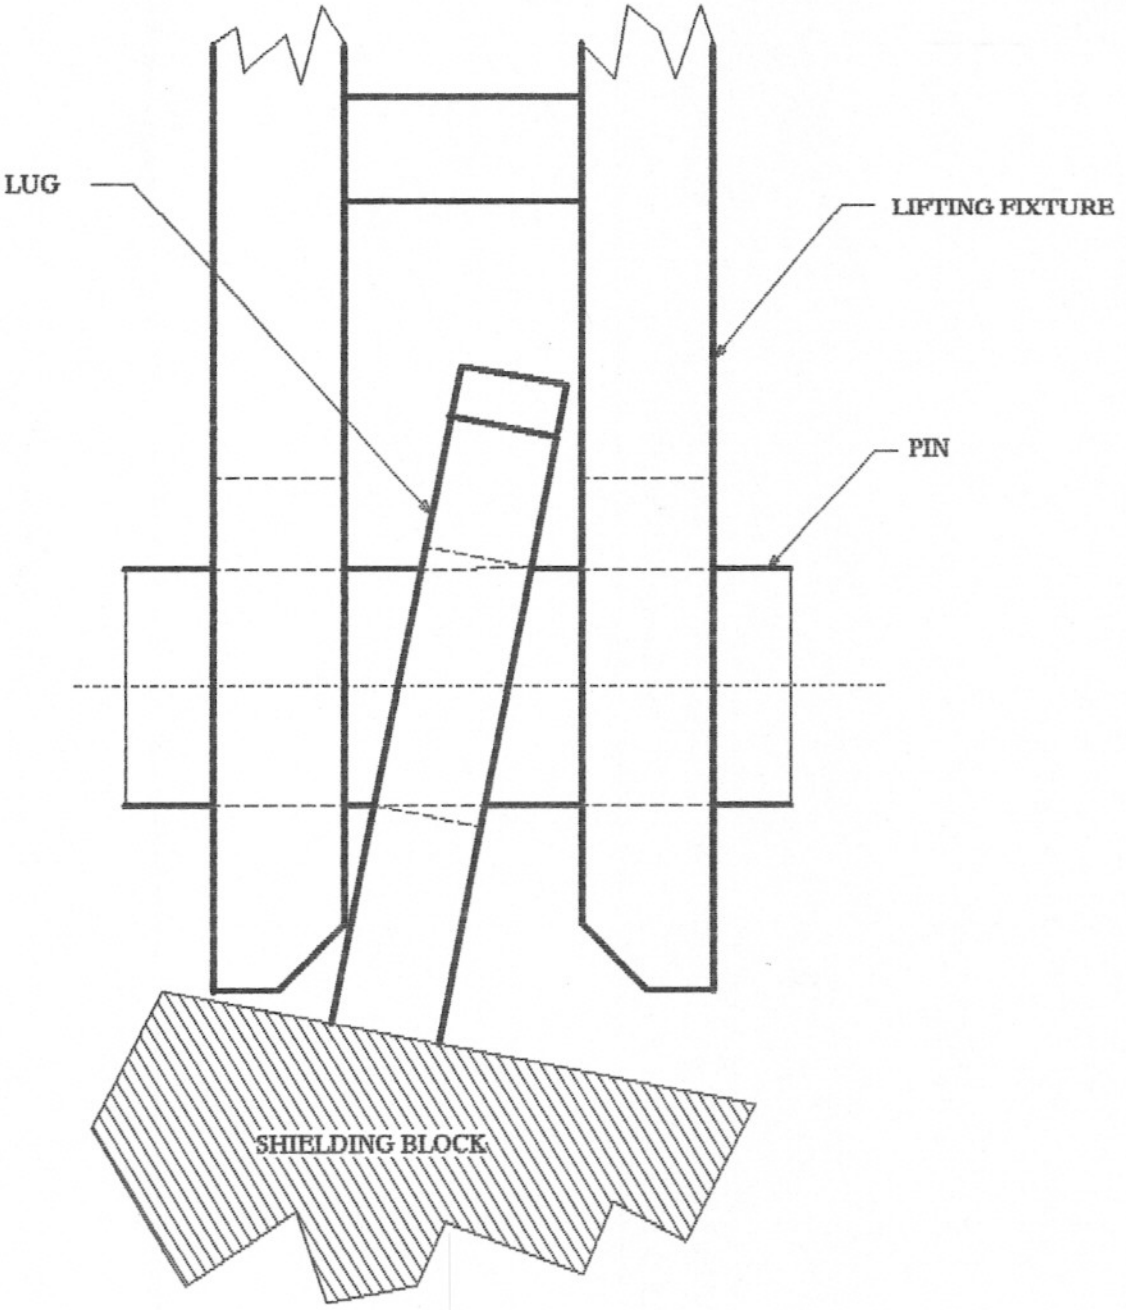
Inspection of the lifting equipment following the B-block failure showed that a large clearance existed between the lug and the lifting fixture used and between the lug and the pin, which can be seen in Fig. 4. The figure shows how these large clearances permitted the lifting fixture to impose large bending forces on the lug during horizontal accelerations. Analysis showed that bending stresses of over 56000 psi could be imposed by an acceleration of only 1 ft/sec^2. These stresses are extremely high and could result in lug failure.

Fig. 4. Old style lifting fixture showing lug in bending.

The second item is being accomplished by making several hardware changes to reduce the stresses on the lugs. The large clearance problem evident in earlier lifting fixture, and a contribution to the first lug failure, has been eliminated by the use of spacers or shims as an interim measure. Since these shims must be installed each time a block is lifted (and thus could be forgotten), a passive type lifting fixture has been designed which will clamp the lugs in a manner which will transfer the bending stresses to an area of the lug which has sufficient strength to safely resist these bending stresses. Calculations show that this fixture reduces bending stresses by up to 50%. A prototype fixture has been built and tested and a full production design of a passive lifting fixture is currently being manufactured for each experimental area crane. A drawing of this new fixture can be seen in Fig. 6.

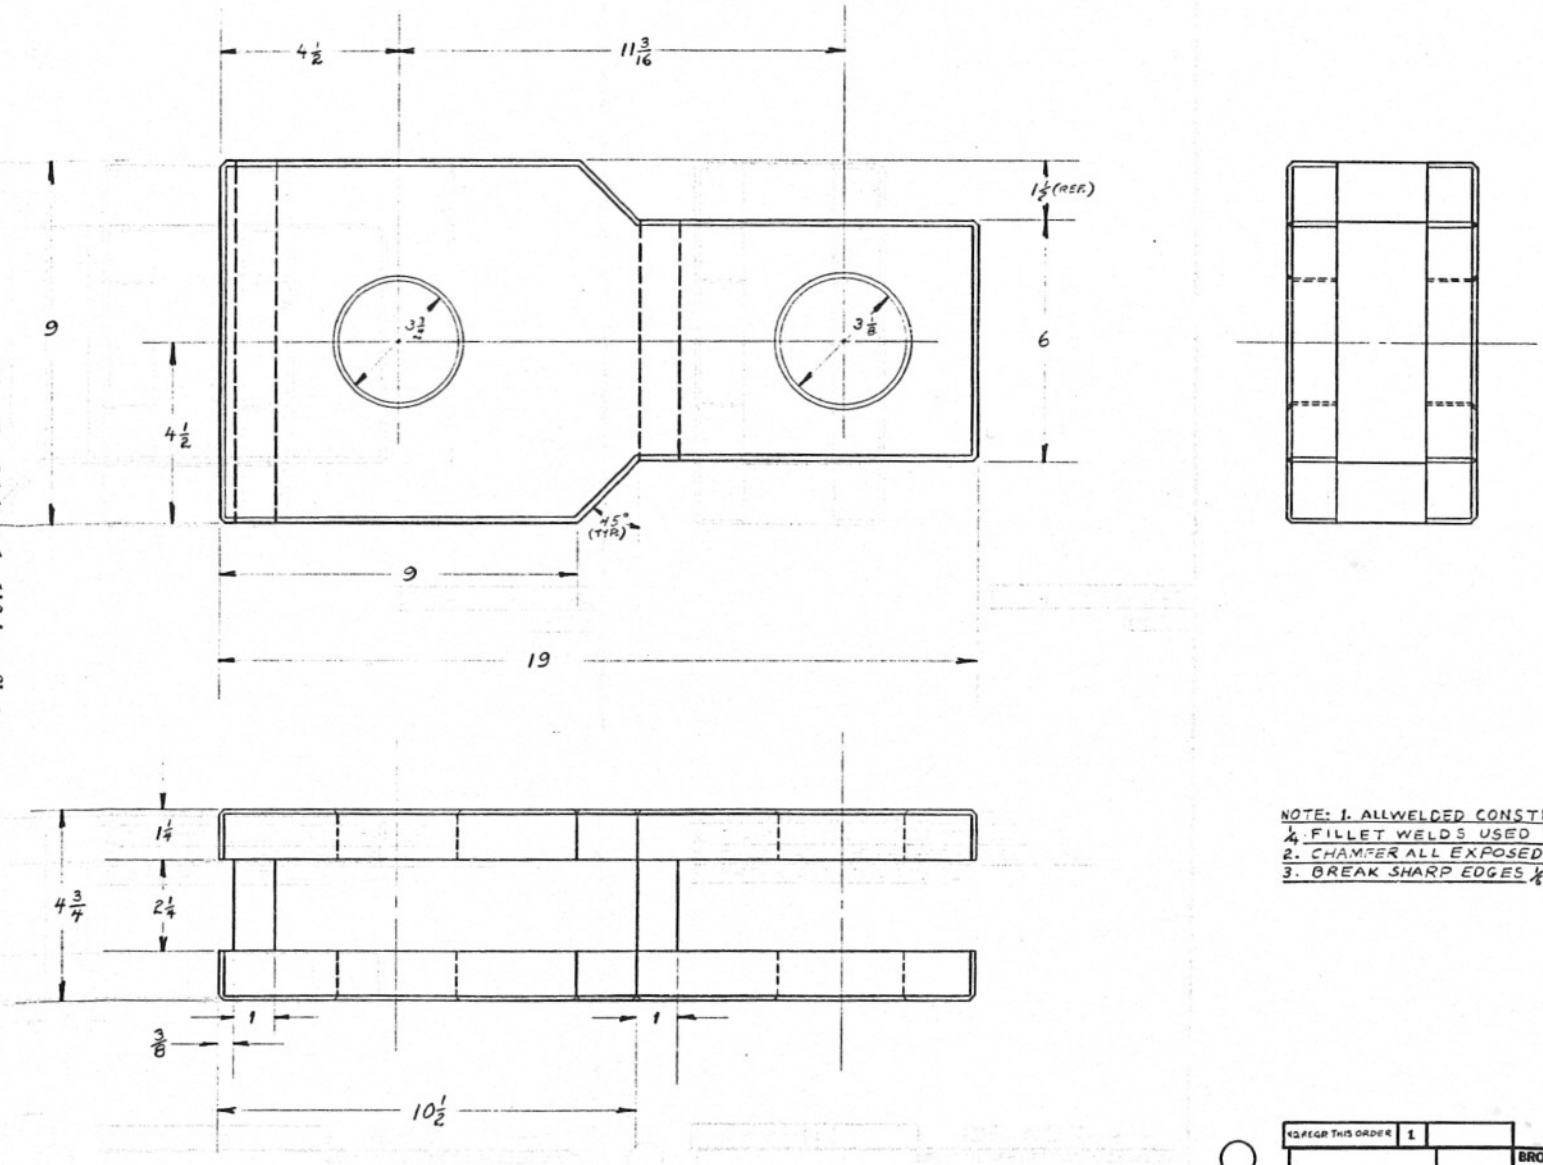
e. Large stresses were encountered when using the old style lifting fixture with a small pin. These stresses were greatly reduced by using shims and a larger pin in the old fixture to reduce the excessive clearances. These stresses were reduced even more by using a new, clamping fixture. The old style lifting fixture can be seen in Fig. 5.

Fig. 5. Old style lifting fixture.

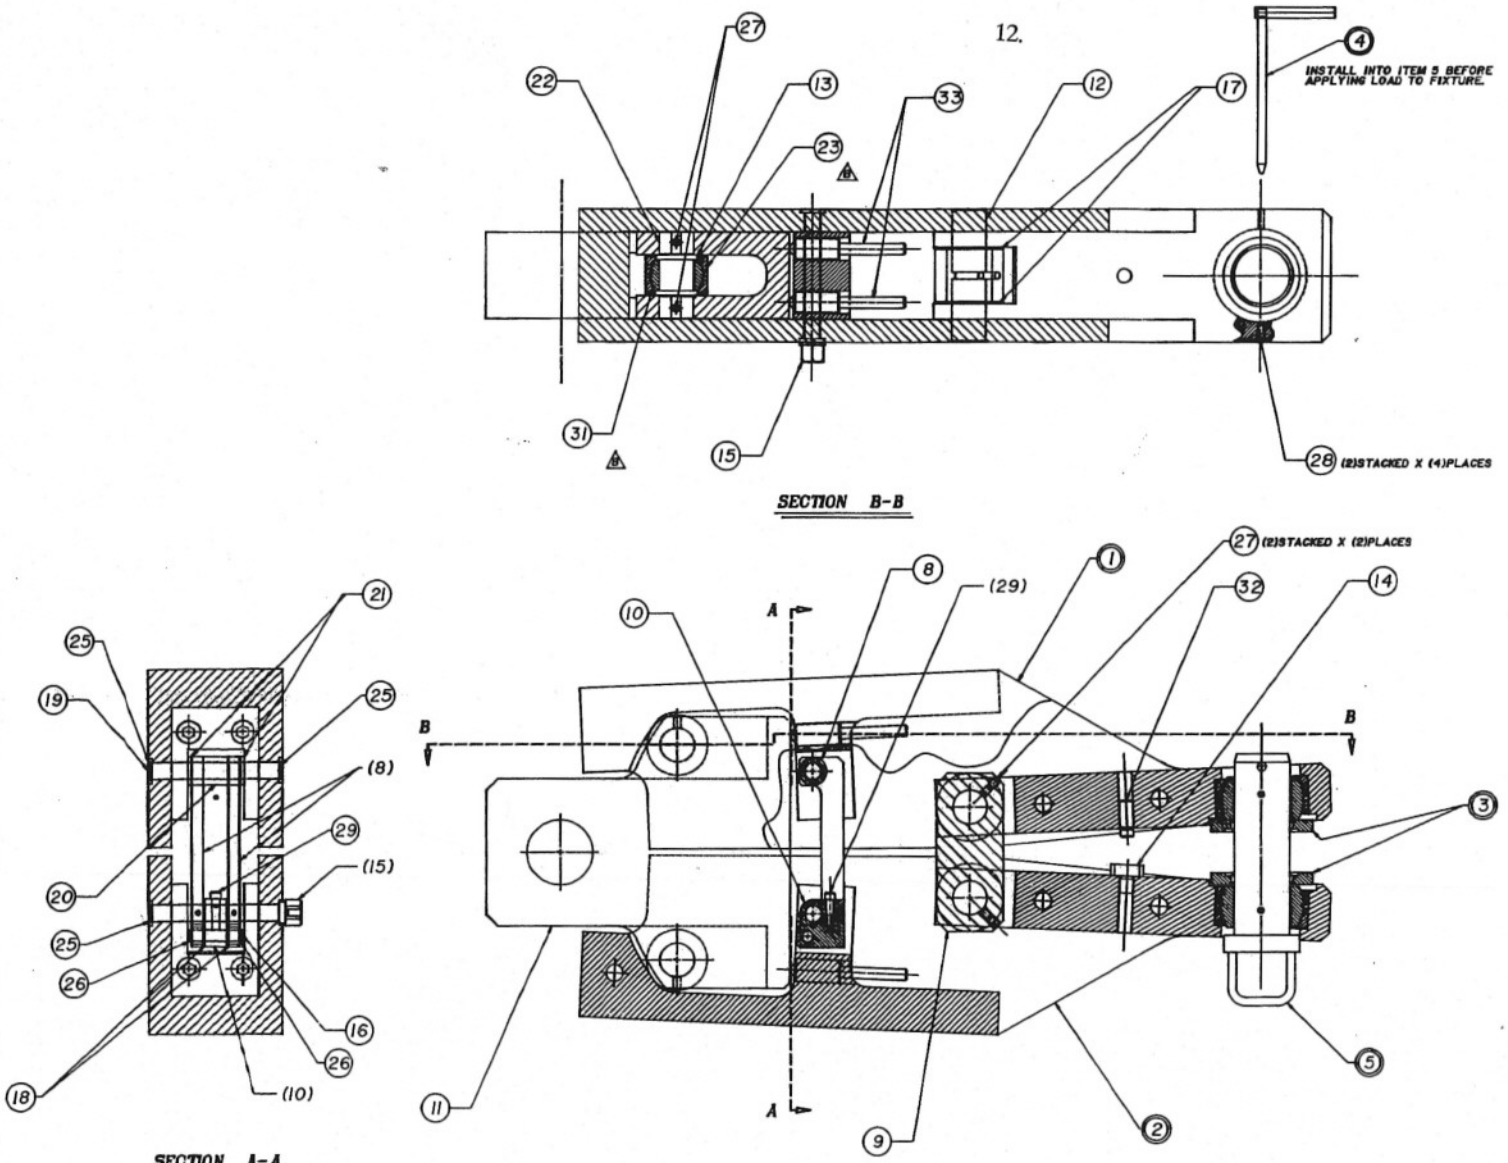
Fig. 6. New clamping lifting fixture.

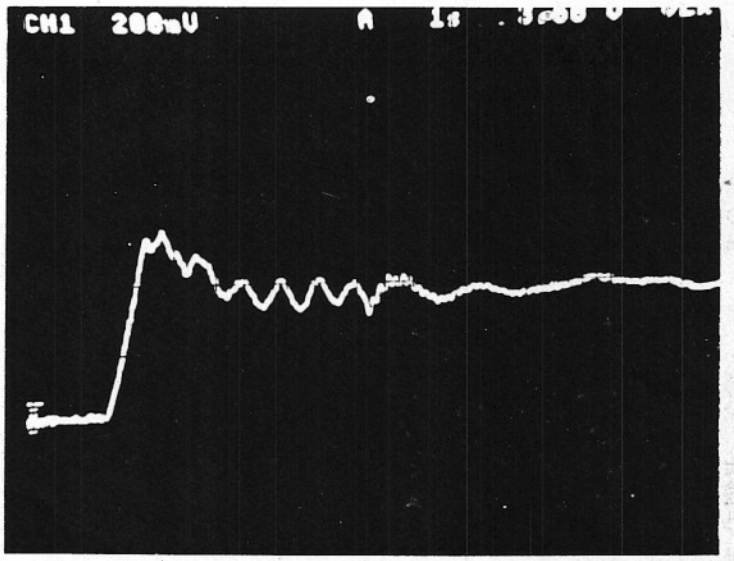
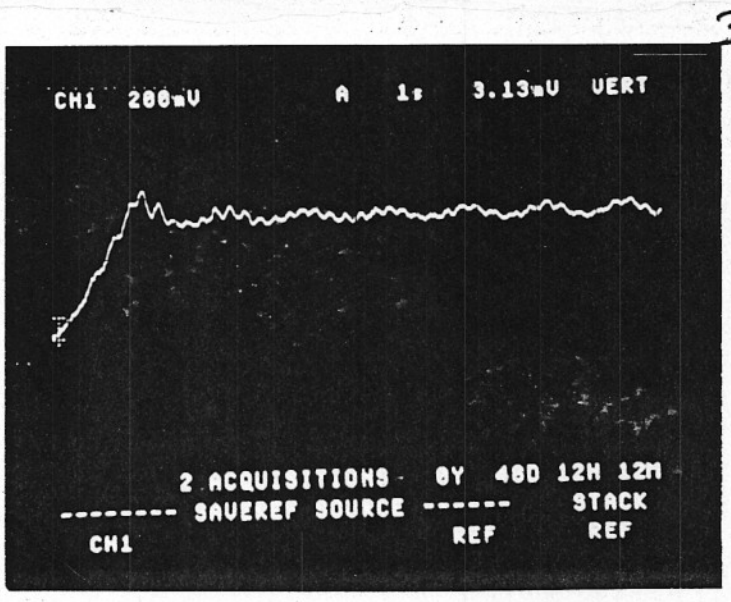
standard stepped motor controls, it was found that stresses on an instrumented block were reduced by a minimum of 28%. Qualitative examples of this reduced stress can be seen in Figs. 7 and 8. Figure 7A shows the strain (stress) of a lug during a slow lift suing an old style (stepped) crane control and Fig. 7B shows the strain using a Variable Frequency Control. Likewise, Fig. 8A shows the strain using the old style control during a fast lift and Fig. 8B shows the strain using the Variable Frequency Control. Speed controls, therefore, will be installed on all new crane motors and retrofitted on appropriate existing motors.

Fig. 7A. Lug strain during slow lift with stepped motor control.

Fig. 7B. Lug strain during slow lift with Variable Frequency Control.

Another hardware change is taking place at the cranes themselves. Since the second lug failure resulted from an inability to determine and control the force exerted on the stuck block, load readout and limiting controls are being procured for each of the Experimental Area's cranes. The testing of such devices has already been accomplished on the new NEEBA crane and it is judged that they work quite well. Additionally, limiting and controlling the rate at which the cranes apply their forces to the lugs can further reduce the lug stresses. This can be accomplished by using Variable Frequency Controls (VFC) on the crane motors. In comparing VFC's with

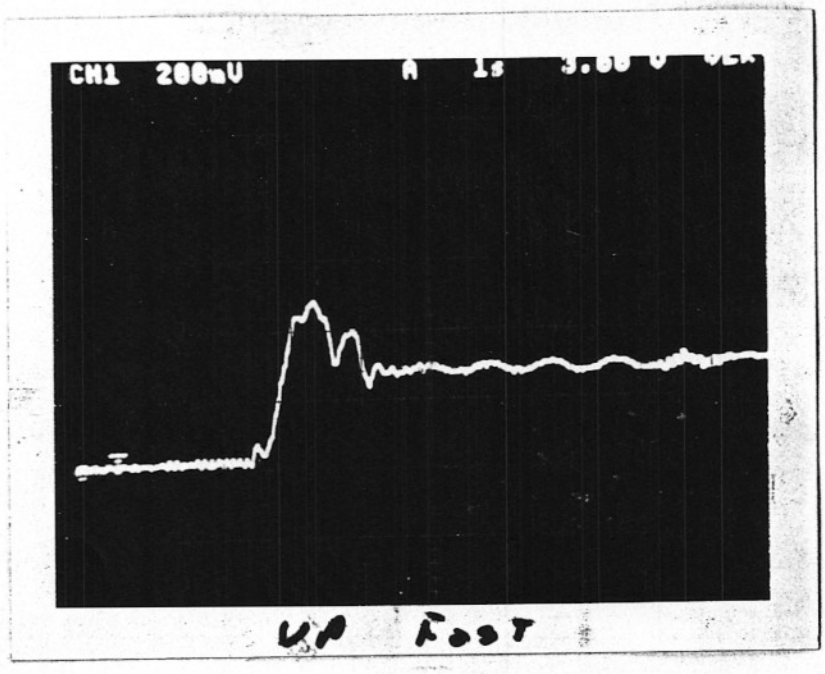
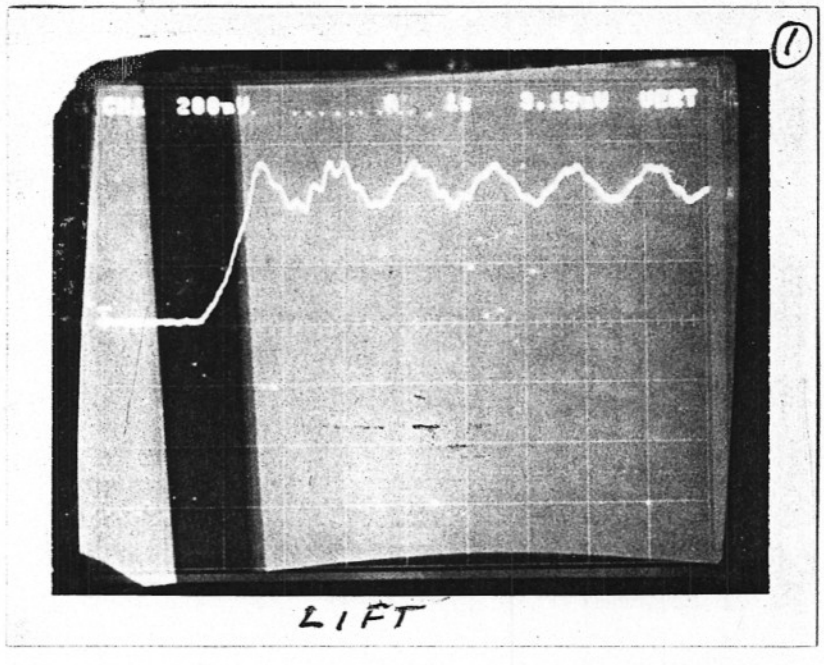
Fig. 8A. Lug strain during fast lift with stepped motor control.

Fig. 8B. Lug strain during fast lift with Variable Frequency Control.
