**RHIC POWER
SUPPLY
HARWARE PLANS
FOR
FEBRUARY 2002
TO
OCTOBER 2002**

RHIC Power Supply Hardware Plans

Major Problems and Solutions from June 2001 to January 2002

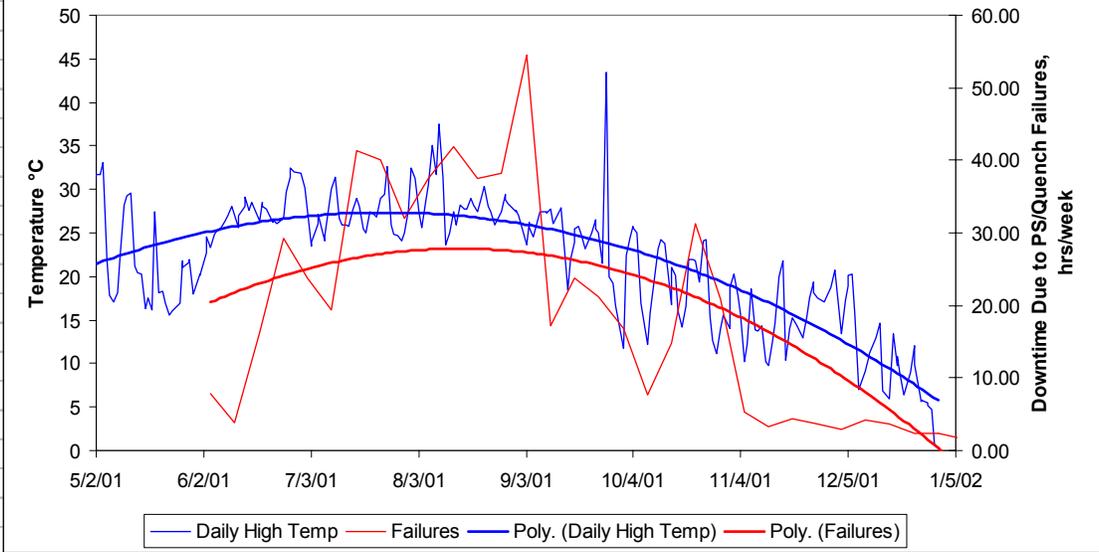
Max Daily Temperature and Power Supply Failures

This next slide is a plot of RHIC Power Supply Failure Hours per Week and Daily Maximum Temperature and Daily Maximum Humidity. Trend Lines are plotted for both.

Failure Hours is defined as
P.S.'s (Y&B) + Main
Magnet P.S.'s + QLI's
