BROOKHAVEN NATIONAL LABORATORY

MEMORANDUM

Date: 11/17/89
To: E. Lessard
From: J. Alessi *g.a.*
Subject: Review of the Linac security system

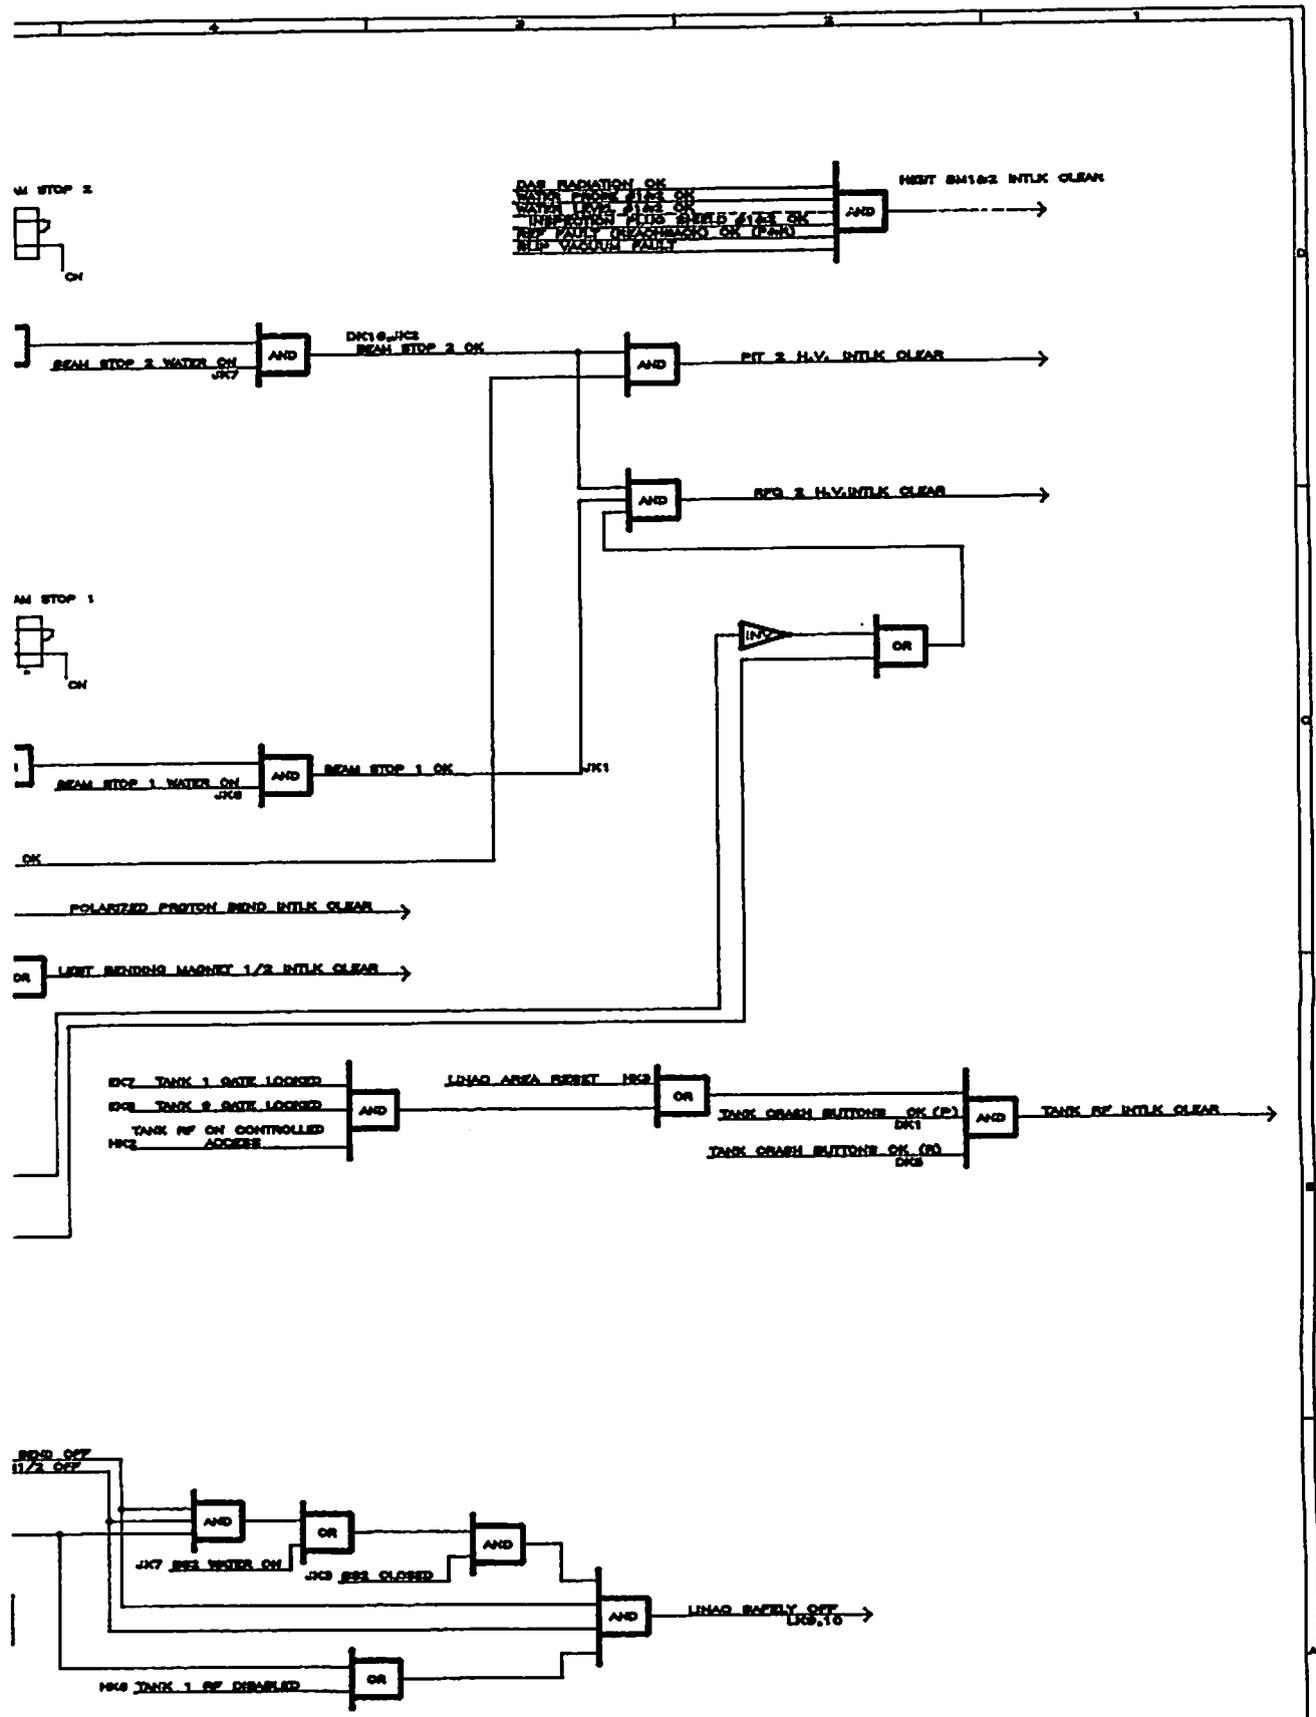
BROOKHAVEN NATIONAL LABORATORY			
UTRON, N.Y. 11972			
Title: APPROVED LINAC SECURITY LOGIC			
Doc#	Document Number	A.J. McGeary	REV
0	LINLOG		0
Date:	July 20, 1982	Sheet	of 1

- NOTES
1. Method to insure low intensity operation to be determined and required to be in place before this signal is enabled
 2. Jumper if single P.S. used for LEFT BM 1/2
 3. Use to run RFQ2 into Lines. Disable Low Intensity mode.

3. We found no discrepancies between the logic diagram and the wiring diagrams. The logic diagram does not fully show the redundancy of the system, but including the redundancy would complicate the diagram to the point that it would be difficult to follow the functionality. Other than the items above, the system seems to perform as it should. There are a couple of minor changes which could be made in the logic, unrelated to High Hazard Safety but rather regarding some conditions to allow equipment testing when the Linac is off. The committee will present these to A. McGeary for future consideration.
