### **Subject: Deuterons from EBIS and CeCPoP Radiological Issues**

### **Deuteron Beams from EBIS**

## CeCPoP Radiation Issues

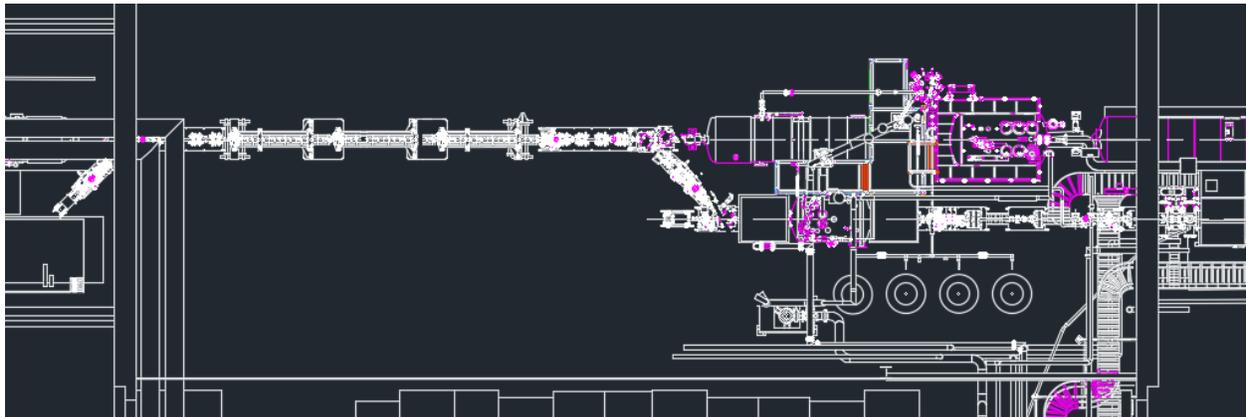
**CeCPoP at IR2.**

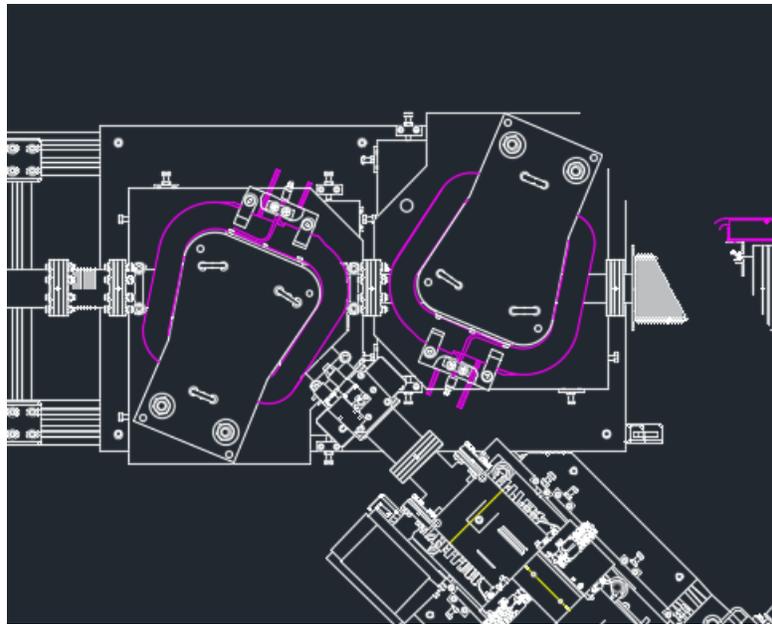
**Electron Injection into RHIC and the pair of dipoles.**

factor of 500 to 5000 that of the electron beam. The electron beam is bent 45° which means the maximum kick to the RHIC beam is 0.09 degrees before being bent back on axis by the partner dipole. All five dipoles are operated in series and have the same bending power. If the Power supply drops off or changes current it does not appear to cause beam loss issues for RHIC. It is intended that the power supply for these dipoles will be monitored by the MPS.

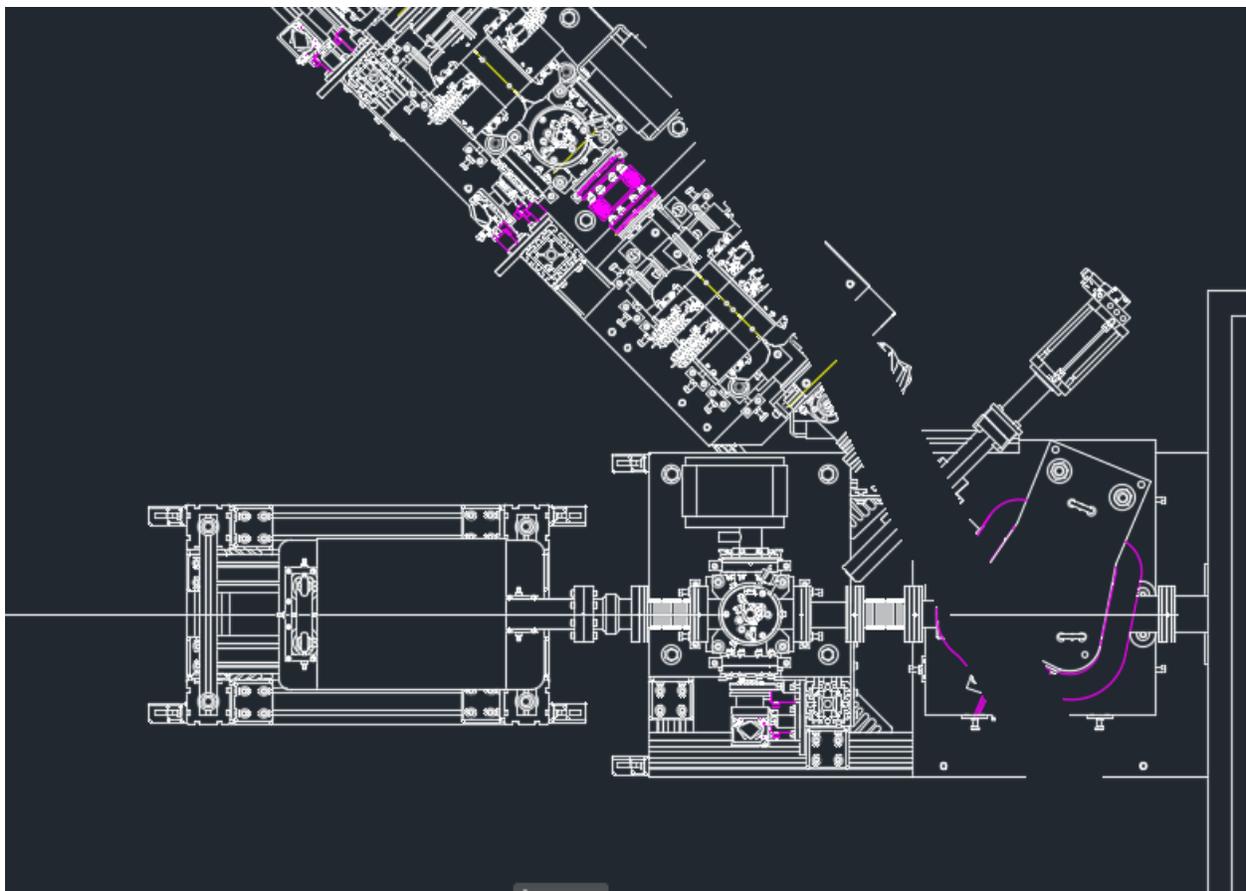
**Low Power beam dump and first 45 degree bending magnet.**

I. Pinayev noted that the expected mode of operations will be low power operations to the straight ahead beam dump (low power dump) with 0.1 W of 2 MeV beam and 1.0 W of 22 MeV beam. He expects that the beam size for 2 MeV will be 1mm. The thermal analysis was conducted for 3mm and 1 Watt. These two factors differences should compensate and the expected temperature in the window would be 56° C. The area of the beam for 22 MeV is expected to be 10 times smaller and at 1 Watt the window could be as hot as 300° C. This is based on the same energy deposition but over a smaller area. This is a machine protection issue since if the window fails the machine turns off and is potentially damaged. It is expected that when beam is transported to the low power beam dump the vacuum valve between the 2 MeV beam transport and RHIC vacuum will be closed. No exposure or ALARA issues are expected for such a failure.

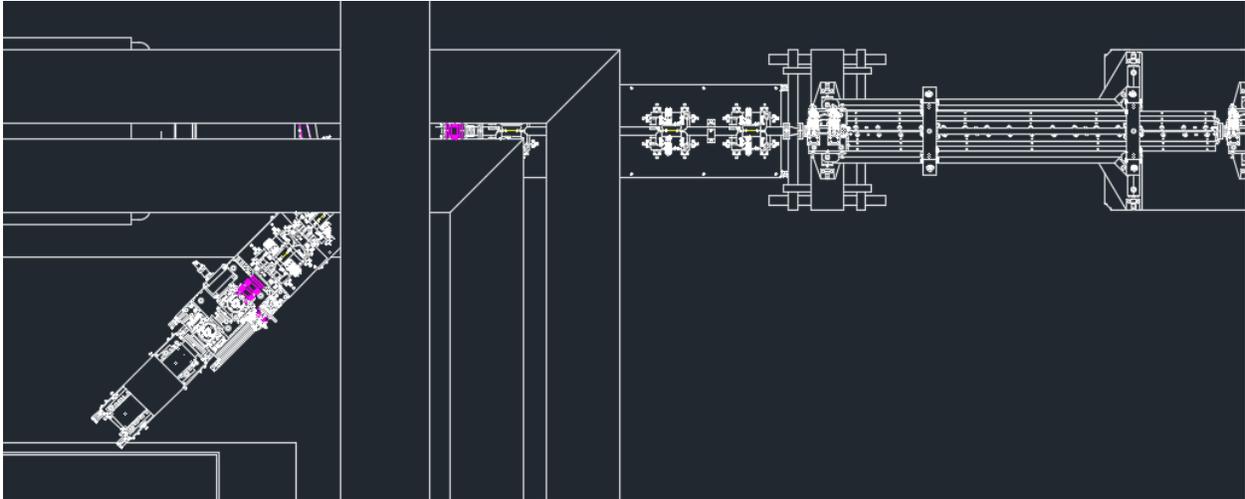
**Extraction to the water cooled beam dump. Some items are obscured by overhead trays and pipes.**

**The Project does not intend to deflect the low energy beam (2 MeV) with the first dipole.** The Project has not requested reviewing the transport of 2 MeV beam to the water cooled beam dump. However, except for possible over-bending by magnets the radiation hazards are higher for the 8500W 22 MeV beam. If the CeCPoP decides to bend the beam with the bending magnet then a short review will need to be conducted.

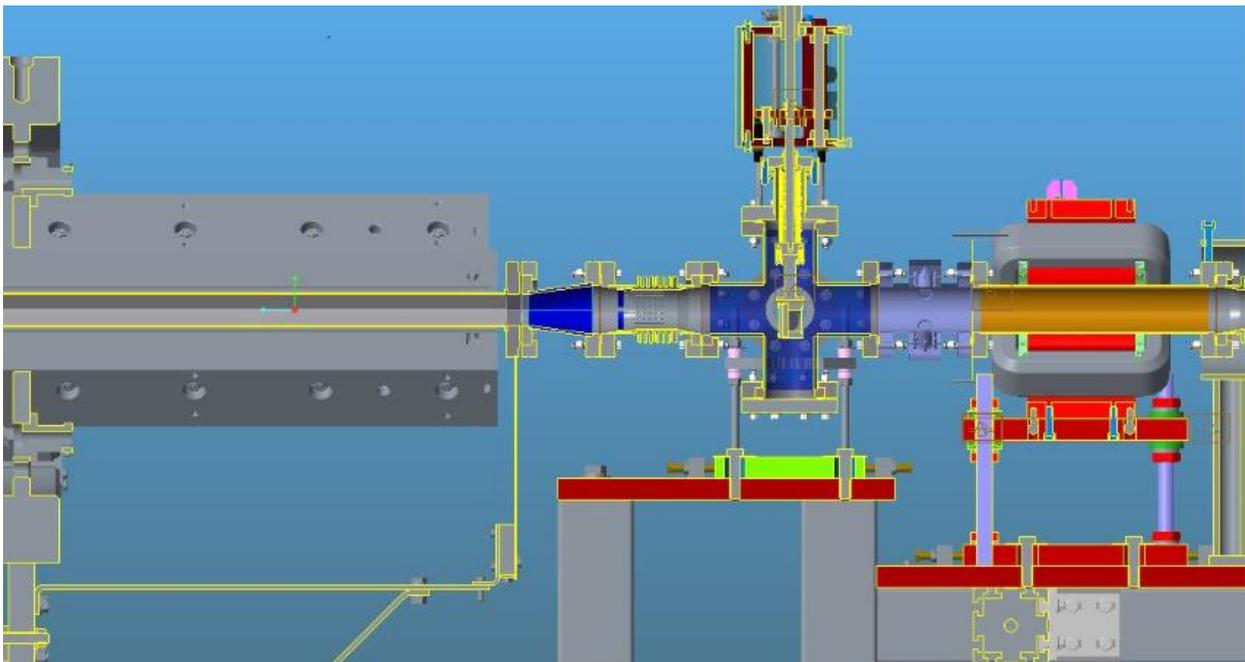
**Decrease in aperture at the undulator is shown in side view.**
