RHIC Retreat 2009
Beam Position Monitor System
July 16, 2009

BPM System Overview

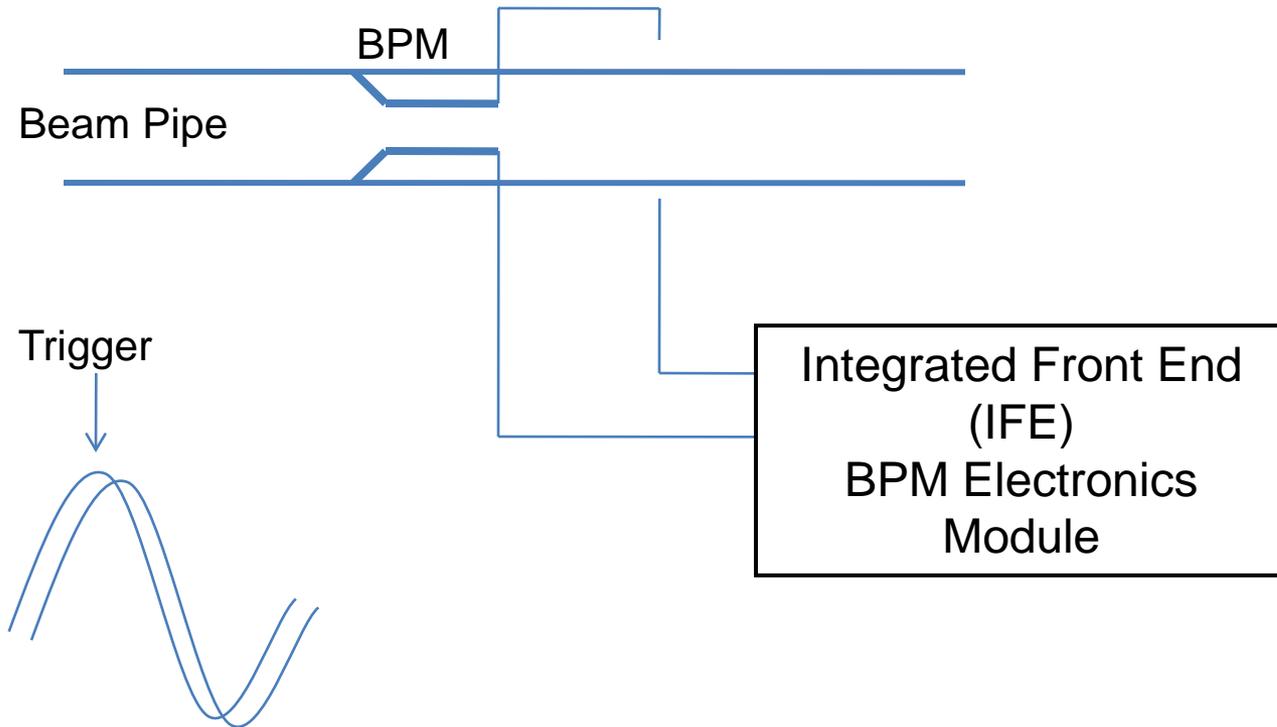
Very Fine Delay Timing

Signals from stripline

When these signals are not perfectly aligned, position measurements vary as trigger position changes. The hardware provides 20 ps per count adjustment.

- Very fine delay timing was found to be critical in order to limit position changes as fixed-trigger timing varies.
 - Although C. Degen has developed a Labview VI to help determine optimal very fine delay settings, significant work is still required to robustly automate this operation.
- Calibration with external signal may be required.
 - The very fine delay timing may not have been properly configured when the external calibration was last performed.
 - This will require a substantial effort – many weeks.

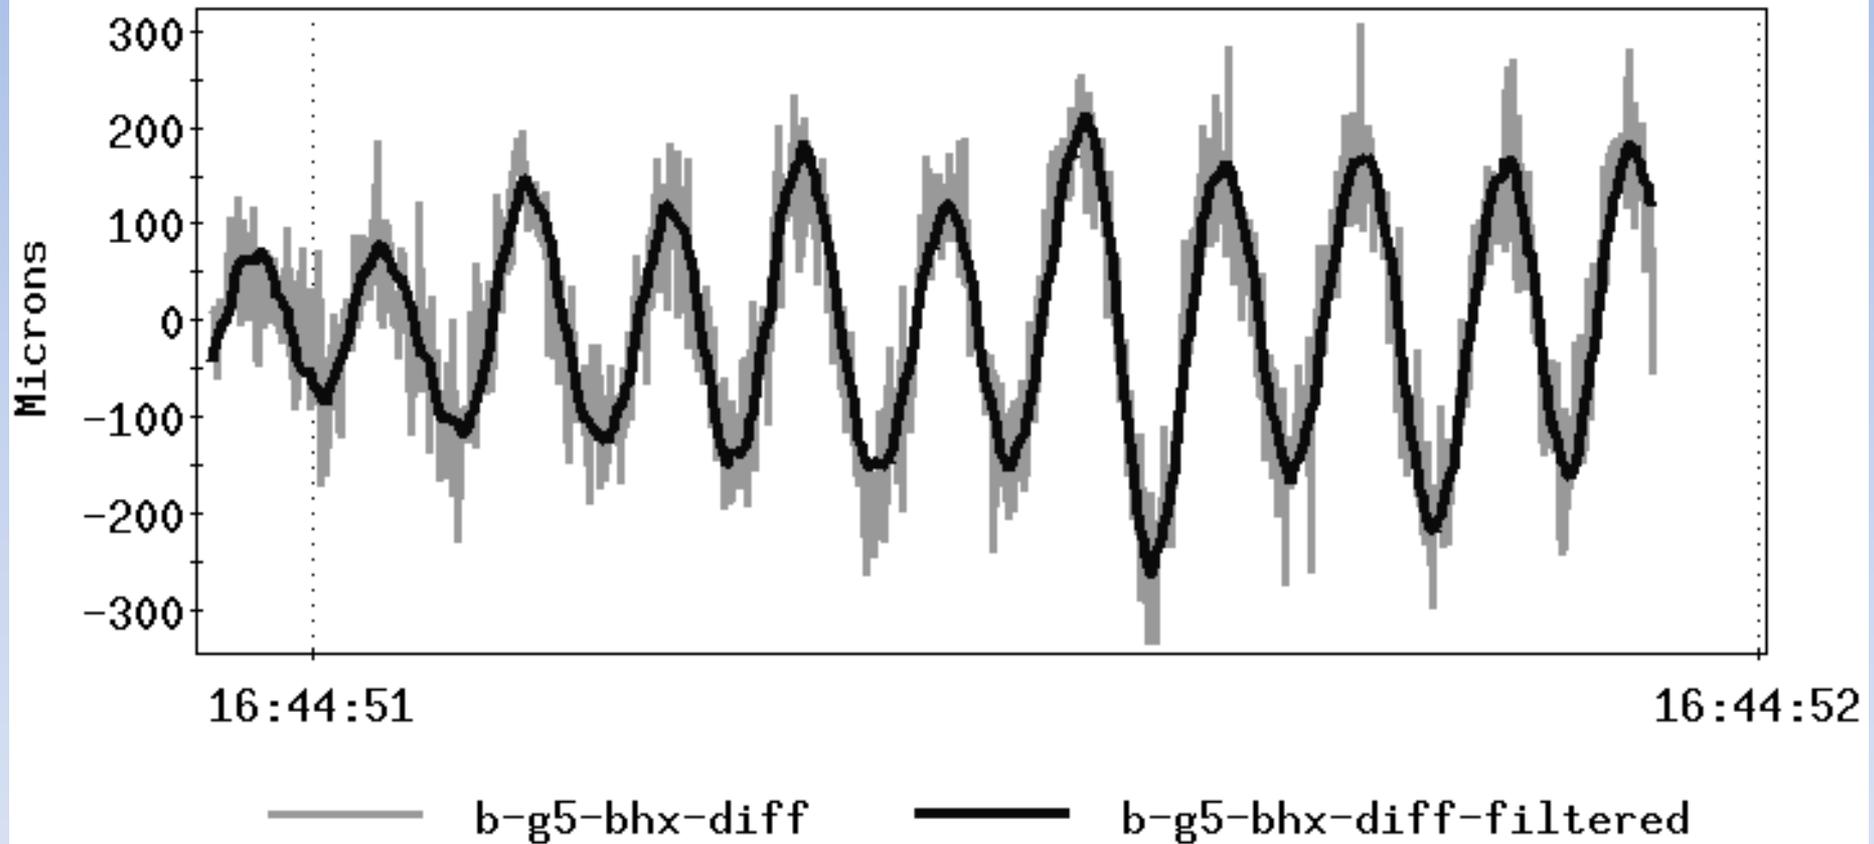
BPM Signal (new output tested this run)

The digital filtered difference signal will be used for the orbit correction calculations.
